# NORTH URBAN WATERSHEDS

Shoal Creek | Waller Creek | Johnson Creek | Lady Bird Lake

Watershed Profile - December 27, 2016

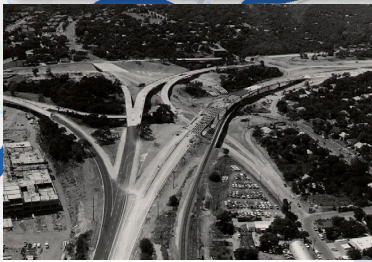
The MoPac Expressway, photographed here undergoing construction in 1974, transects the entire **Johnson Creek** watershed.

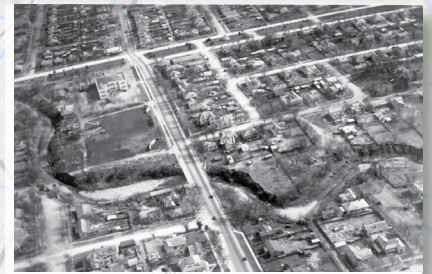
Channel erosion has long affected **Waller Creek**. It is visible in the top image of the creek at East 1st St., now Cesar Chavez St. The photo was taken prior to the construction of I-35 in the 1950s. Below this image, Edwin Waller's 1839 plan shows how the city grid was planned without considering the creek, promoting encroachment.

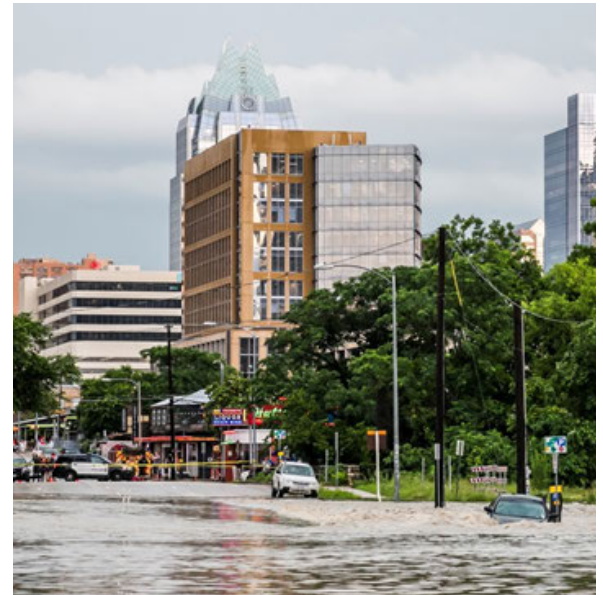
*Flooding on lower Shoal Creek, Memorial Day 2015*

Due to the topography of the floodplain and undersized nature of the channel, floodwaters routinely flow along **Lamar Boulevard** between 15th and 9th streets. Businesses and roadways in this area are subject to inundation during medium and large storm events.

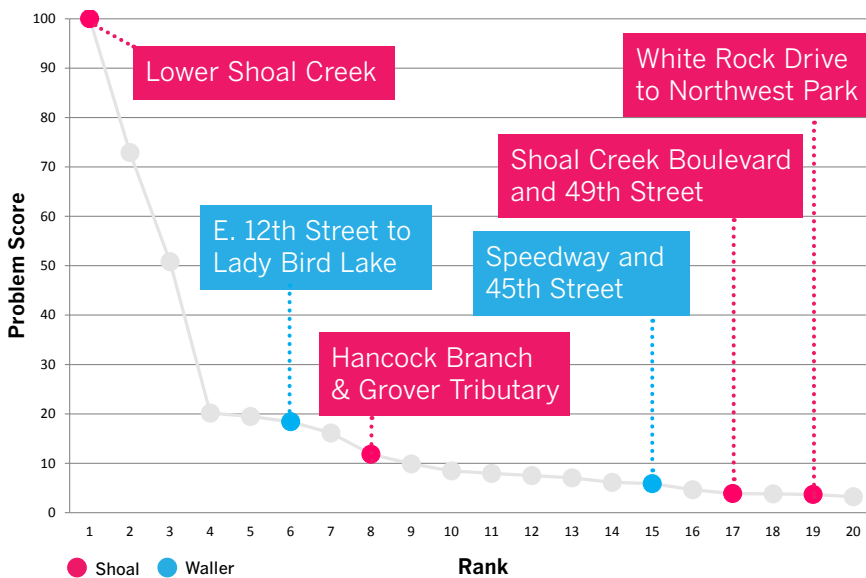
## Creek Flood Structures: Top 20 Problem Scores

Problem scores are a function of three elements:

- 1) Problem severity,
- 2) The number of resources impacted, and
- 3) The type of community resources impacted by the problem.

The graph to the left plots the citywide top 20 ranked groups of structures by their problem scores. Shoal (magenta) and Waller (blue) creeks feature six of the top 20 flood problems. With a problem score of 100, Lower Shoal Creek between 15th Street and Lady Bird Lake is the worst flooding problem in the city. This also makes it the highest-ranked structure cluster. For fiscal year 2017, WPD will undertake a study to identify and evaluate potential flood mitigation solutions for this area.

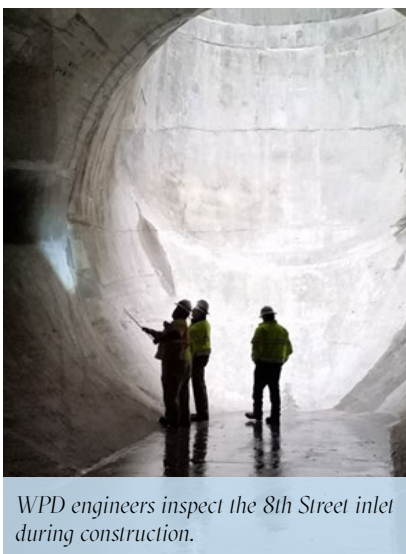
*WPD engineers inspect the 8th Street inlet during construction.*

The Waller Creek Tunnel project addresses flooding (#6 rank) and erosion (#1 rank) along lower Waller Creek. The floodplain is 800 feet wide at points, potentially flooding significant areas of downtown. When complete, the tunnel will remove 28 acres of property from the 100-year floodplain, providing flood protection to 42 buildings and 12 roadway crossings. The tunnel system will also replace water within the tunnel with fresh water from Lady Bird Lake to prevent the water from becoming septic. As an added benefit, this recirculation system will supplement creek baseflow, enhance water quality, and improve the ability to support aquatic life. Furthermore, the tunnel will facilitate redevelopment in the Waller Creek District. While the tunnel itself allows development in an area that was previously within the floodplain, the larger park, stream, and trail improvements will also create an amenity to anchor the value of nearby redevelopment—all of which contribute to the economic structure created to pay back the bonds for the tunnel construction through a tax increment financing (TIF) zone.

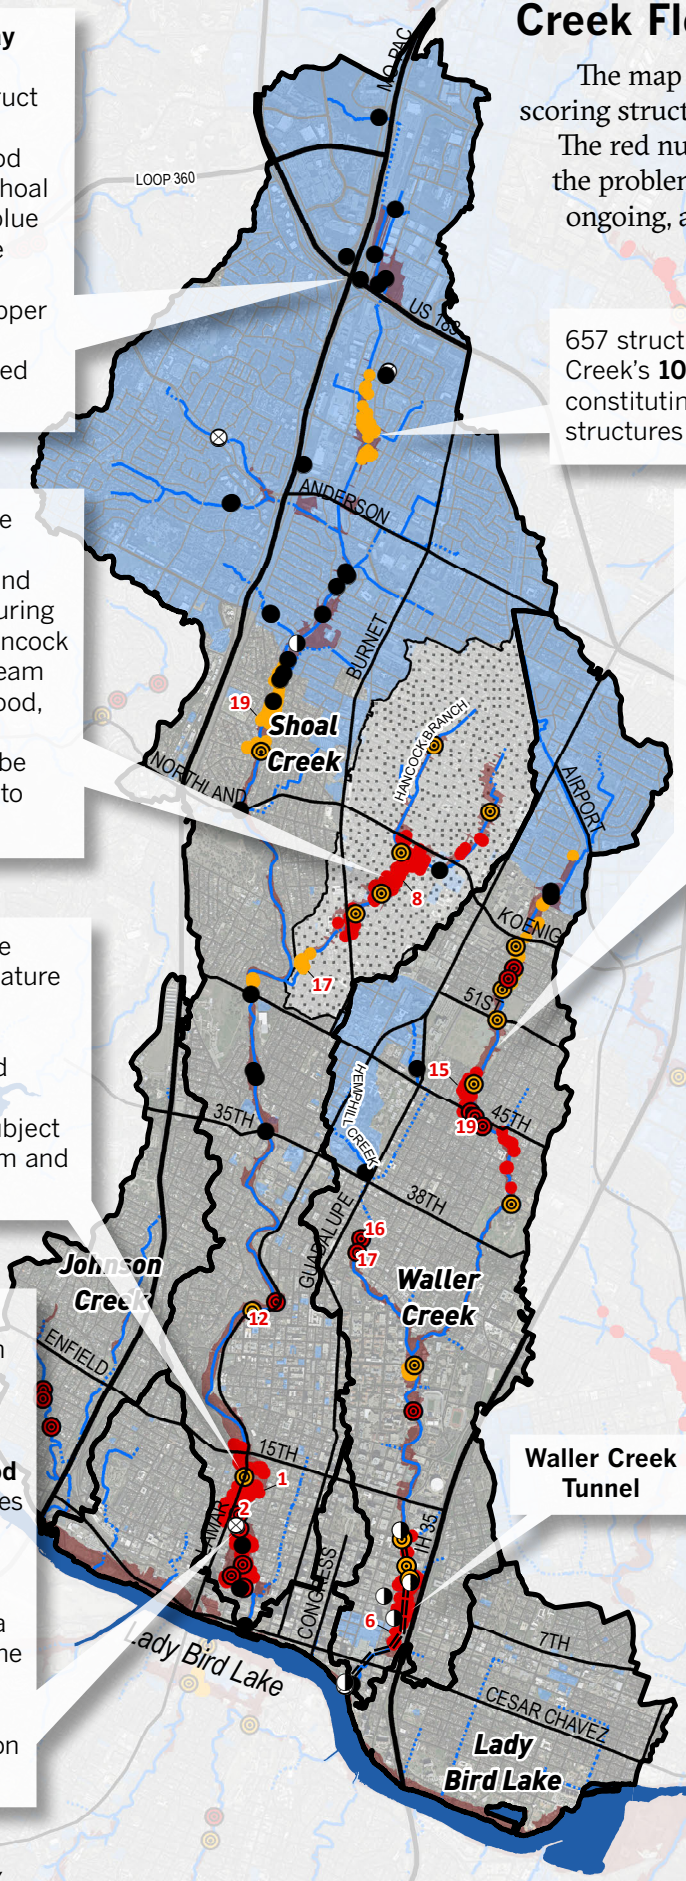
The map below shows “high” and “very high” scoring structure clusters and roadway crossings. The red number indicates the citywide rank of the problem. The map also includes completed, ongoing, and planned creek flood solutions as filled, half-filled, or open points.

Since the **1981 Memorial Day Flood**, WPD has spent over \$65 million dollars to construct detention ponds, channel modifications, and other flood mitigation solutions in the Shoal Creek watershed. The light blue areas represent the drainage areas to detention ponds. Detention is critical in the upper third of the watershed, as it allows the flows to be released into the creek more slowly.

Ninety-six structures near the **Hancock Branch and Grover Tributary** along Joe Sayers and Grover avenues are at risk during an 100-year flood. As the Hancock Tributary is directly downstream of the Brentwood neighborhood, any solution to the localized flooding in Brentwood must be carefully designed so as not to worsen flooding in this area.

657 structures are within Shoal Creek's **100-year floodplain**, constituting 15% of citywide structures in the floodplain.

Two **low-water** crossings on 9th and 10th streets between Lamar Blvd. and West Ave. have been closed nine times between 2010 and 2016. Real-time data from the **Flood Early Warning System** enables WPD to close crossings in advance of flooding. Early warning is crucial at this location, as flooding during a 100-year storm can reach nine feet. These crossings will be assessed in the Lower Shoal Creek Flood Hazard Mitigation Project.

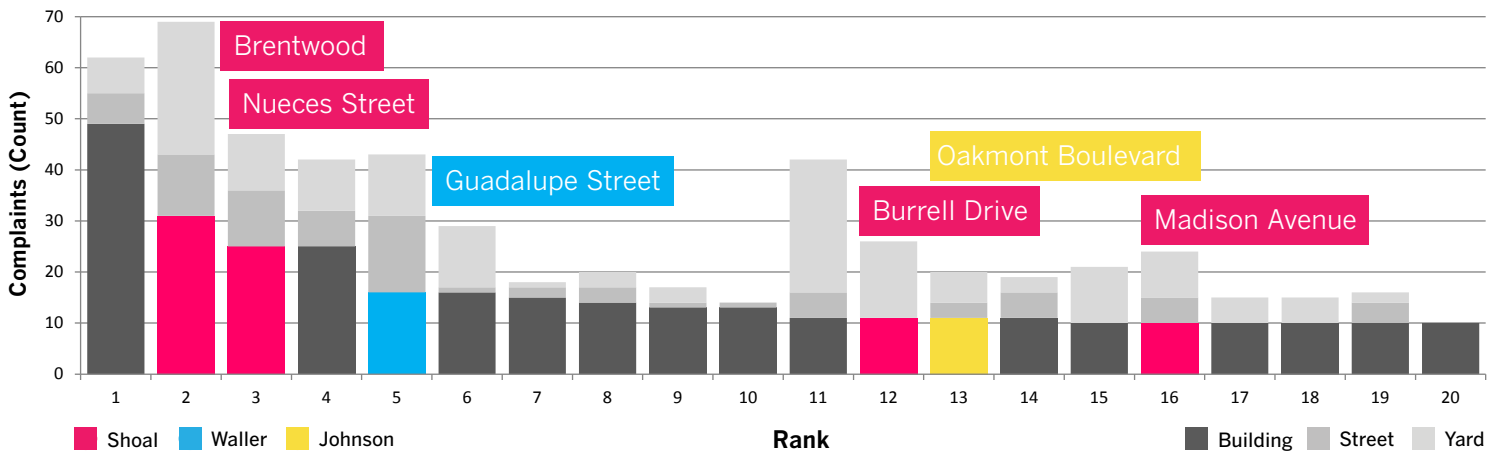
Localized Flood Problem Areas: Top 20 Ranked Problem Areas

The graph below plots the citywide top 20 ranked problem areas by the total number and type of complaints. Shoal (magenta), Waller (blue), and Johnson (yellow) creeks feature six of the top 20 ranked problem areas. The Brentwood neighborhood in Shoal Creek is the second ranked problem area. As this area is also a high priority for the erosion mission and directly upstream of the Hancock Tributary of Shoal Creek, a comprehensive multi-mission solution is needed to address the problem. WPD is initiating a feasibility study that evaluates all possible solutions.

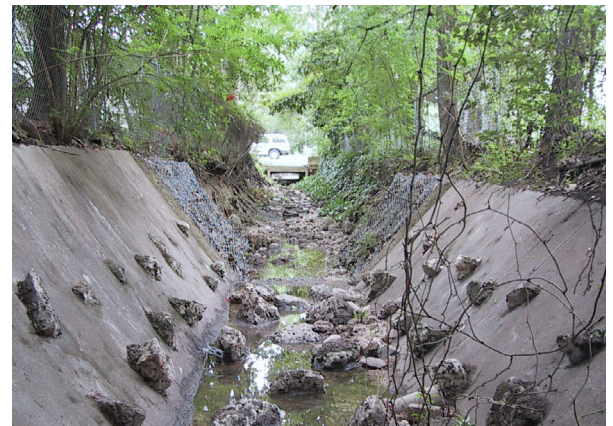
Grover Tributary

The Brentwood neighborhood was developed throughout the 1940s and 1950s with drainage infrastructure that was designed prior to modern drainage criteria. Undersized channels, culverts, and storm drains result in street and structure flooding on a frequent basis. Development of the neighborhood also altered the natural drainage patterns of the two main channels, Hancock Branch and Grover Tributary, both of which are severely eroding. A preliminary engineering study for a multi-mission project in the area is planned to begin in fiscal year 2017. The purpose of this study is to recommend feasible, cost-effective solutions to flooding and stream erosion in the area, while also incorporating improvements to stormwater quality.

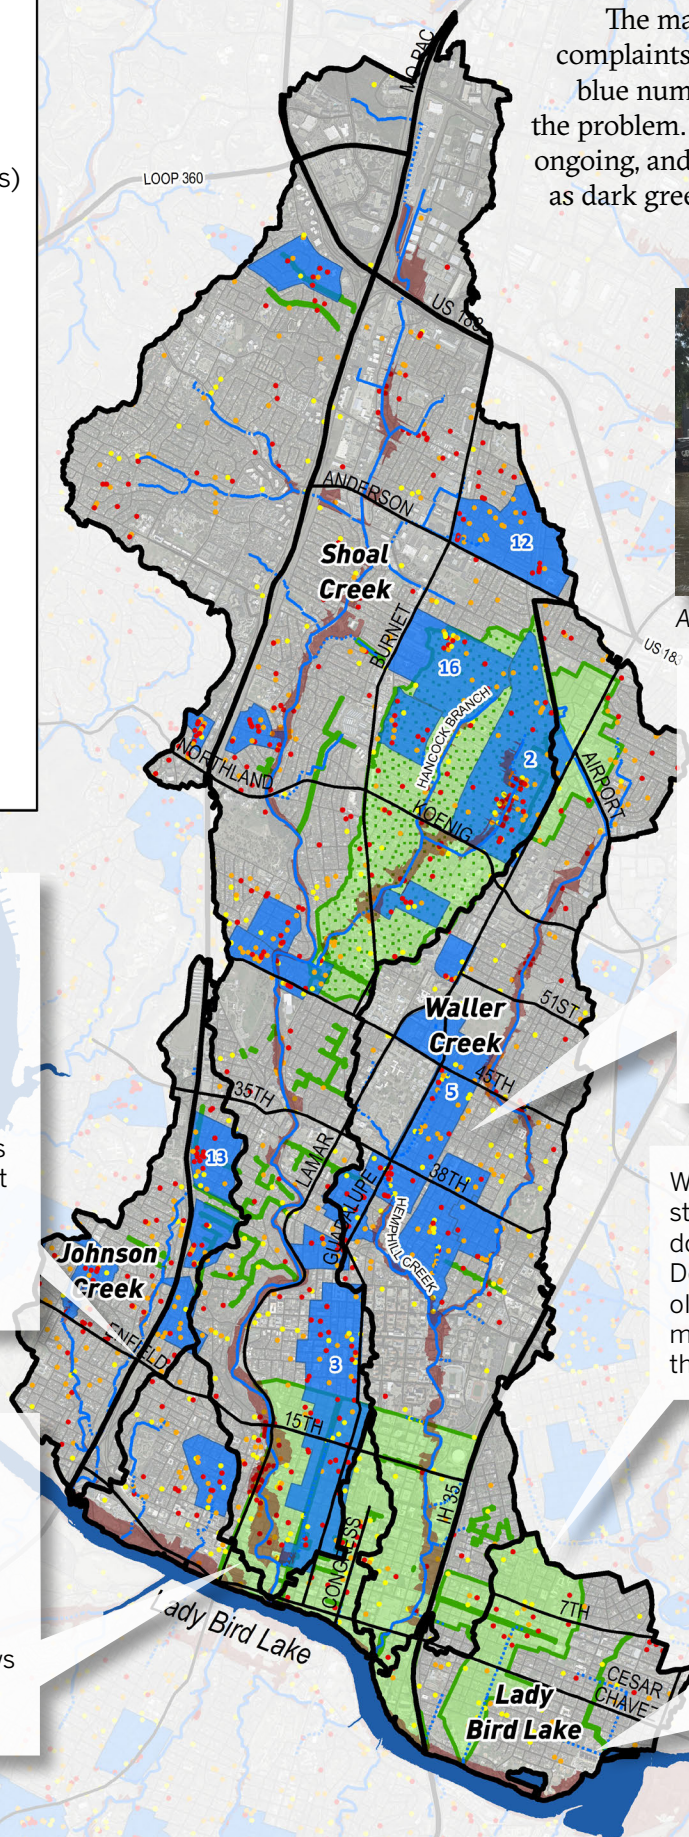
The map below shows localized flooding complaints and identified problem areas. The blue number indicates the citywide rank of the problem. The map also includes completed, ongoing, and planned localized flood solutions as dark green lines, areas of green, or areas of green with a dark green dots.

**Johnson Creek**, typically surpassed by Waller and Shoal in terms of problem severity, has the greatest portion of its watershed identified as a Localized Flood Problem Area (almost 22%). Preliminary engineering is underway to evaluate alternatives to address 10 building, 7 yard, and 2 street flooding complaints within Johnson's **Oakmont Boulevard** problem area, which is ranked 13th in the city.

Because **Hyde Park** was largely developed in the 1920s and '30s, many of its storm drains are undersized. While WPD's vactor trucks can remove blockages from undersized systems, significant capacity upgrades are often needed. The **Guadalupe Street** problem area is ranked 5th citywide. Preliminary engineering is underway to evaluate alternatives to address 15 building, 16 street, and 10 yard flooding complaints.

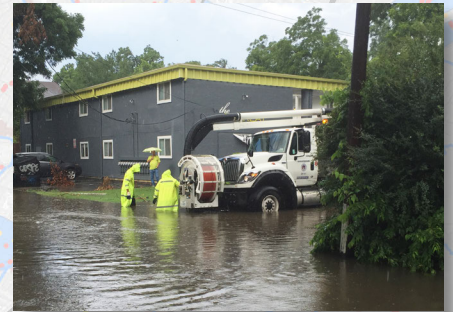
A vactor truck crew in Hyde Park

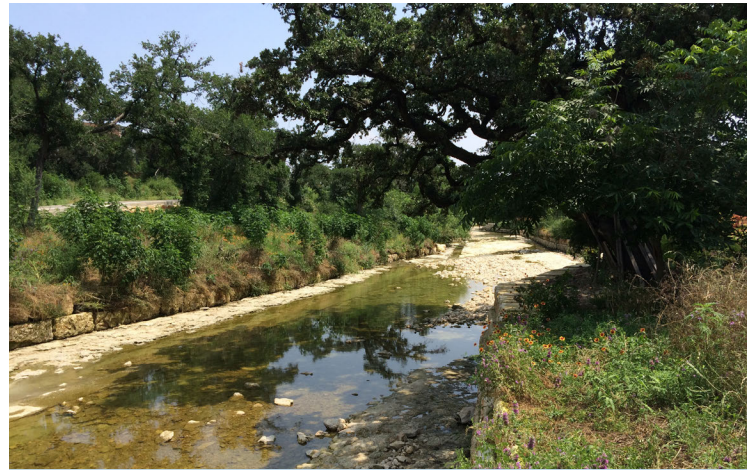
Restoration along Shoal Creek in Pease Park between 15th and 28th streets.

**Highlighted Project: Shoal Creek Restoration**  
 The Shoal Creek Restoration project aims to provide erosion protection to Shoal Creek, improve the quality of stormwater runoff, and restore native vegetation along the creek corridor. In addition to stabilizing approximately 3,000 feet of the creek bank, the project will also retain or restore the natural character of the greenbelt and integrate with existing uses in Pease Park.

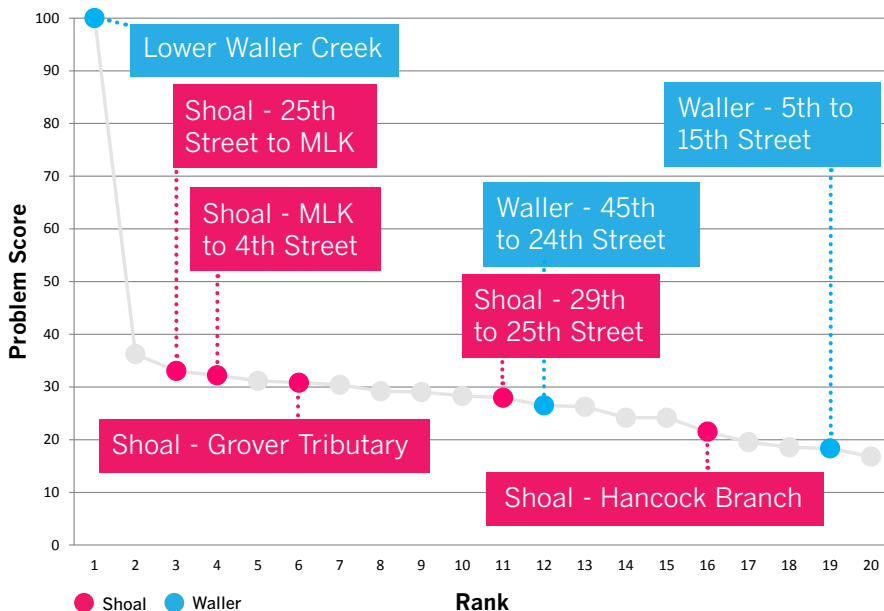
## Erosion Reaches: Top 20 Problem Scores

The graph below plots the top 20 ranked reaches by problem score. Shoal (magenta) and Waller (blue) creeks feature eight of the citywide top 20 ranked reaches. With a score of 100, lower Waller Creek is by far the most severely impacted reach in the city. The Waller Creek

District Creek and Trail Improvements Project will address this reach by providing a stable, ecologically sustainable creek system from Waterloo Park to Lady Bird Lake in collaboration with the Waller Creek Conservancy. WPD is also initiating a feasibility study to address the Grover Tributary and Hancock Branch of Shoal Creek (ranked #6 and #16, respectively).

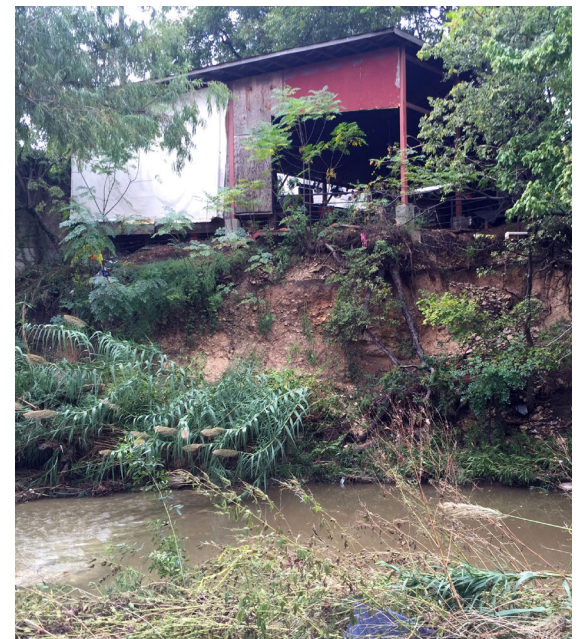
Severe erosion threatens resources along lower Waller Creek.

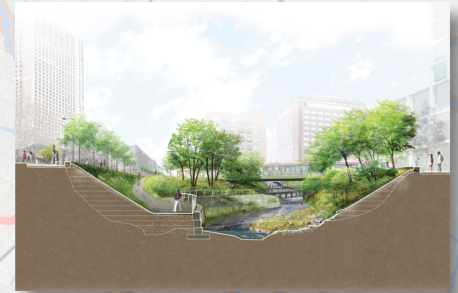
Rendering of Waller Creek at 4th St.

The Waller Creek Tunnel, while vital to flood mitigation, does not fully address the functional aspects of Waller Creek. The **Waller Creek District Creek and Trail Improvements** is a project currently underway that aims to provide a stable, ecologically sustainable creek system from Waterloo Park to Lady Bird Lake in collaboration with the Waller Creek Conservancy. Erosion threatens numerous resources in this reach, including buildings, the hike and bike trail, a bridge, and utilities.

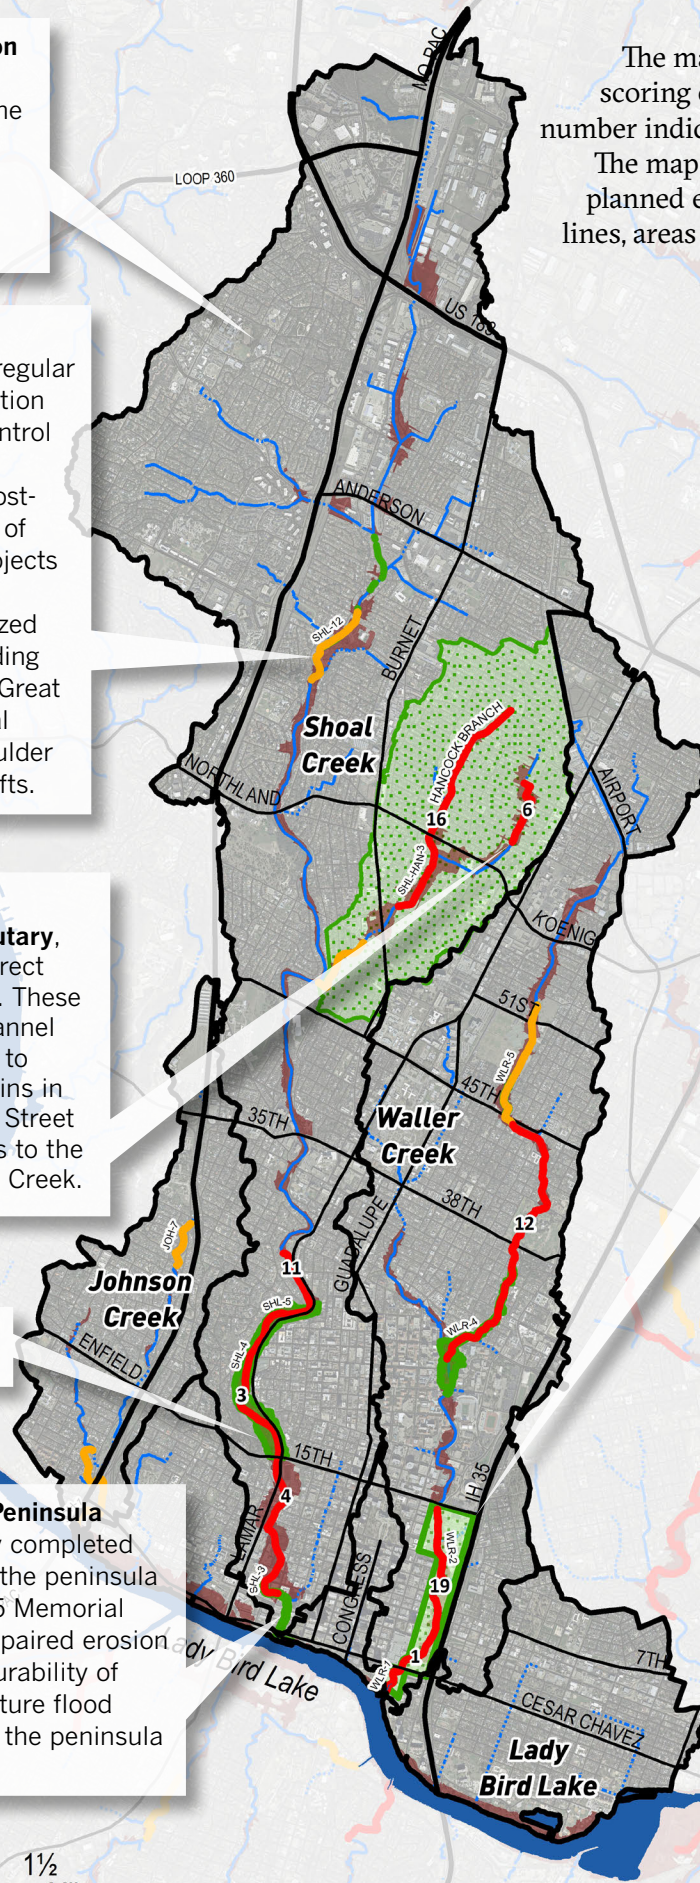
The map below shows “high” and “very high” scoring erosion geomorphic reaches. The black number indicates the citywide rank of the problem. The map also includes completed, ongoing, and planned erosion control solutions as dark green lines, areas of green, or areas of green with a dark green dots

Half of the **top 20 erosion problem score sites** citywide are located in the north urban watersheds. All top 20 sites will be addressed in ongoing or planned projects.

There are two 90-degree bends in the **Grover Tributary**, apparently intended to direct the channel between lots. These sharp turns make the channel exceptionally susceptible to erosion. The channel begins in the vicinity of Brentwood Street and eventually discharges to the Hancock Branch of Shoal Creek.

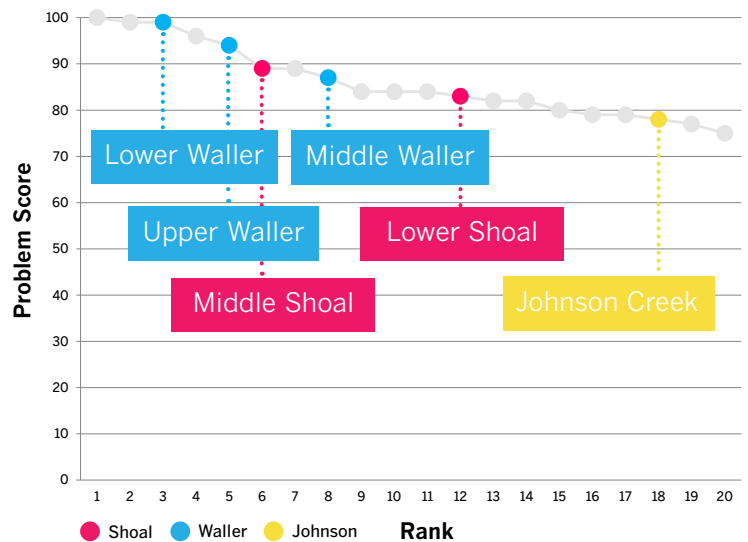
## Water Quality Reaches: Top 20 Problem Scores

The graph below plots the citywide top 20 ranked reaches by CIP problem score. Shoal (magenta), Waller (blue), and Johnson (yellow) creeks feature six of the top 20 ranked reaches, with all three of Waller Creek's reaches in the top 20.

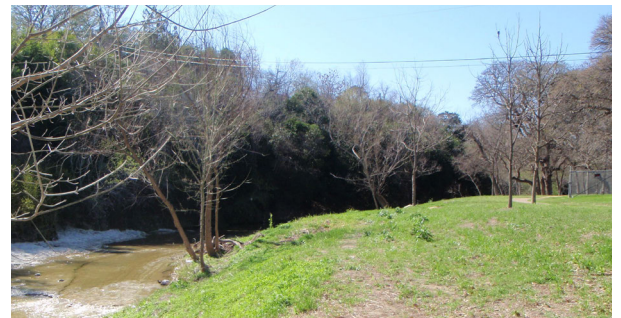
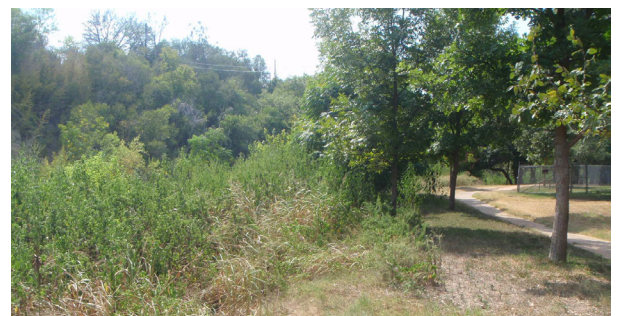
Dottie Jordan Recreation Center before (top) and after (bottom) a Grow Zone was established along Little Walnut Creek.

The north urban watersheds are among the worst scoring watersheds for riparian vegetation. Grow Zones are an effort to promote healthy riparian vegetation along creeks in over 50 sites in several city parks. WPD staff work with the Parks and Recreation Department to decrease mowing along the creek, which allows a more biologically diverse plant community to grow in place of the existing, degraded turf. WPD then monitors these sites to document the transition, ensure that vegetation does not impede the flow of water, and make sure that restoration goals are being reached. They also meet with neighborhood associations, conduct educational creek walks, and post signs to explain the process. Over time, native grasses and, eventually, trees become established and transform the areas into more ecologically functional, beautiful landscapes. In addition to the wide variety of ecological services that these buffers provide, they are also integral to the effort to reduce fecal bacteria loads in Waller and Shoal creeks.

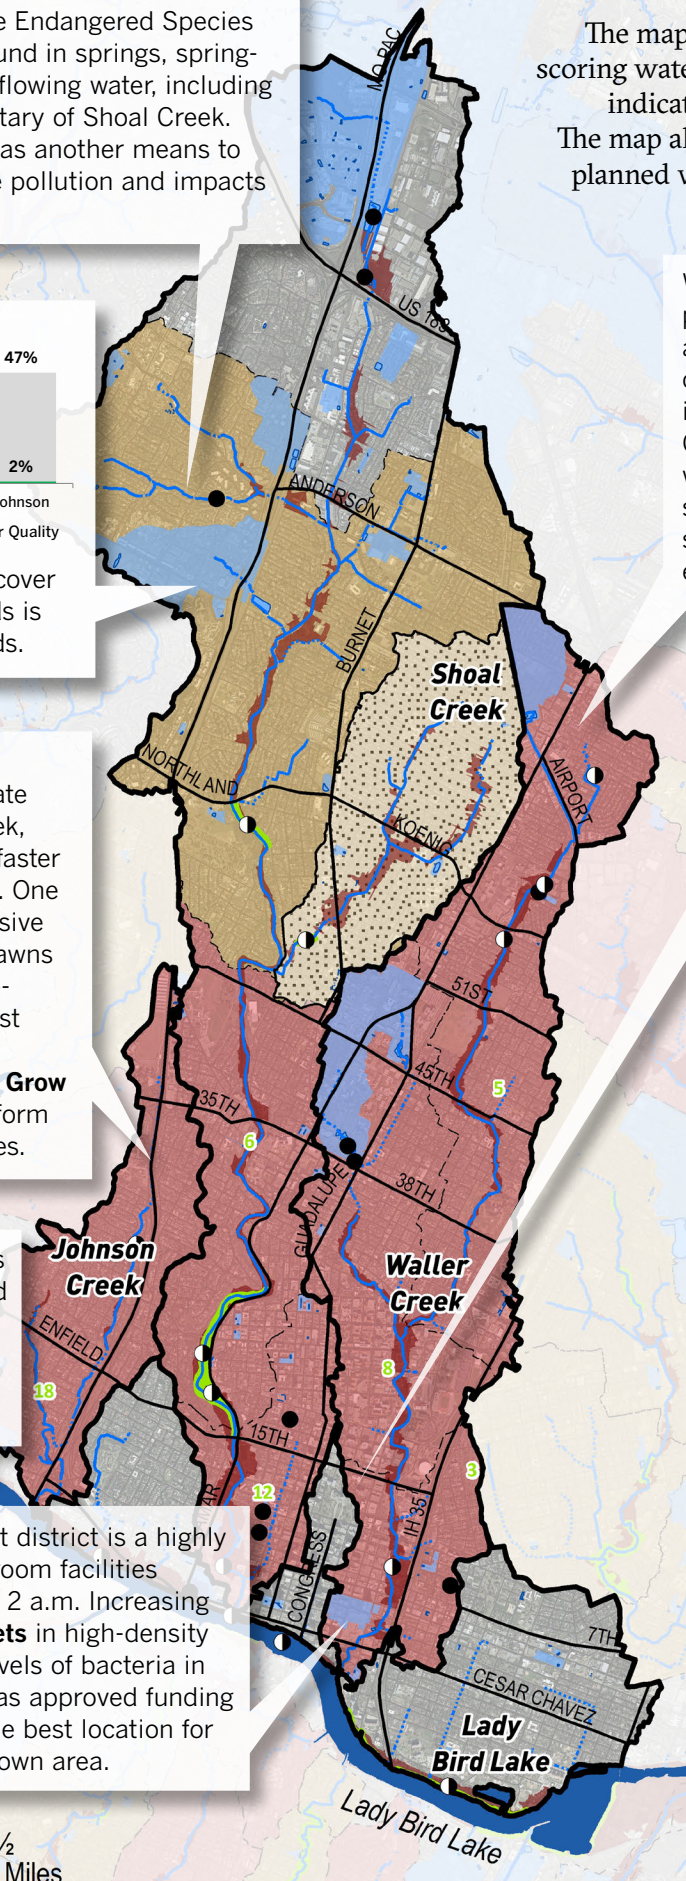
The map below shows “high” and “very high” scoring water quality reaches. The green number indicates the citywide rank of the problem. The map also includes completed, ongoing, and planned water quality solutions as filled, half-filled, or open points.
