Shoal Creek Characterization Report (Draft 2 – 1/30/2019)

DRAFT – NOT FOR PUBLIC DISTRIBUTION

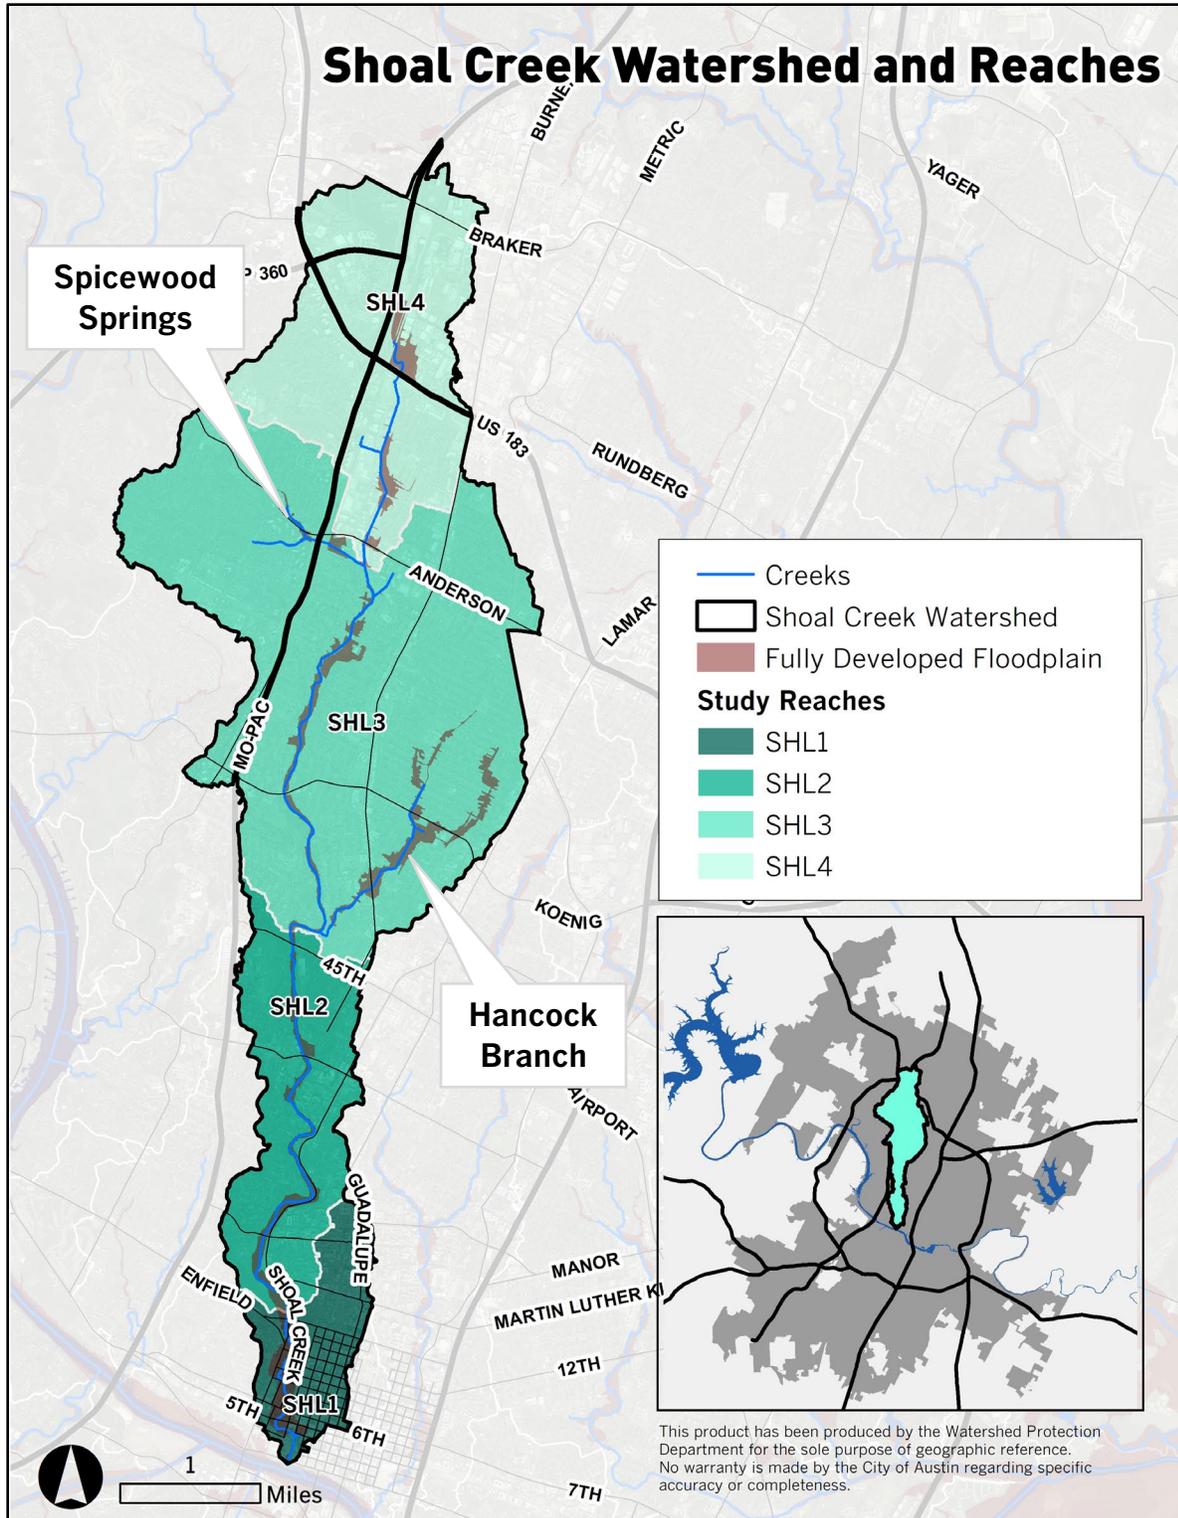
146 *Figure 2 Shoal Creek Watershed and Reaches (COA-WPD, 2018)*

129 The City of Austin Watershed Protection Department (COA-WPD) breaks the watershed into four
130 study reaches for purposes of analysis—SHL1, SHL2, SHL3, and SHL4 (see Figure 2). Reaches are a
131 segment of a creek, with the land area draining to those segments defining the reaches’ subwatershed.
132 These reaches and their subwatersheds comprise the basic unit of analysis throughout this report.
133 Reach boundaries are determined based on patterns in geomorphology, hydrology, and land use.
134 Dividing the watershed into reaches provides the ability to evaluate trends at a higher level of detail,
135 while providing the flexibility to move sampling site locations if necessary.

137 Shoal Creek begins just north of the junction of Loop 360 and Mopac and flows south until it
138 empties into Lady Bird Lake between West Avenue and Nueces Street. The creek is best known for
139 the 1981 Memorial Day Flood that devastated lower Shoal Creek and claimed 13 lives, but it has
140 experienced significant flooding events throughout Austin’s history. Shoal Creek has two major
141 tributaries. Spicewood Springs is a small tributary in northwest Austin, named for a nearby spring.
142 The Hancock Branch drains the area between Burnet Road and North Lamar Boulevard. Shoal
143 Creek also has the distinction of having the oldest trail in Austin, which was built by volunteers in
144 the early 1960s (Shoal Creek Conservancy, 2013).

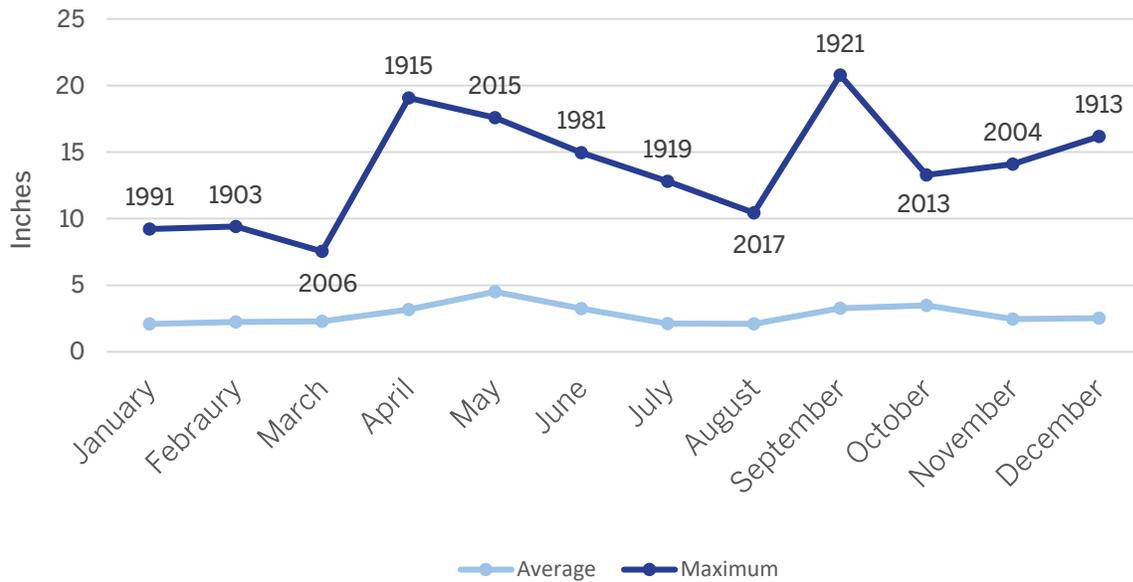
179 *Figure 3 Austin Monthly Rainfall (1897 - 2018) (NWS, 2019)*

158 Austin’s climate is characterized by long, hot summers and short, mild winters, with warm spring
159 and fall transitional periods. Austin averages around 34 inches of rainfall per year, with May,
160 September, and October being the wettest months. Yearly total rainfall varies widely, from 11.42
161 inches in 1954 to 65.31 inches in 1919 (NWS, 2018). Austin also experiences periodic drought
162 conditions, with a record of 88 days without precipitation in 1894-1895 (NWS, 2018). According
163 to the Climate Change Projections for the City of Austin report, projected changes in Austin’s
164 climate include increases in annual average temperatures, more frequent high temperature extremes,
165 and more frequent drought conditions in the summer. The report also projects little change in
166 annual average rainfall, but more frequent extreme rainfall (Hayhoe, 2014).

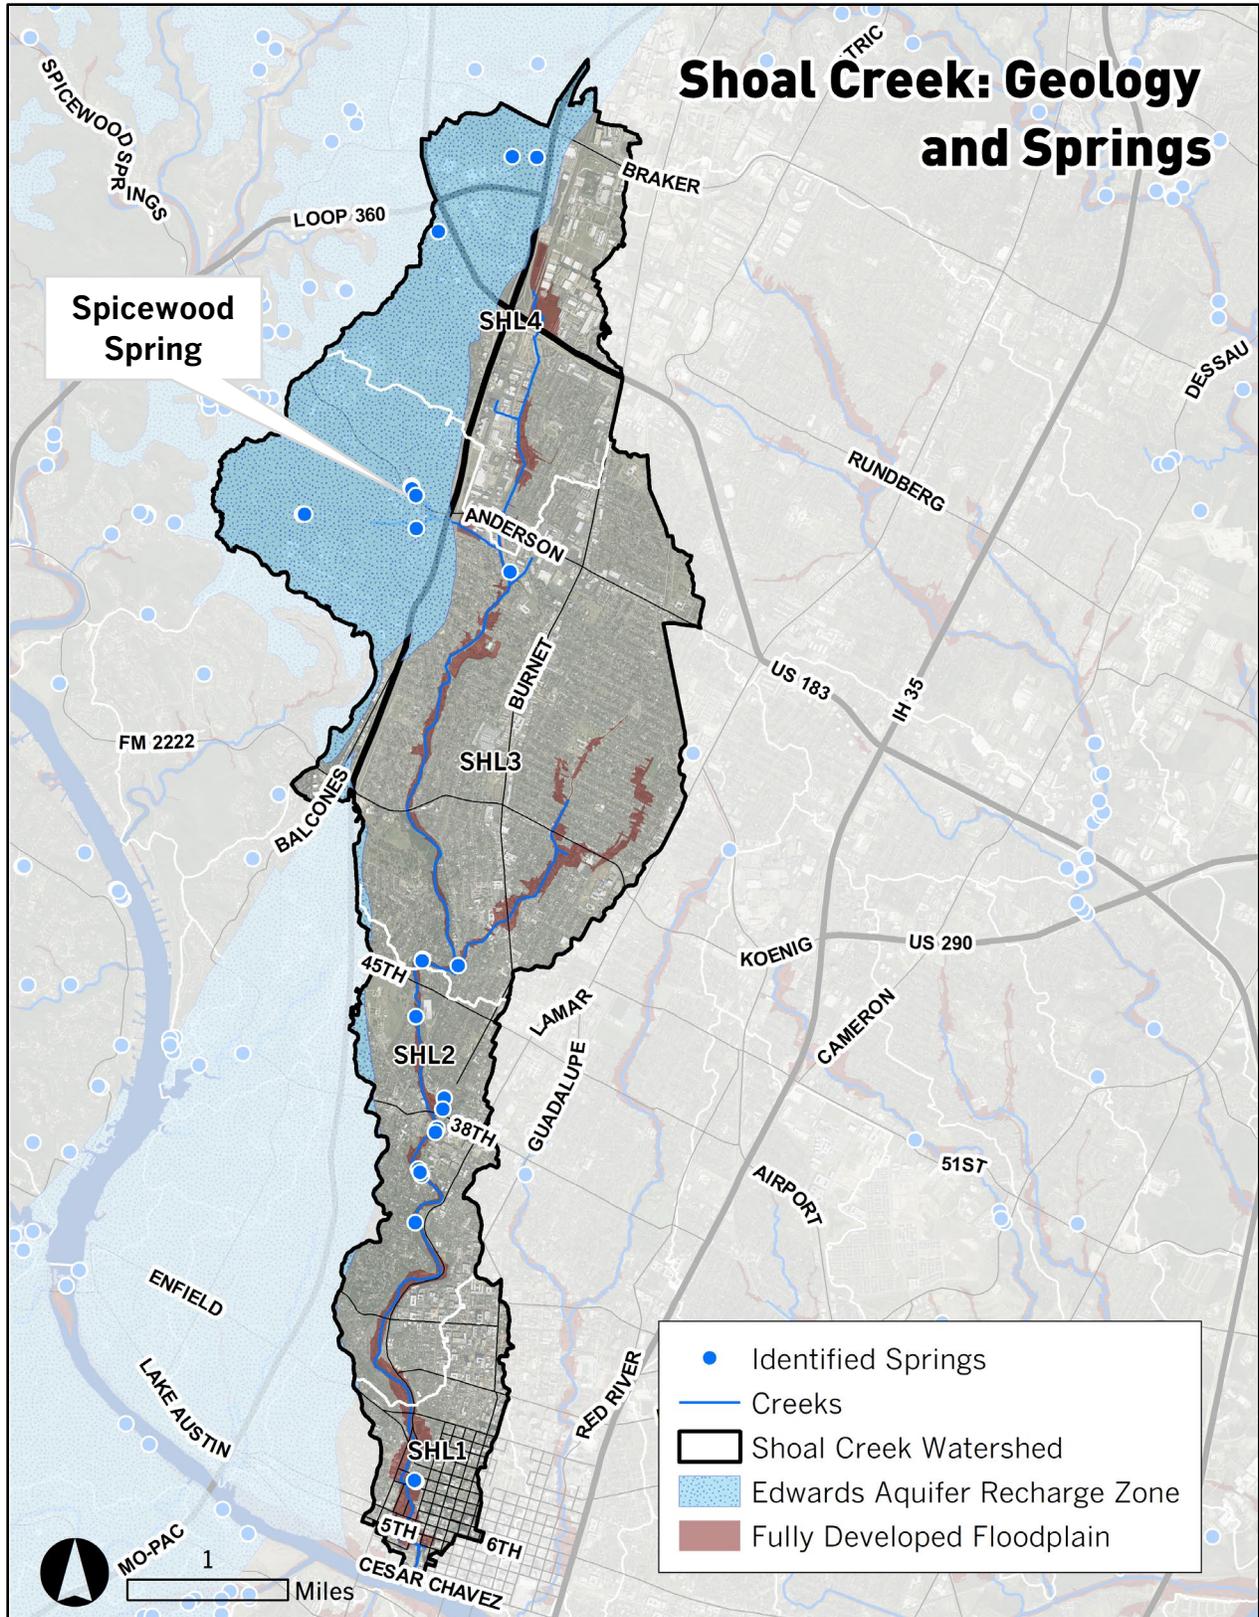
208 *Figure 5 Shoal Creek Geology and Springs (COA-WPD, 2018)*

197 With 30 identified natural seeps or springs, the Shoal Creek watershed contains approximately 5%
 198 of the identified seeps/springs within the City of Austin full purpose jurisdiction (COA-WPD,
 199 2018). Two notable springs within the Shoal Creek watershed include Seiders Spring and Spicewood
 200 Spring. Seider Spring was the site of popular resort and bathhouse that operated from 1871 to 1896
 201 (Brune, 1981). Spicewood Spring is a verified habitat for the Jollyville Plateau salamander (*Eurycea*
 202 *tonkawae*), which was listed as federally threatened under the Endangered Species Act in 2012. The
 203 Jollyville Plateau salamander has a very limited range—it is found only in springs, spring-fed
 204 streams, and subterranean streams of nine watersheds within the Northern Edwards Aquifer. Because
 205 this species remains aquatic throughout its life, it depends on the quality and quantity of

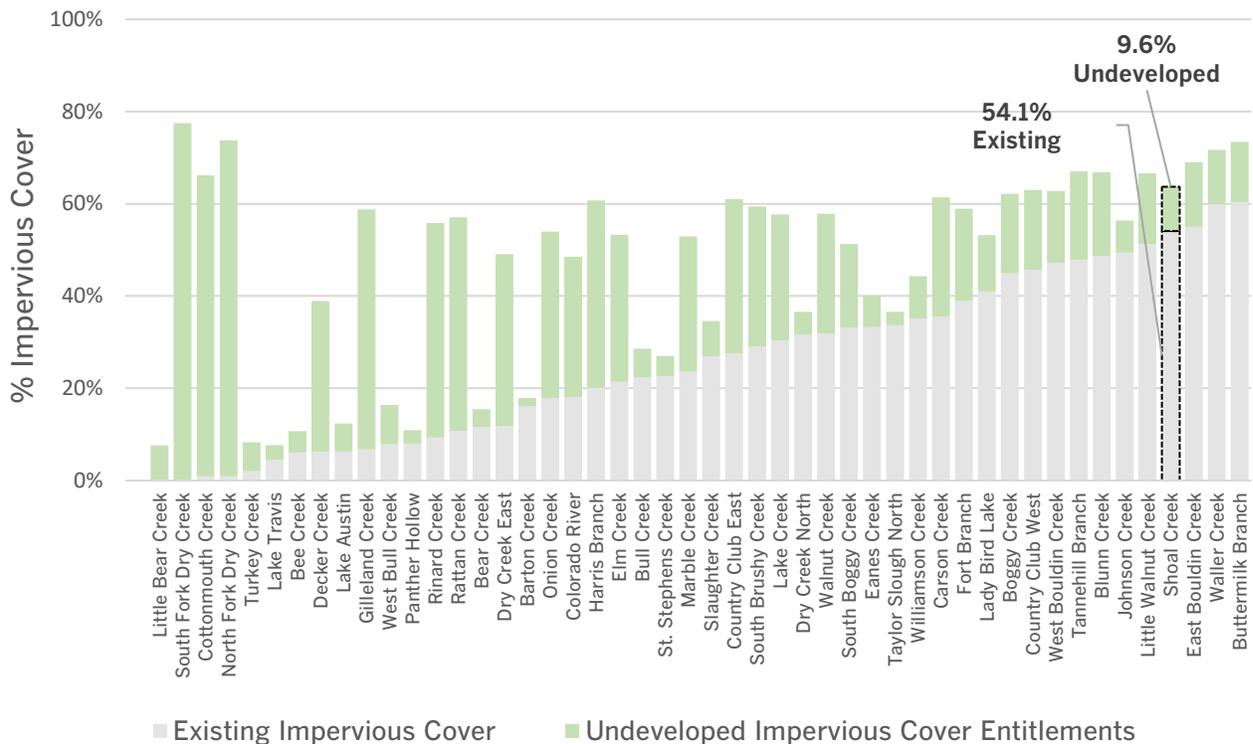
285 *Figure 15 Existing and Maximum Allowed Impervious Cover; Full Purpose Jurisdiction (COA-WPD,*
 286 *2018)*

275 The Shoal Creek watershed is the fourth most impervious watershed in the city, with 54% existing
 276 impervious cover. Based on a City of Austin Watershed Protection Department (COA-WPD)
 277 analysis of impervious cover maximum buildout, Shoal Creek watershed could reach approximately
 278 64% impervious cover if each site developed to its impervious cover maximum (COA-WPD, 2018).
 279 This analysis represents a conservative estimate of maximum buildout, as it does not account for site-
 280 specific environmental features such as steep slopes, sensitive features, and trees. The regulatory
 281 protections associated with these features could potentially lower the total amount of impervious
 282 cover achieved for any given site. Thus, the maximum percentage of impervious cover shown below
 283 for each watershed is higher than the ultimate anticipated buildout.

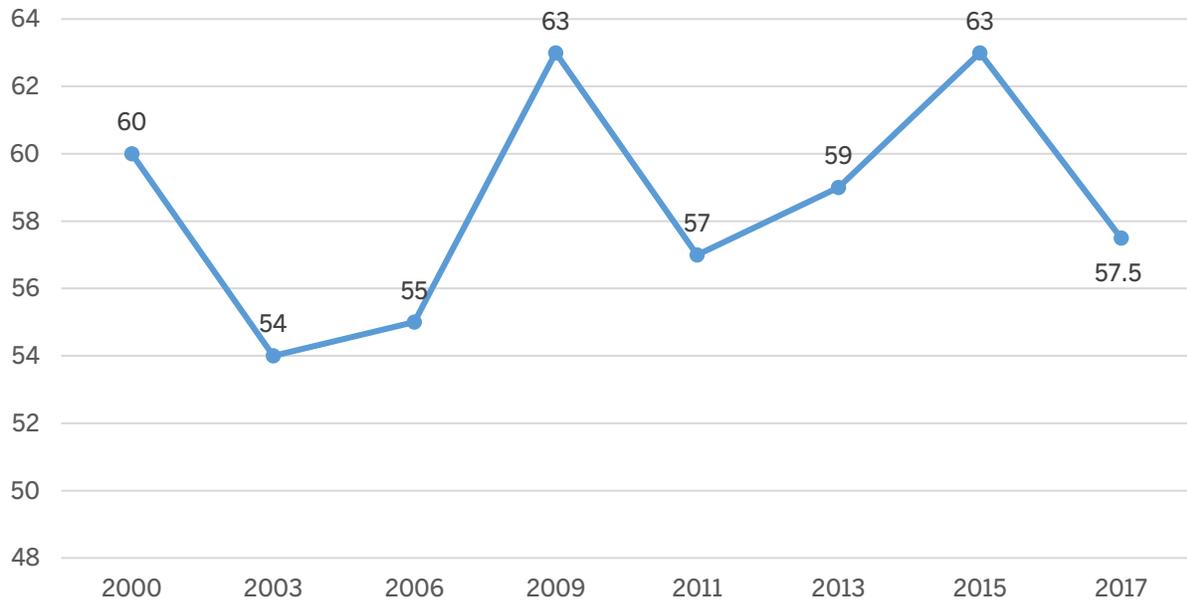
344 *Figure 16 Overall Environmental Integrity Index Score (2003 - 2017) (COA-WPD, 2017)*

337 The overall EII score is calculated as the average of the subindices, which results in equal weighting
 338 of each subindex. The scores range between 0 and 100, with higher EII scores indicating more fully
 339 functional creek reaches that are less degraded by human disturbance. A reach with an overall EII
 340 score ranging from 62.5 to 75 is classified as in “Good” health. The 2017 EII indicates that Shoal
 341 Creek is within the “Fair” range with a score of 57.5 (See Figure 16). The full EII summary for
 342 Shoal Creek can be found in [Appendix X](#).

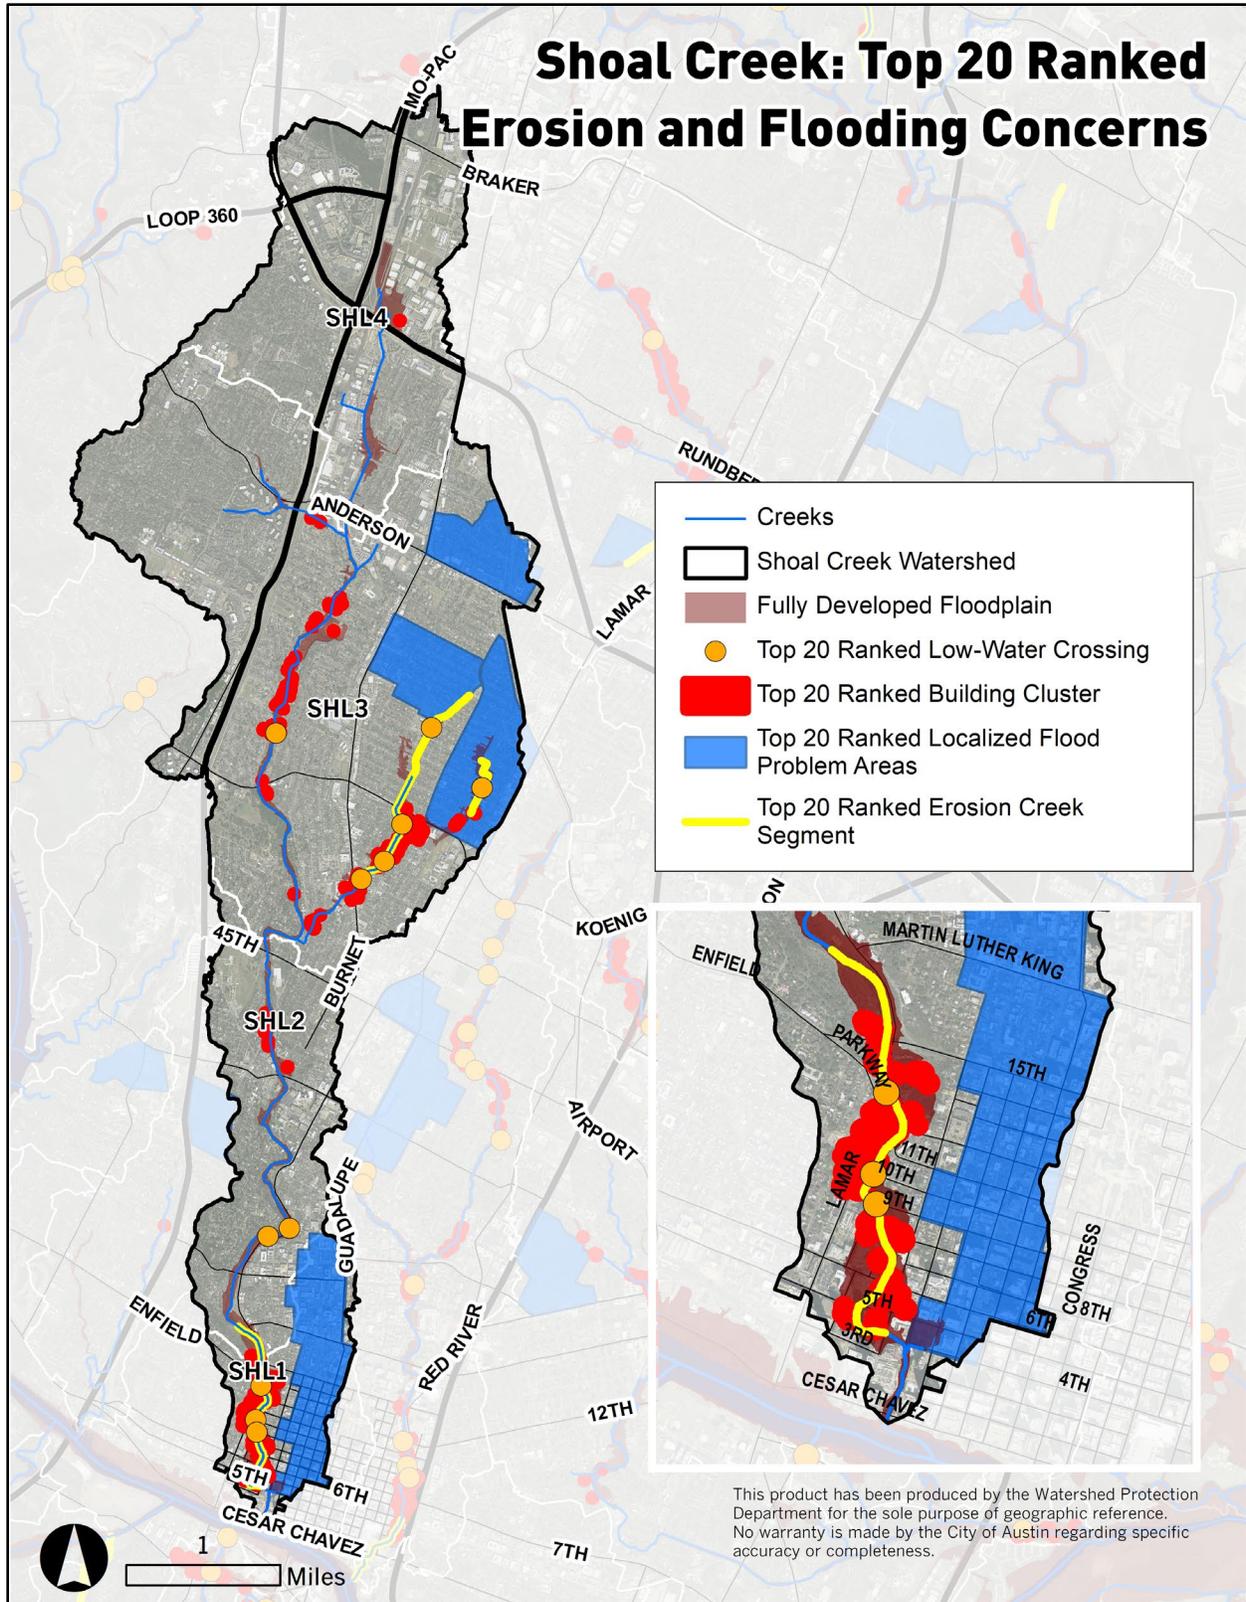
400 *Figure 18 COA-WPD Fiscal Year 2019 Top 20 Ranked Erosion and Flooding Concerns (COA-WPD,*
 401 *2018)*

Location	Reach	Narrative Score	Citywide Rank
Grover Tributary - From confluence with Shoal Creek to upstream end near Grover Dr	Hancock-Grover-2	Very High	3
Arroyo Seco - From 550 ft. upstream of North Loop Rd. to W St. Johns	Hancock-3	Very High	9
Shoal Creek Mainstem - From W. 6th St to W. 15 th Street	Shoal-3	Very High	20

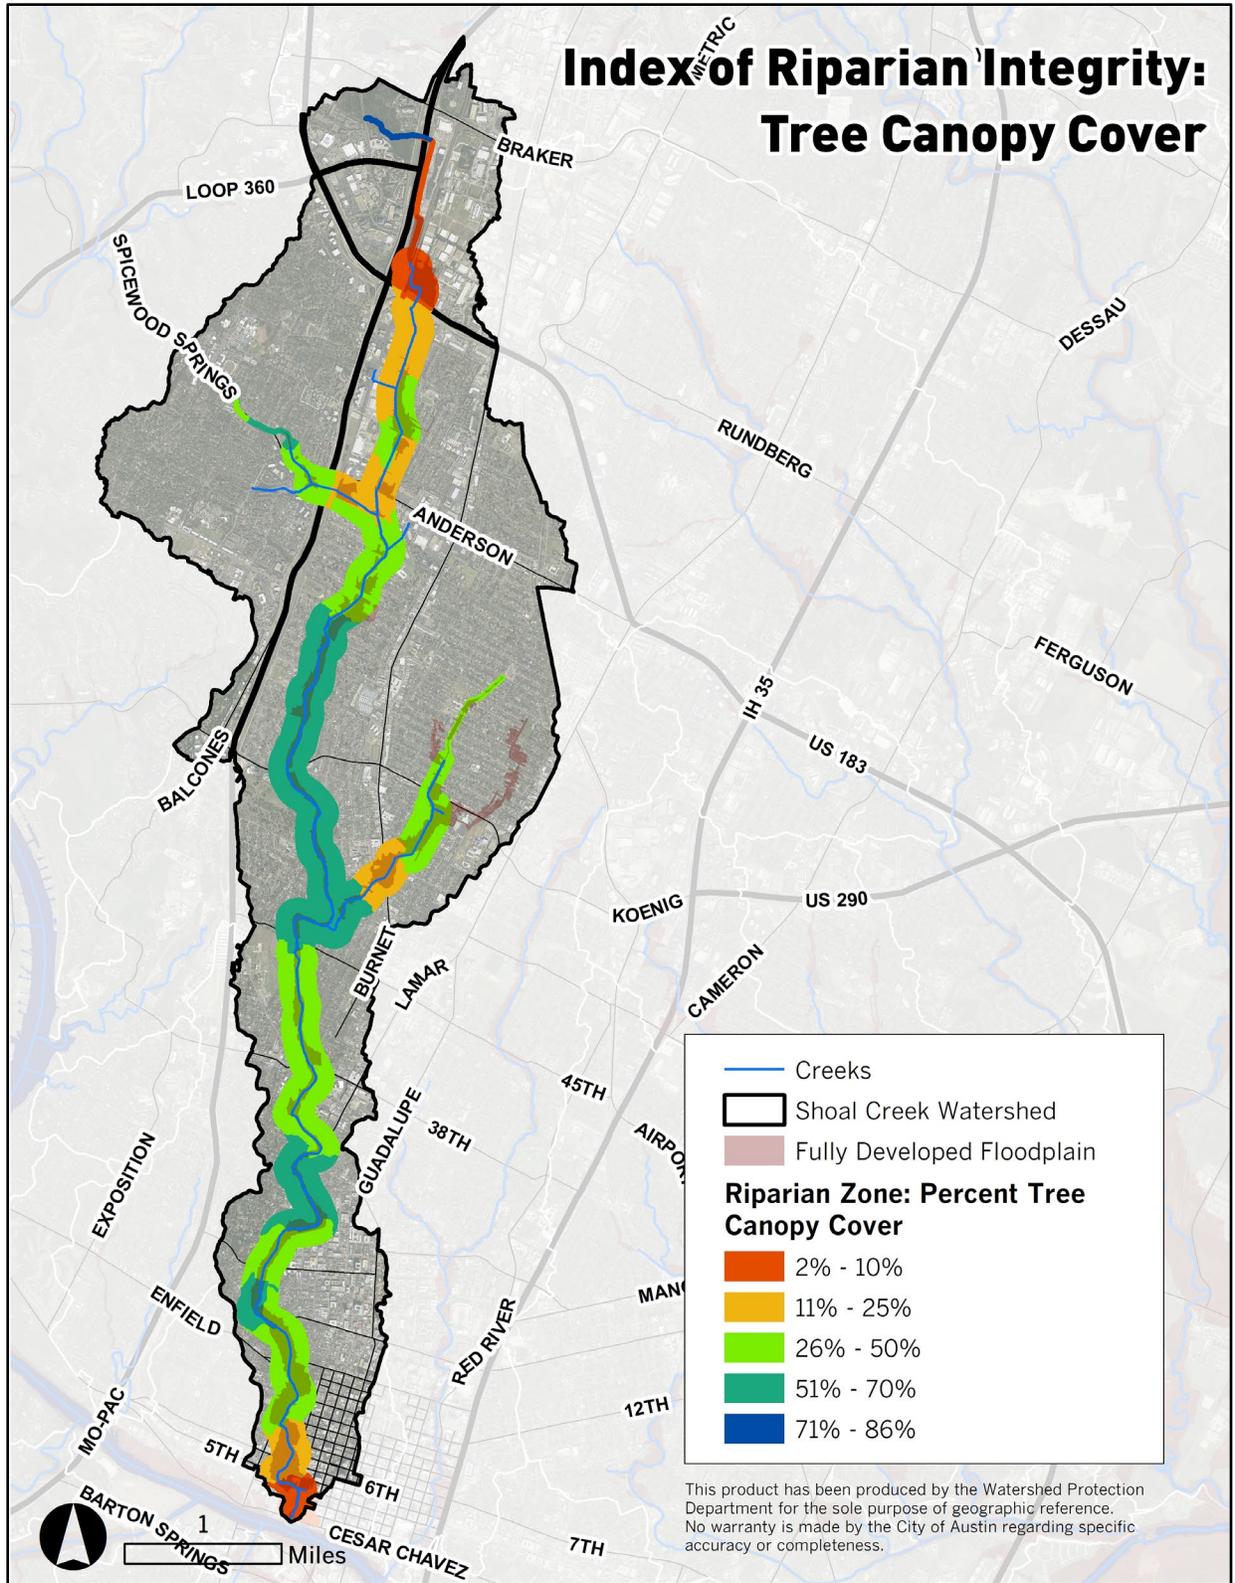
466 *Figure 19 Index of Riparian Integrity: Tree Canopy Cover (COA-WPD, 2018)*

452 The Index of Riparian Integrity (IRI) (Scoggins et al., 2013) represents an effort to utilize remote
453 sensing techniques (e.g., aerial photography) to assess riparian condition throughout an entire stream
454 corridor and identify areas with a high potential of functional deficiency. Aerial mapping and
455 interpreting technologies have advanced to a point where it is possible to use aerial imagery to
456 evaluate riparian zones rather than labor-intensive field studies. The IRI approach uses aerial imagery
457 to characterize 37 riparian areas along the creek corridor according to their percent impervious cover,
458 percent tree canopy, and percent of pervious non-canopy area. Table 7 and Figures 19, 20, and 21
459 show these values in each of these 37 riparian areas (Please note that tree canopy can overlap
460 impervious areas for this analysis.). Together, these three measures are a good indicator of the relative

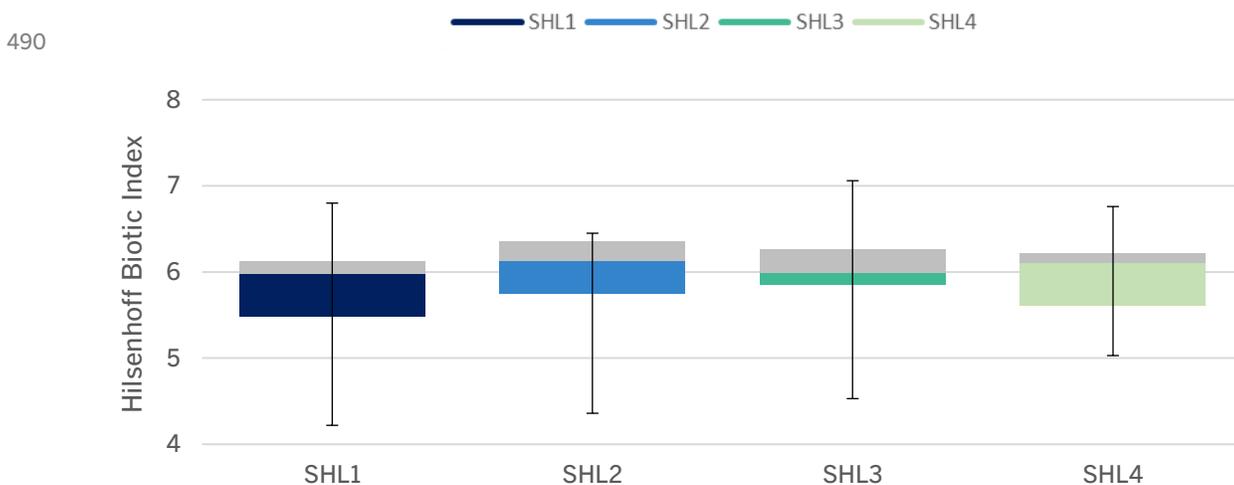
491
 492 *Figure 22 Hilsenhoff Biotic Index (COA-WPD, 2017)*

The Hilsenhoff Biotic Index (HBI) metric estimates the overall tolerance of the community. Organisms are assigned a tolerance number from 0 to 10 pertaining to that group's known sensitivity to organic pollutants; 0 being most sensitive, 10 being most tolerant. All of the sites on Shoal Creek have a community that is relatively tolerant to nutrient stressors, with a relative lack of sensitive species.

486 Figures 22 - 25 describe the diversity and tolerance of the macroinvertebrate and diatom
 487 communities found at each EII sampling site during the most recent sampling. The whiskers
 488 indicate the minimum and maximum values and the boxes indicate the interquartile range.
 489 Throughout the report, individual EII reaches are indicated with the following colors:

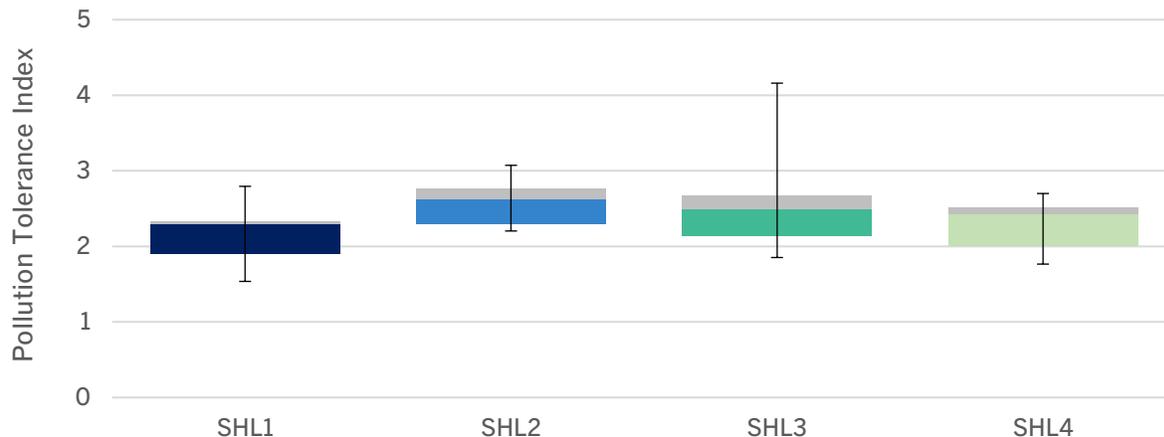
504 *Figure 25 Diatom Pollution Tolerance Index (COA-WPD, 2017)*

The Pollution Tolerance Index rates diatom taxa by their sensitivities to increased environmental degradation. There is some improvement of scores at the middle sites, but generally all sites are similar, with scores between 2 and 3.

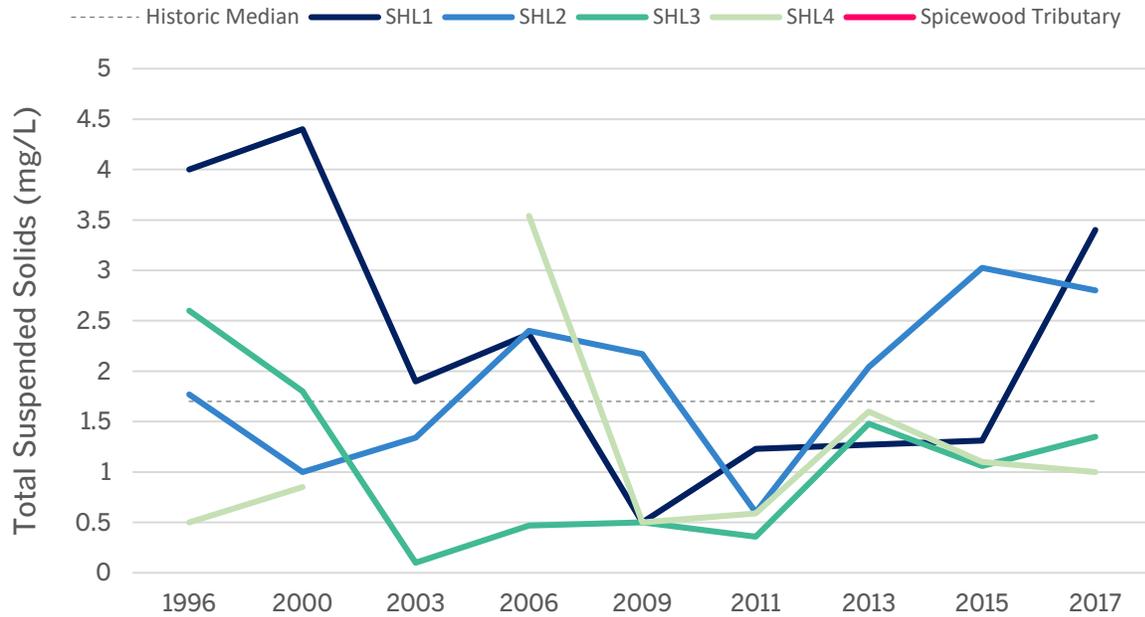
513 *Figure 26 Total Suspended Solids (mg/L) (1996 – 2017) (COA-WPD, 2018)*

Although it is naturally occurring, sediment levels can be elevated from accelerated and unnatural erosion from active and historic development practices. Nutrients and other pollutants can be released from eroded soil and the fine silty particles degrade the habitat for aquatic life. Shoal Creek is generally below average for Total Suspended Solids compared to other watersheds. Total Suspended Solids is typically higher and more variable for Shoal Creek's downstream reaches (SHL1-2) and decreases as you travel upstream (SHL3-4).

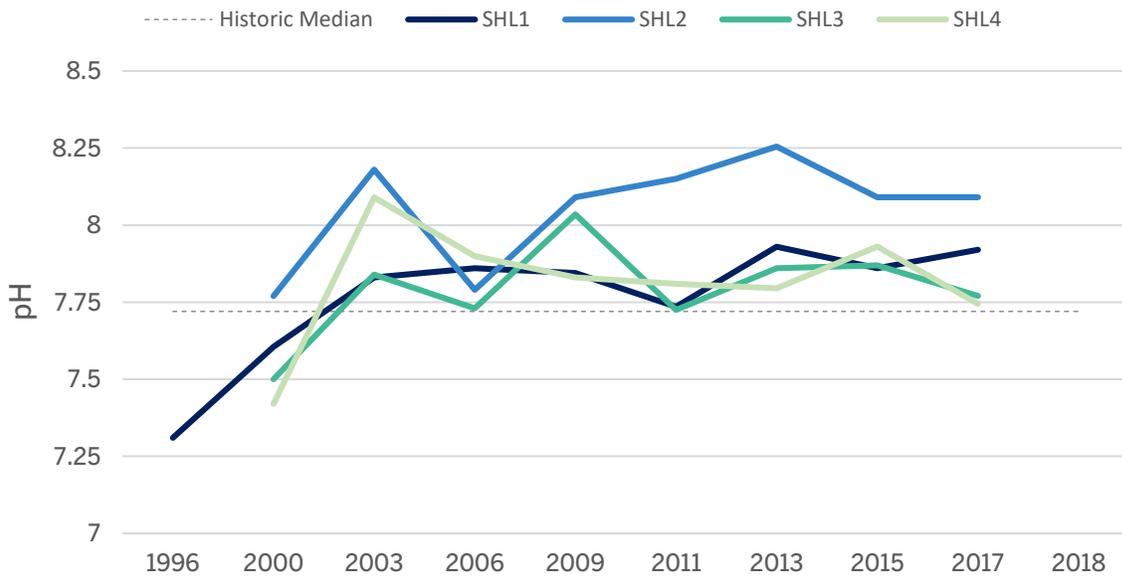
520 *Figure 28 pH (2000 – 2017) (COA-WPD, 2018)*

Shoal Creek's pH generally falls within the expected range.

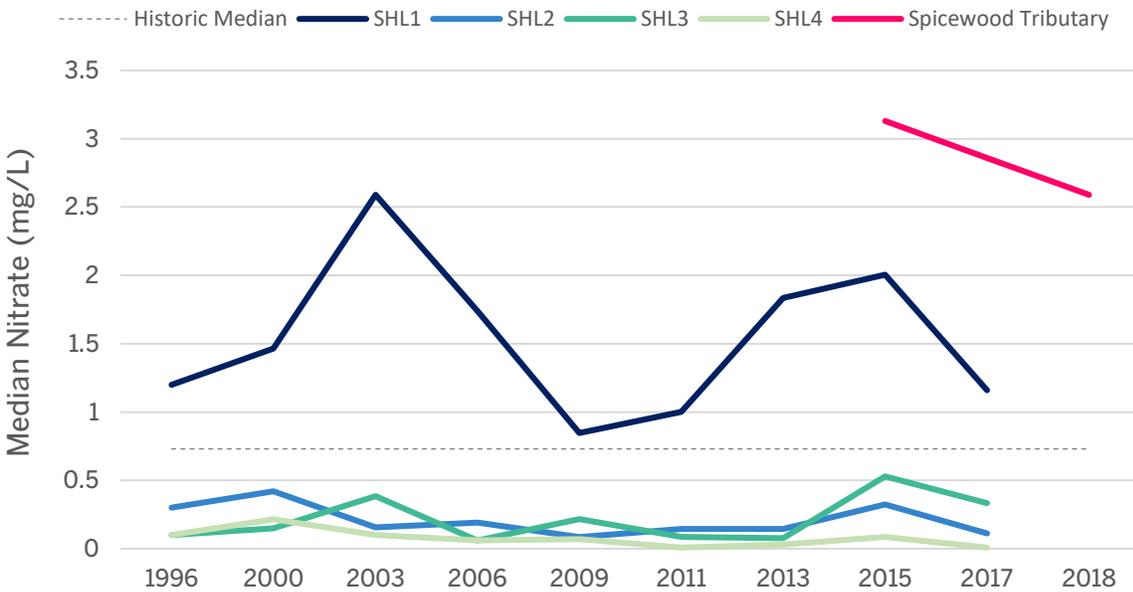
547 *Figure 32 Nitrate (mg/L) (1996 – 2018) (COA-WPD, 2018)*

Nitrates are a form of nitrogen, which is found in several different forms in terrestrial and aquatic ecosystems. Levels of nitrate are very high for the Spicewood Spring Tributary.

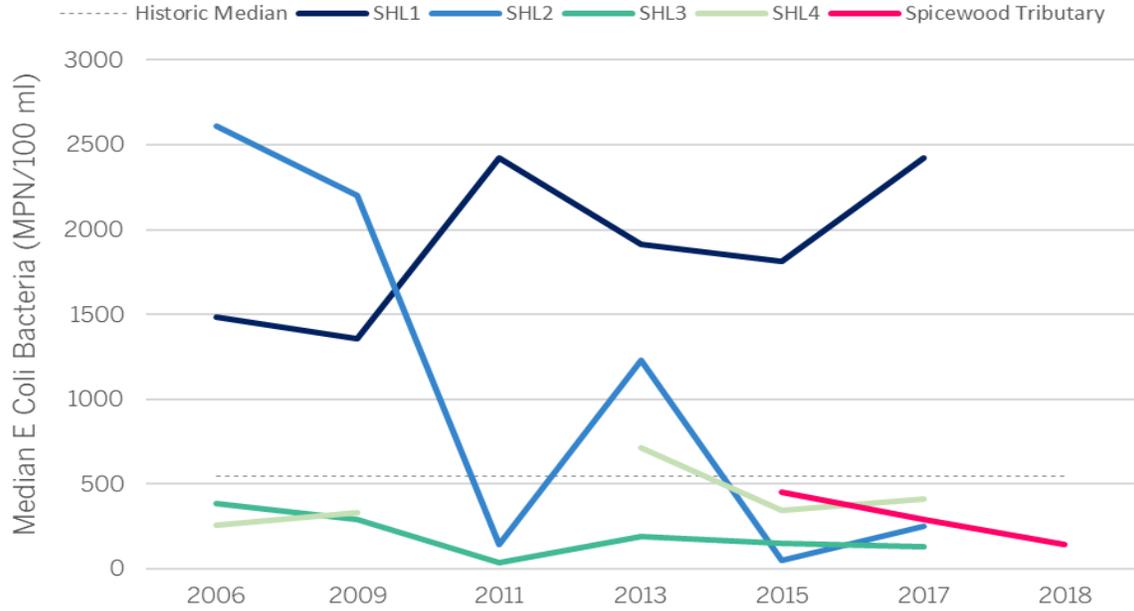
Figure 34 E. Coli Bacteria for EII Reaches and Spicewood Springs Tributary (2006 – 2018) (MPN/100 ml)

563 tend to have a higher concentration of human and animal fecal inputs. The most probable sources of
564 E. coli contamination in urban streams include sewage spills, chronic sewage leaks from wastewater
565 lines, leakage from on-site sewage facilities, uncollected pet waste, untreated latrine sites that develop
566 where indigent communities congregate, and areas where fecal material from urban wildlife
567 accumulates (WPD, 2012). See Figure 35 for a summary of E. coli bacteria for EII reaches.

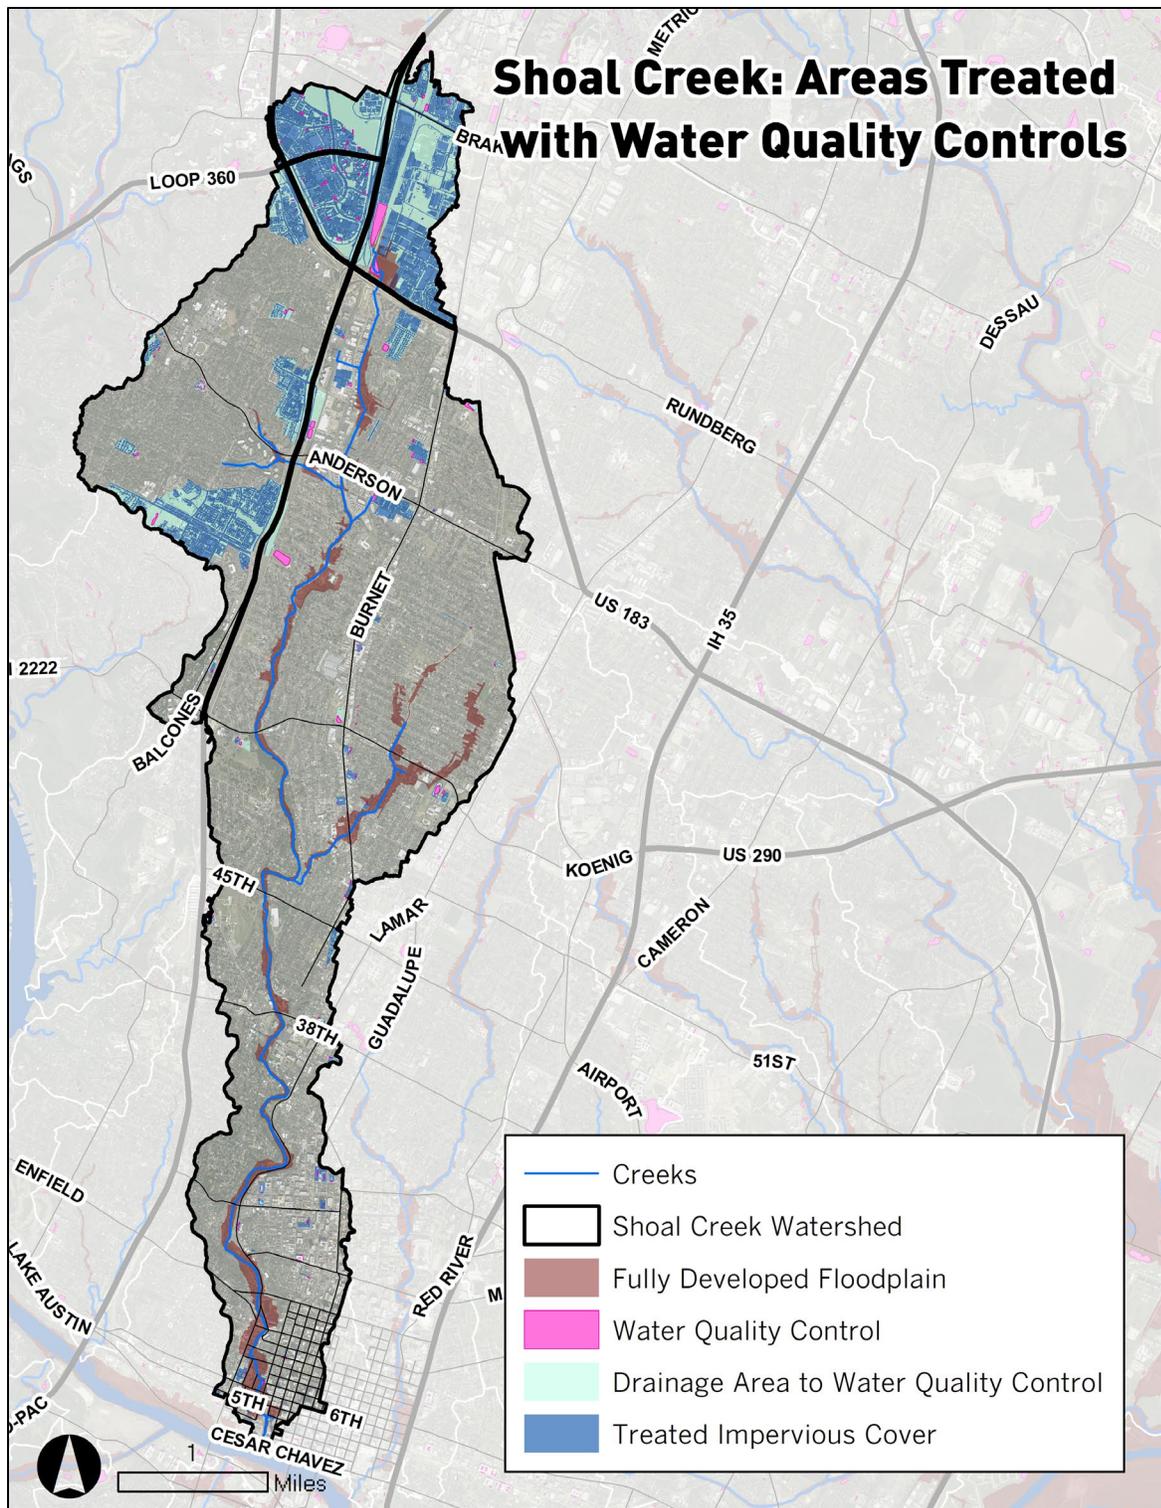
617 *Figure 38 Areas Treated with Water Quality Controls - The dark blue areas represent impervious cover*
 618 *that is treated for water quality. While the portion of the Shoal Creek watershed north of US 183 is*
 619 *almost completely treated, approximately 80% of the watershed's impervious cover has no treatment.*
 620 *(COA-WPD, 2018)*

604 Because Shoal Creek was among the first areas to be developed in Austin, large portions of the
605 watershed were developed prior to modern watershed regulations. Thus, most watershed protection
606 efforts in the Shoal Creek watershed must necessarily target the repair of problems caused by
607 longstanding, unregulated development. Shoal Creek watershed has the largest number of parcels
608 developed prior to the 1974 Waterway Ordinance. Over 56% of development in Shoal Creek was
609 built prior to this ordinance, while 71% of development was built prior to the introduction of water
610 quality control requirements in 1991. Because most development occurred prior to 1991, only 19%
611 of the watershed’s impervious cover is treated by water quality controls (see Figures 37 and 38).
612 Please refer to Page 62 for a comprehensive description of watershed regulations.

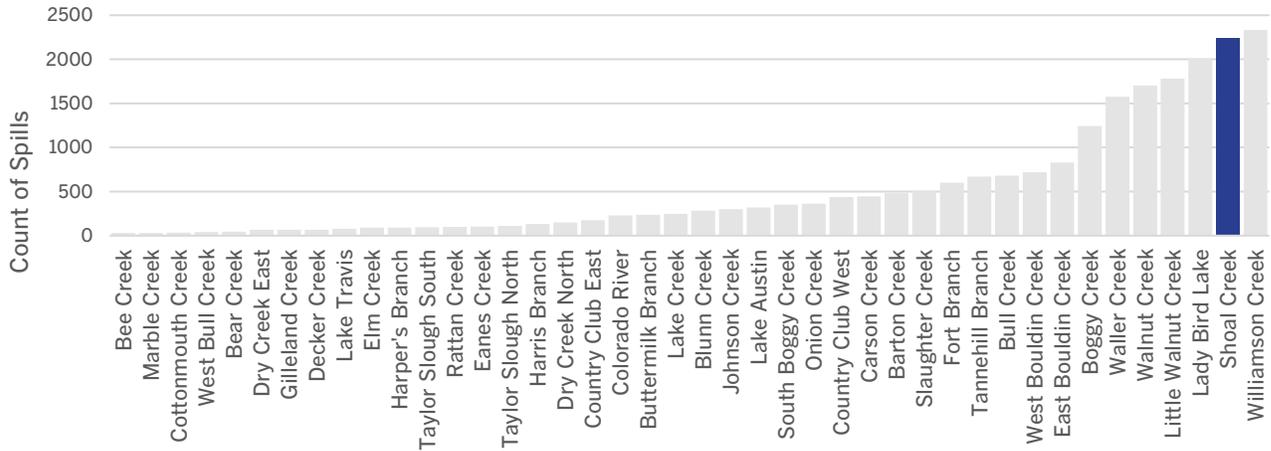
Figure 39 Total Reported Illicit Discharge Investigations, 1994 - 2018 (watersheds with discharge counts under 30 are excluded) (COA-WPD, 2018)

622 COA-WPD’s Spills Response program investigates illicit discharges to the storm sewer system and
 623 spills of hazardous and non-hazardous materials that threaten waterways. Spills Response
 624 investigations include identifying the source of the discharge and monitoring cleanup. Discharges
 625 may occur through illicit plumbing connections to the City’s storm sewer system, wastewater
 626 overflows, deliberate dumping, or accidental spills. Because the wastewater infrastructure tends to be
 627 older and more prone to failure, Shoal Creek has a relatively high rate of illicit discharges compared
 628 to other watersheds. Investigations of illicit discharges reports are concentrated in the SHL1 and
 629 SHL2 reaches, most likely due to a higher density of population and urban activity.

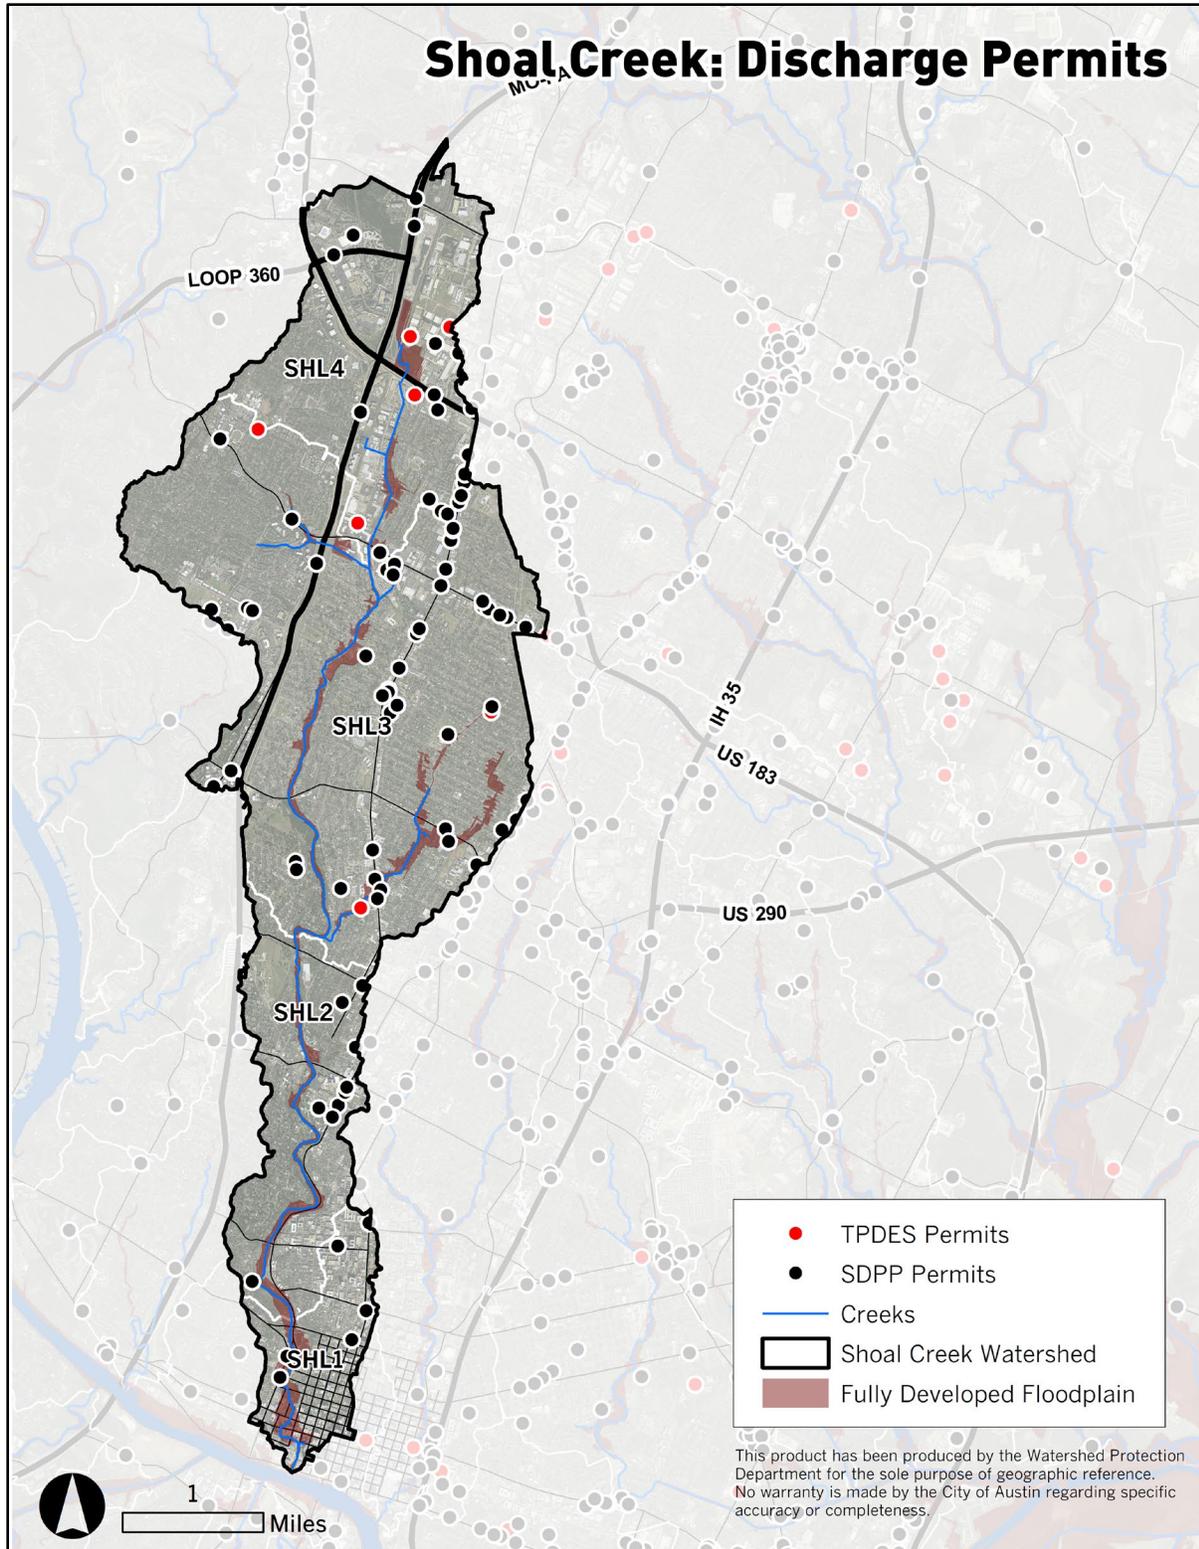
Figure 42 State and City Discharge Permits – There is a high density of SDPP discharge permits along North Lamar Boulevard. (COA-WPD, 2018)

649 COA-WPD’s Stormwater Discharge Permit Program (SDPP) is responsible for identifying and
 650 tracking business facilities that may contribute a substantial pollutant load to the City’s municipal
 651 separate storm sewer system (MS4). This program permits and routinely inspects specific
 652 commercial and industrial businesses within the Austin City limits to ensure best management
 653 practices are followed to prevent polluting discharges. Site inspections evaluate waste handling,
 654 storage and disposal practices, maintenance activities, and operational condition of water quality
 655 controls. This program also maintains a database of industrial and high-risk facilities subject to Texas
 656 Pollution Discharge Elimination System (TPDES) permits. There are 83 SDPP city permits (7.6%
 657 of total permits) and 7 TPDES state permits (8.5% of total permits) within the Shoal Creek
 658 watershed.
