Shoal Creek Characterization Report (Draft 2 – 1/30/2019)

DRAFT – NOT FOR PUBLIC DISTRIBUTION

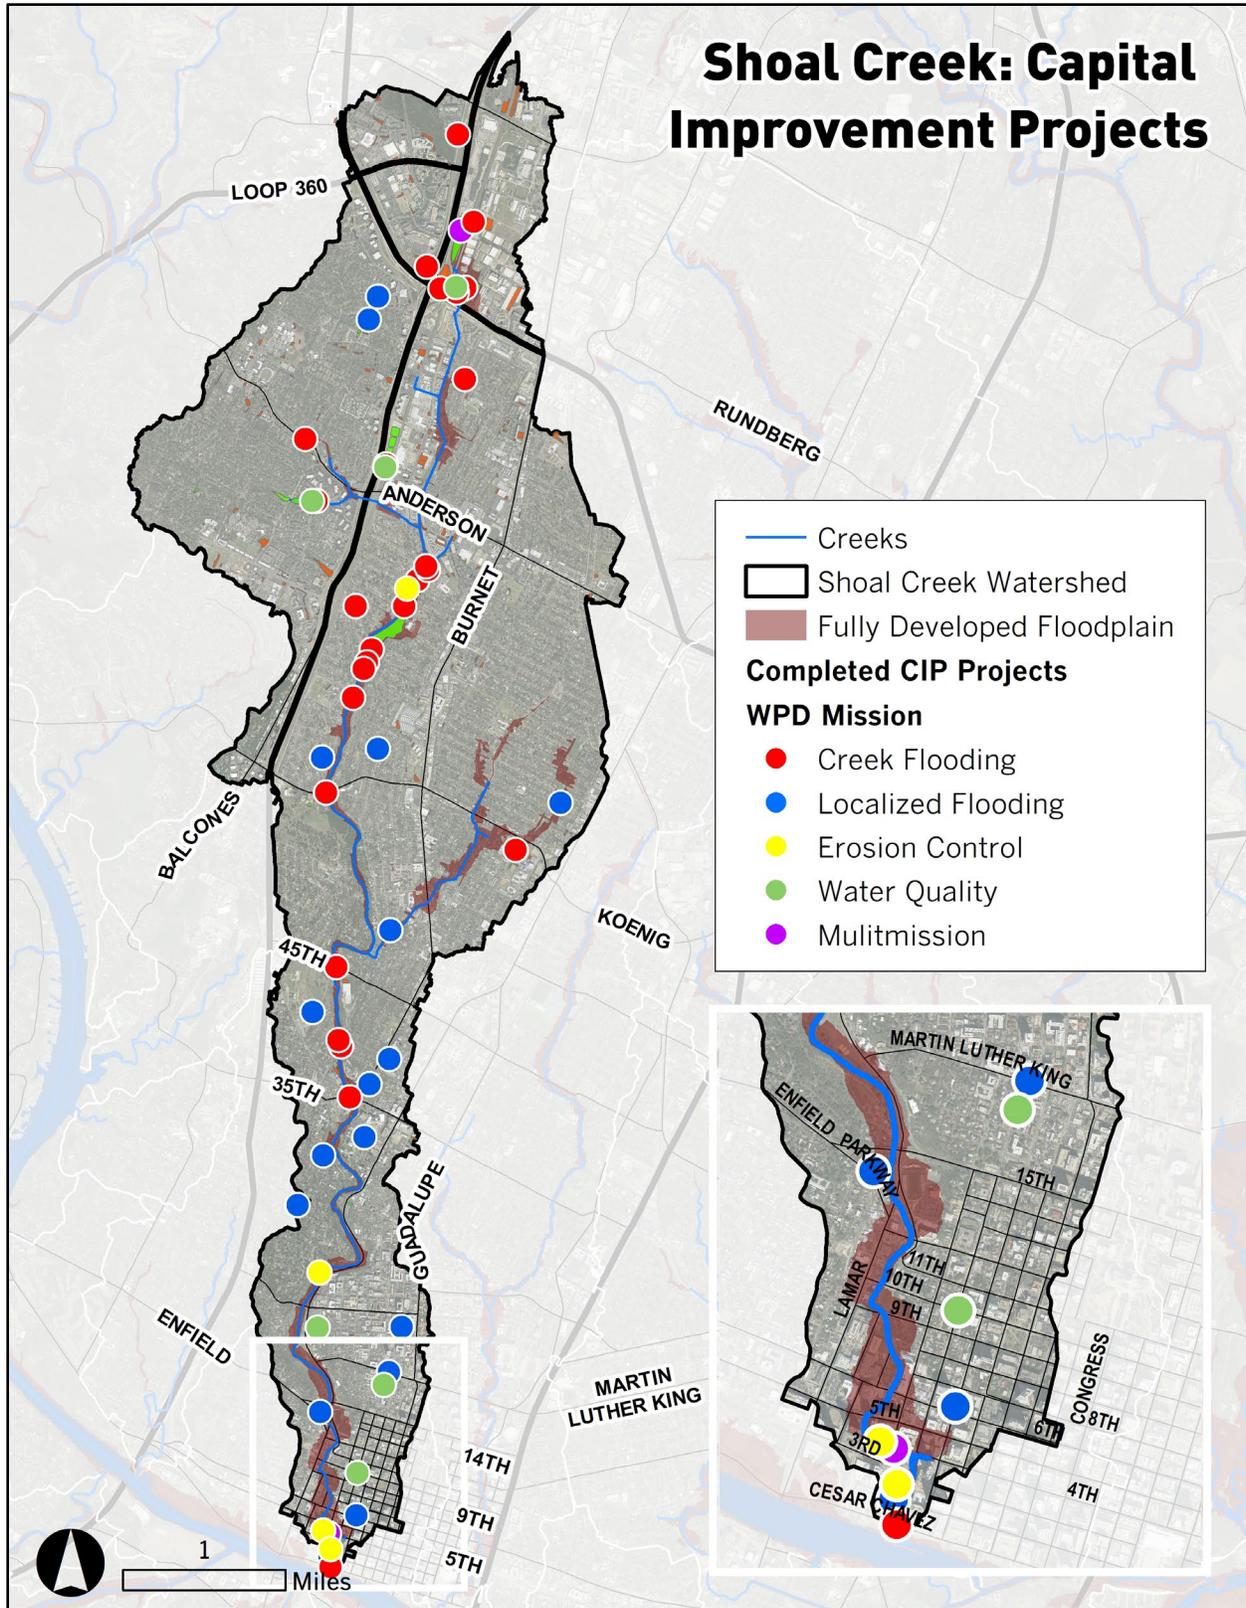
702 Figure 43 COA-WPD Capital Improvement Projects (COA-WPD, 2018)

672 Capital projects, also called Capital Improvement Program (or CIP) projects, are typically large City-
673 sponsored projects that construct, upgrade, or repair public infrastructure, including storm drain
674 systems, low water crossings, and stream restoration. Capital projects are typically used to retrofit
675 areas that were developed prior to modern drainage and environmental regulations. CIP projects
676 differ from other COA-WPD projects in that they are generally large-scale, more expensive
677 construction projects instead of routine maintenance or repairs. CIP projects are also planned and
678 managed by the department's CIP program and funded by the capital budget instead of the
679 operating budget. COA-WPD's capital budget is funded by a combination of sources, including the
680 Drainage Utility Fund, Council and voter-approved bonds, and developer mitigation funds. COA-
681 WPD has invested over \$83 million in improvements to the Shoal Creek watershed.
