MEMORANDUM

SUBJECT: Slope Failure Lower Shoal Creek

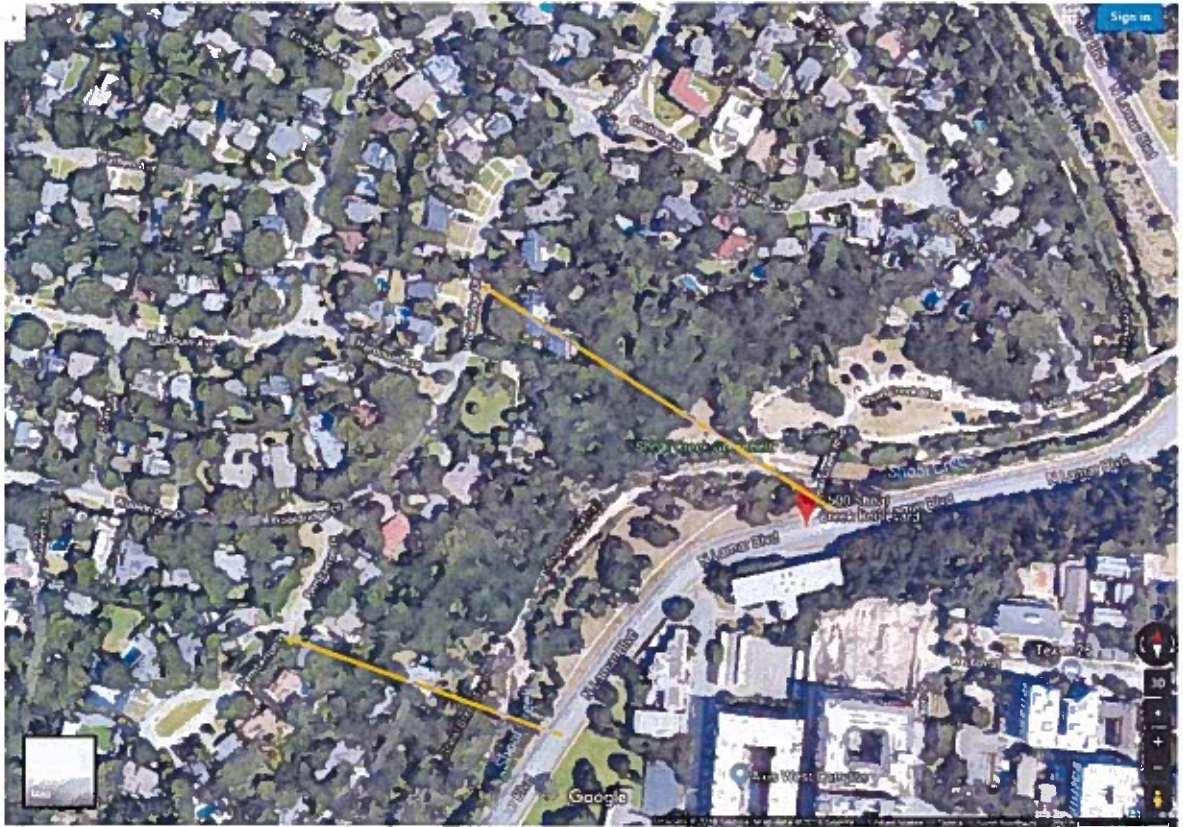
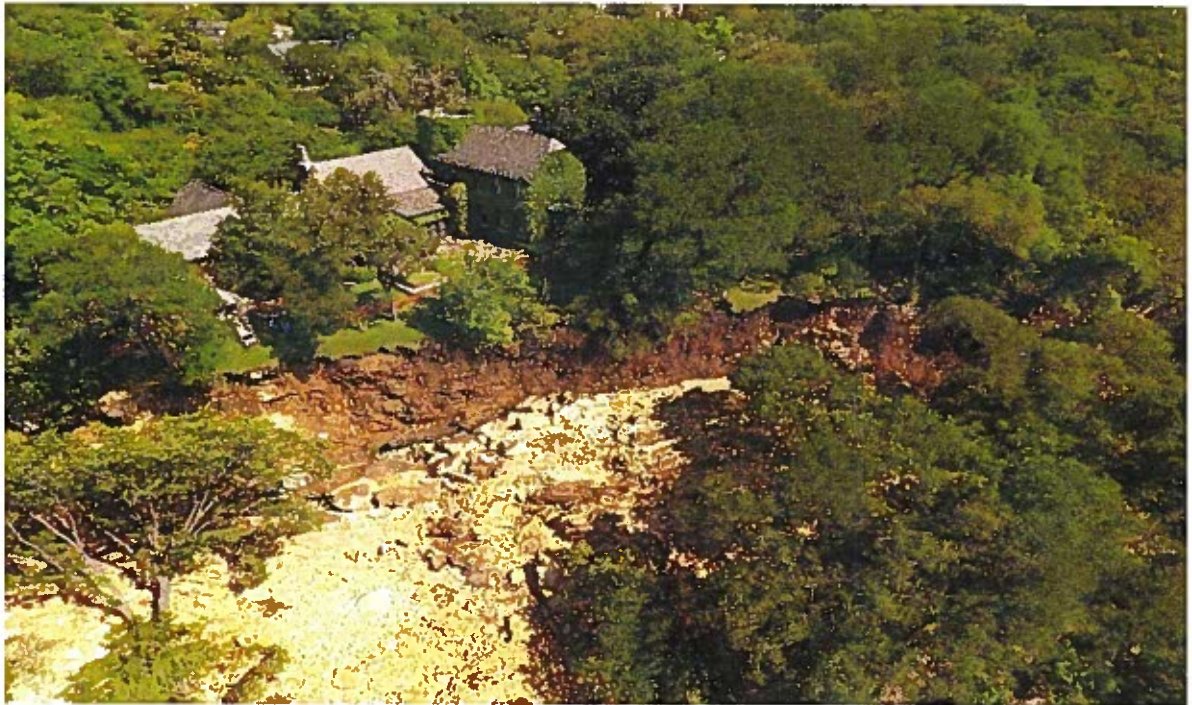
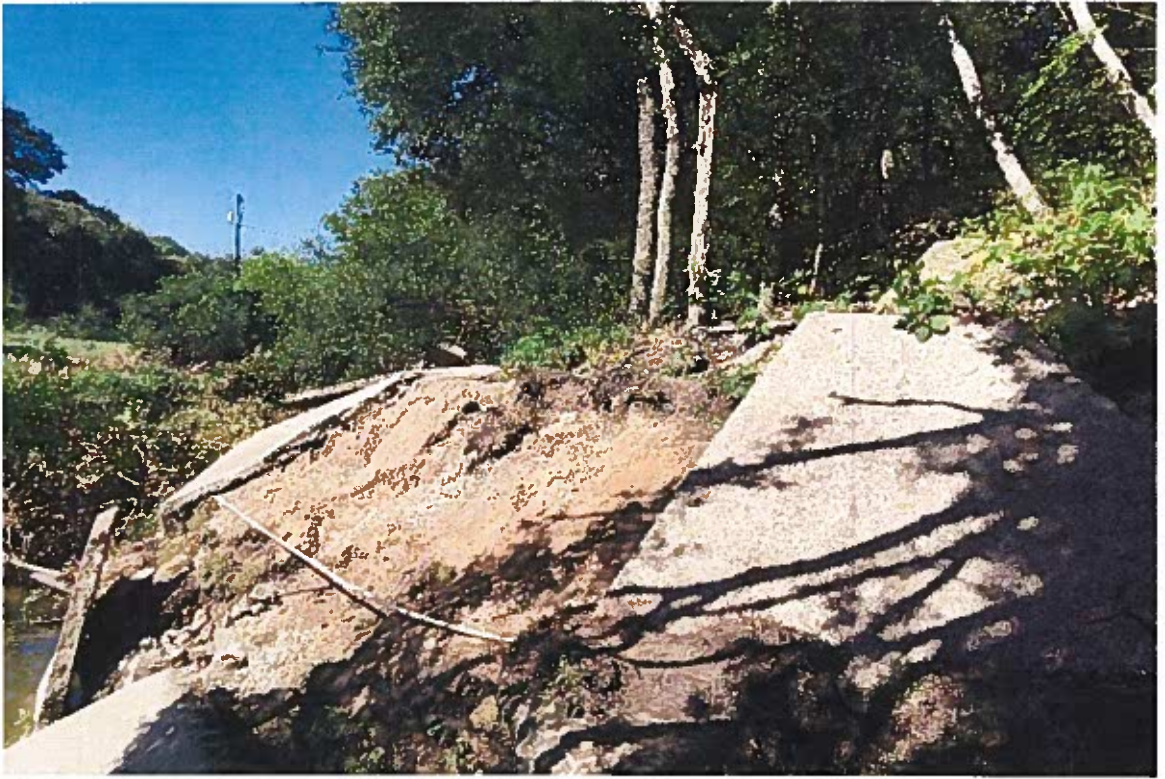
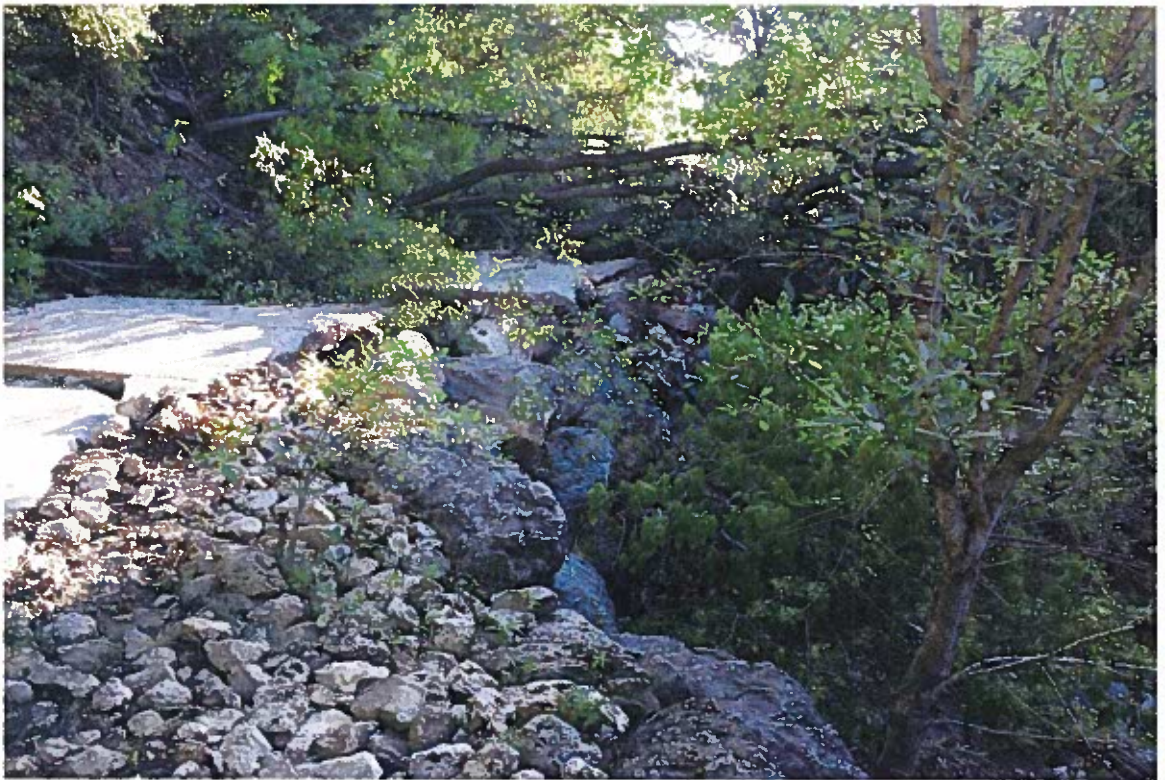
On Friday, May 4, 2018, following the severe weather that moved through the Austin area, a slope failure occurred on the west bluff overlooking Shoal Creek adjacent to the 2500 block of North Lamar Blvd. There were no injuries to persons or pets along the hike and bike trail. The trail was immediately cordoned off from 24th Street to Shoal Creek Boulevard. There have been no reports of injury from private homeowners atop the bluff in the 2400 block of Wooldridge Drive, although the backyards of several homes overlooking the bluff were visibly impacted. City of Austin parkland and approximately 300 feet of the hike and bike trail along Shoal Creek were damaged by this slope failure. A boulder wall, constructed by the Watershed Protection Department (WPD) in 1999 to stabilize the channel bank, was also severely damaged. Of immediate concern is the large quantity of soil, rock and debris in the creek channel from the slope failure. This could pose a problem with conveyance of flood flows within the creek.

There appears to be a history of slope failures in this area, with the most recent having occurred in 1998. The bluff above Shoal Creek is comprised of Buda Limestone overlying an unstable Del Rio Clay formation. Fractures can develop in the limestone and large masses slide off, riding on top of the clay. The fracturing is the result of movement in the clay beneath the limestone. Similar historical failures have been noted by geologists along the bluff just north of last Friday's slope failure. While the specific cause of this slope failure is unknown at this point, the heavy rains that occurred prior to the failure may have played a role. Mass movement of soil like this is typically a combination of geology, water and topography (steep slopes). Please note that the hike and bike trail improvements were very likely not a contributing factor in the cause of this massive slope failure, but were impacted by it. No recent stream stabilization work has occurred in the impacted stream reach.

- As noted, the trail has been closed and PARC is considering options to reroute pedestrian and bike traffic;
- AW is conducting a TV inspection of the wastewater line to determine if there has been structural damage;

- WPD is conducting aerial video reconnaissance of the site to better assess the extent of the slope failure;
- WPD engineers will obtain new survey data and perform modeling to determine the degree to which the flood conveyance capacity of the creek channel has been impacted;

- WPD engineers and field operations personnel are assessing measures that might be employed to mitigate obstruction of flood flows (e.g., removal of materials from the channel and vegetation from the floodplain) and provide temporary stabilization;

- The WPD Safety Office is assessing potential work hazards and will develop a safety plan prior to any work commencing at the site;
- A forensic geotechnical analysis will be conducted to determine cause and extent of slope failure and likelihood of further soil movement; and
