# Shoal Creek Characterization Report (Draft 4 – 5/29/2019)

## **I. Executive Summary**

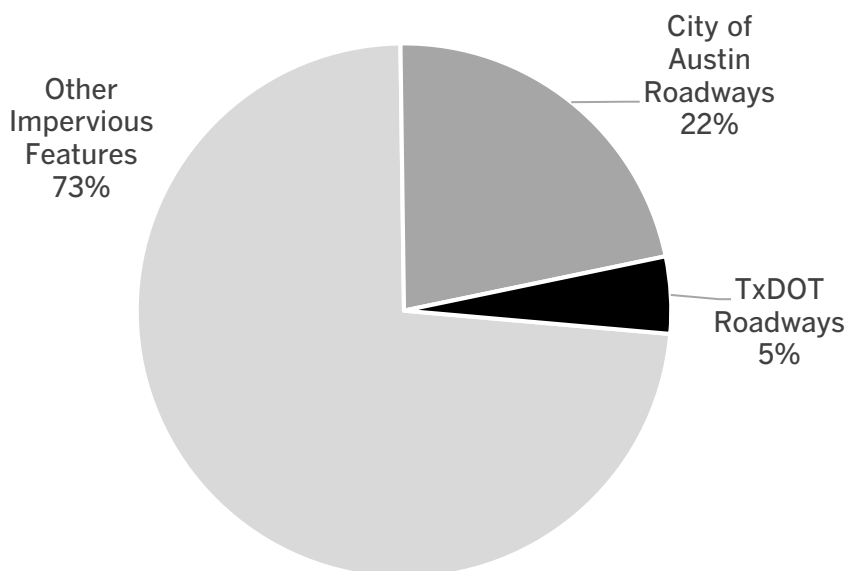
*Figure 15 Composition of Shoal Creek Watershed's Impervious Cover (COA-WPD, 2019)*

The Shoal Creek watershed is the fourth most impervious watershed in the city, with 54% existing impervious cover. Roadways comprise approximately 27% of the watershed's impervious cover (see Figure 15). Most roadway impervious cover is not currently treated for water quality, with approximately 16% of roadway impervious cover treated via water quality controls (COA-WPD, 2019).

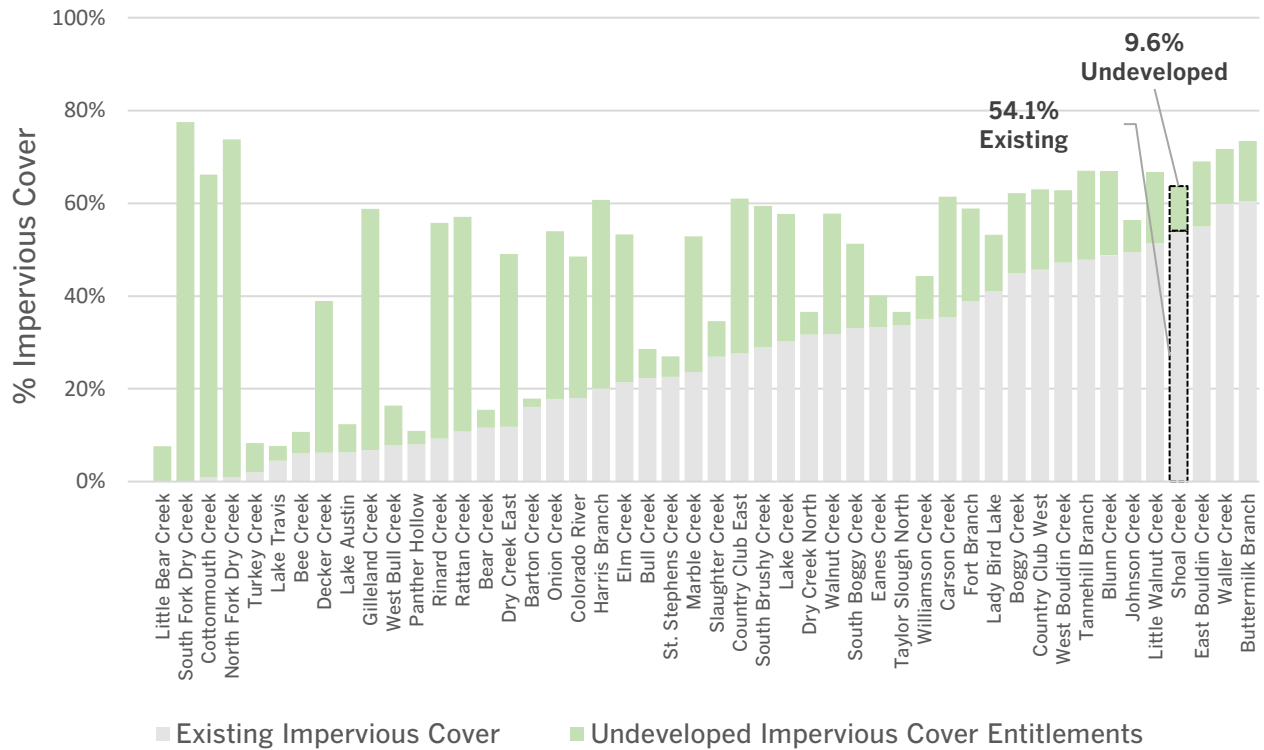
Figure 16 Existing and Maximum Allowed Impervious Cover; Full Purpose Jurisdiction (COA-WPD, 2018)

Based on a City of Austin Watershed Protection Department (COA-WPD) analysis of impervious cover maximum buildout, Shoal Creek watershed could reach approximately 64% impervious cover if each site within the watershed developed to its impervious cover maximum (COA-WPD, 2018). This analysis represents a conservative estimate of maximum buildout, as it does not account for site-specific environmental features such as steep slopes, sensitive features, and trees. The regulatory protections associated with these features could potentially lower the total amount of impervious cover achieved for any given site. Thus, the maximum percentage of impervious cover shown below for each watershed is higher than the ultimate anticipated buildout.

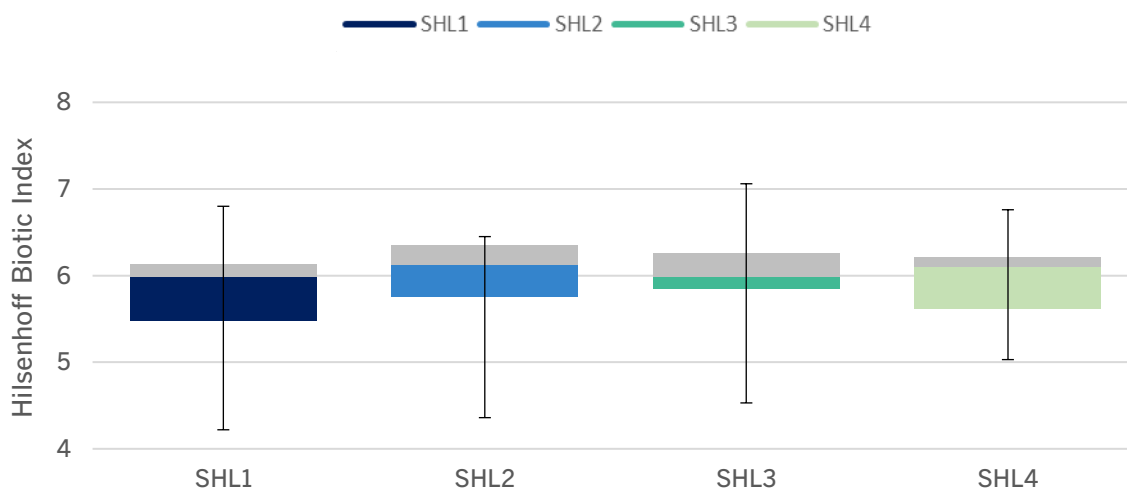
Figure 24 Hilsenhoff Biotic Index (COA-WPD, 2017)

The Hilsenhoff Biotic Index (HBI) metric estimates the overall tolerance of the community. Organisms are assigned a tolerance number from 0 to 10 pertaining to that group's known sensitivity to organic pollutants; 0 being most sensitive, 10 being most tolerant. All of the sites on Shoal Creek have a community that is relatively tolerant to nutrient stressors, with a relative lack of sensitive species.

Figures 24 - 27 describe the diversity and tolerance of the macroinvertebrate and diatom communities found at each EII sampling site during the most recent sampling. The whiskers indicate the minimum and maximum values and the boxes indicate the interquartile range. Throughout the report, individual EII reaches are indicated with the following colors:

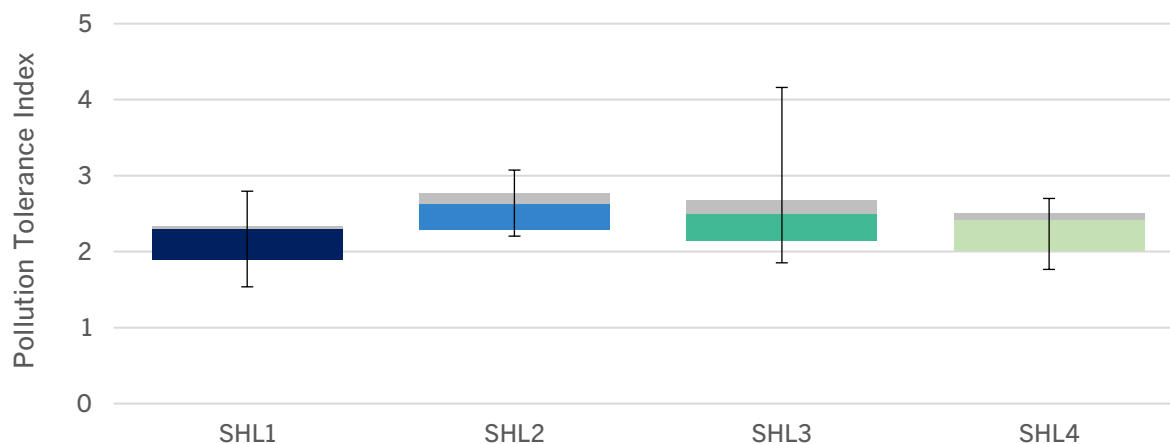
Figure 27 Diatom Pollution Tolerance Index (COA-WPD, 2017)

The Pollution Tolerance Index rates diatom taxa by their sensitivities to increased environmental degradation. There is some improvement of scores at the middle sites, but generally all sites are similar, with scores between 2 and 3.

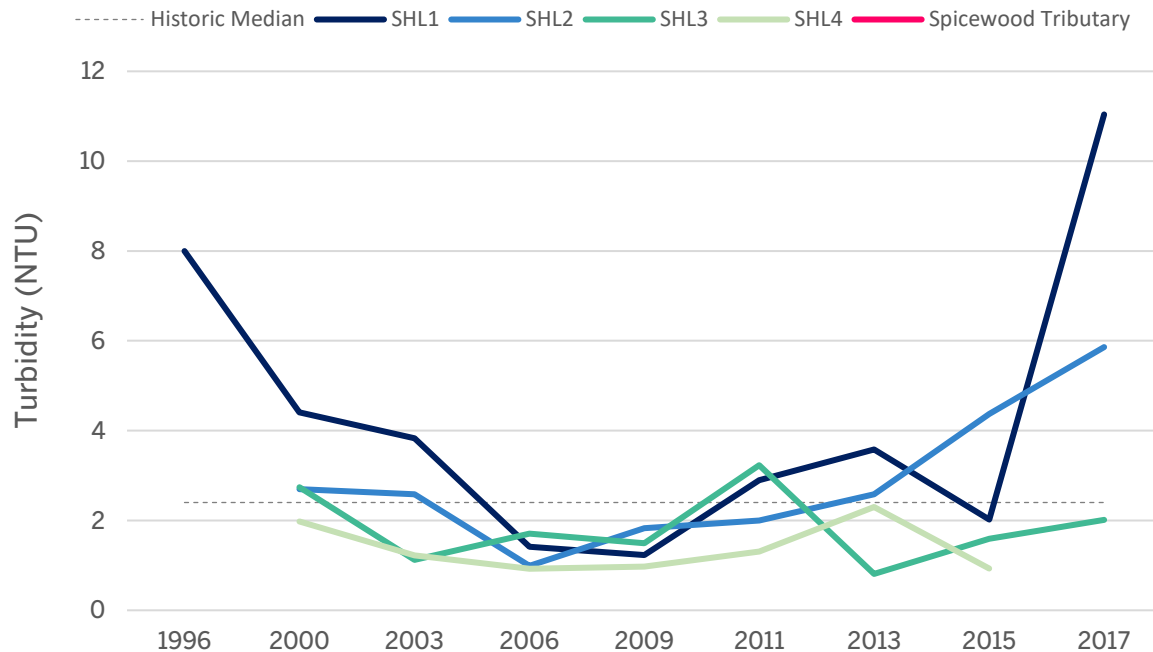
Figure 29 Turbidity (2000 - 2017) (COA-WPD, 2018)

Turbidity is the measure of the clarity of a liquid. Murky, turbid water blocks sunlight for aquatic vegetation and can harm sensitive tissues such as fish and invertebrate gills and eggs. Shoal Creek generally has low turbidity.

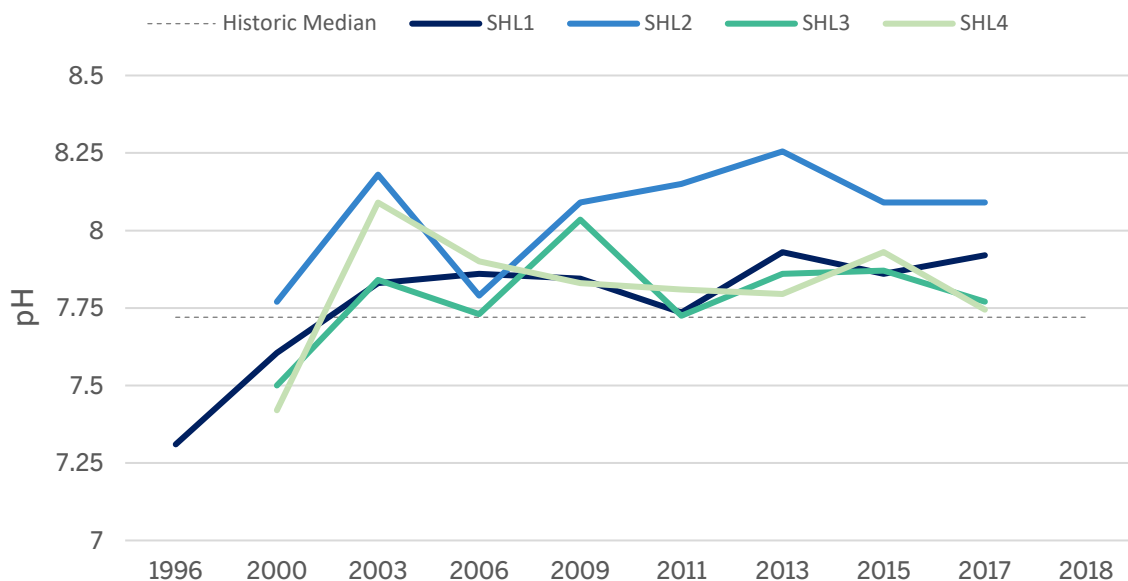
Figure 30 pH (2000 – 2017) (COA-WPD, 2018)

Shoal Creek's pH generally falls within the expected range.
