# Shoal Creek Watershed Characterization Report

## August 2019

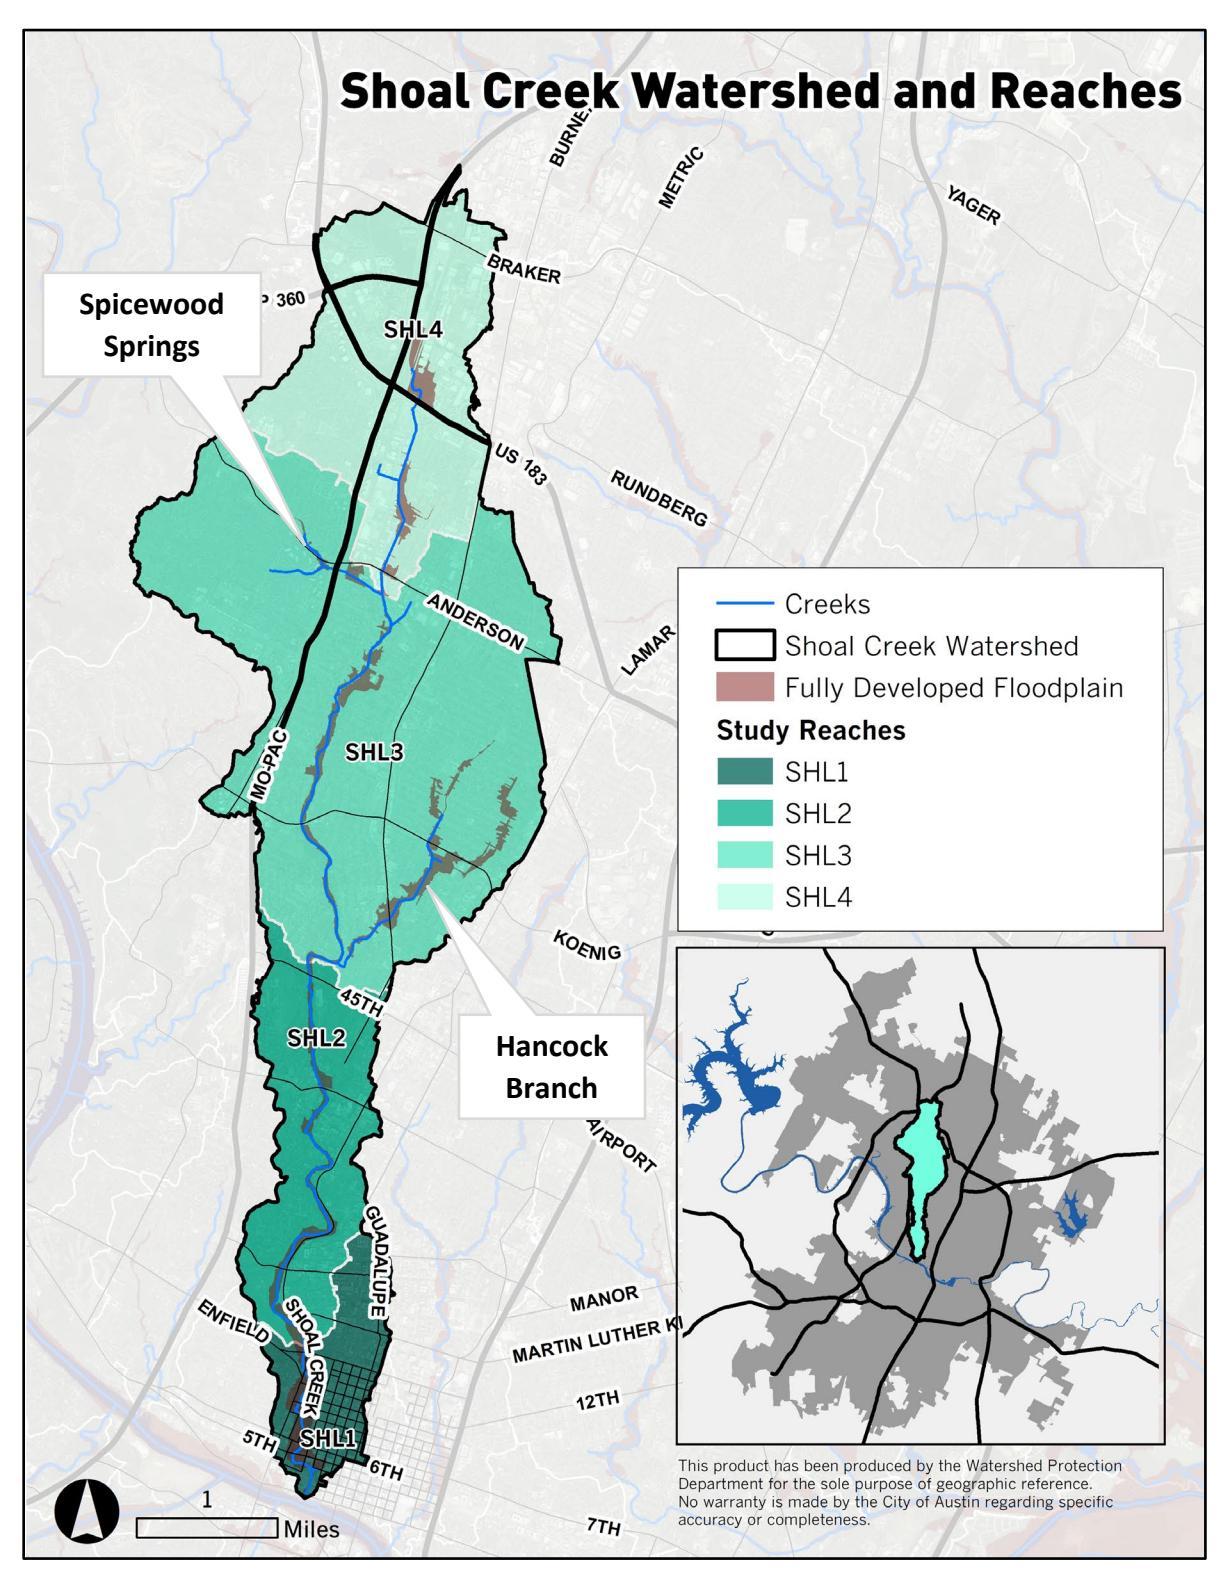
Figure 2 Shoal Creek Watershed and Reaches (COA-WPD, 2018)

Shoal Creek begins just north of the junction of Loop 360 and Mopac and flows south until it empties into Lady Bird Lake between West Avenue and Nueces Street. The creek is best known for the 1981 Memorial Day Flood that devastated lower Shoal Creek and claimed 13 lives, but it has experienced significant flooding events throughout Austin's history. Shoal Creek has two major tributaries. Spicewood Springs is a small tributary in northwest Austin, named for a nearby spring. The Hancock Branch drains the area between Burnet Road and North Lamar Boulevard. Shoal Creek also has the distinction of having the oldest trail in Austin, which was built by volunteers in the early 1960s (Shoal Creek Conservancy, 2013).

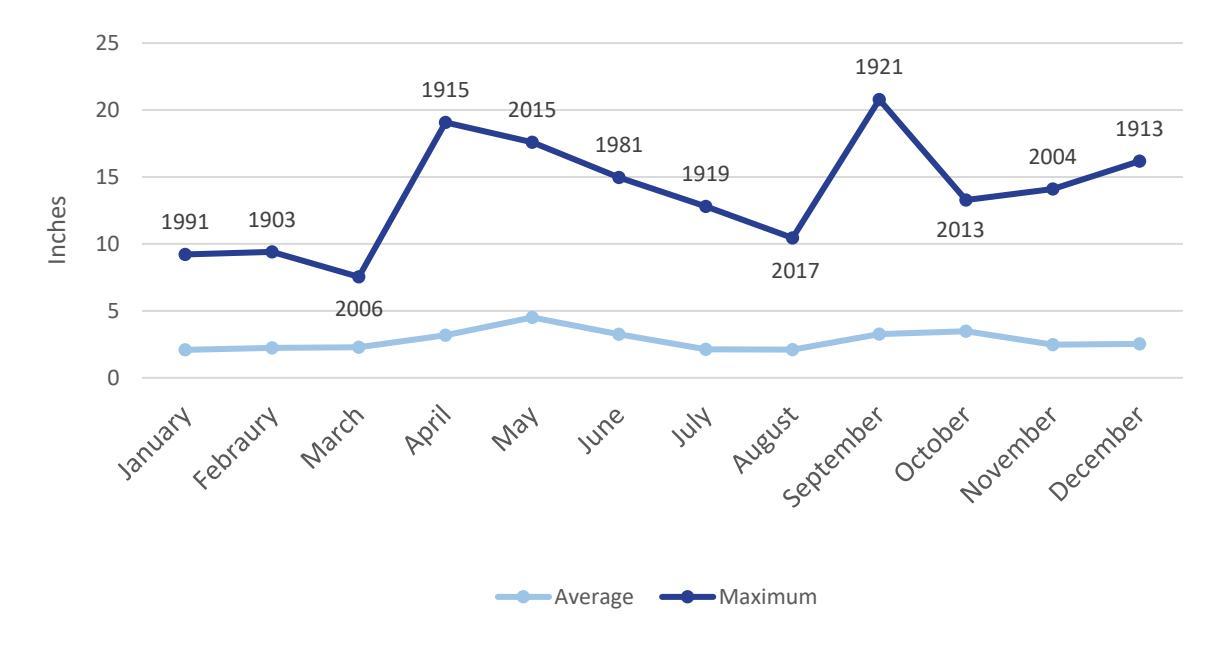
Figure 3 Austin Monthly Rainfall (1897 - 2018) (NWS, 2019)

Austin's climate is characterized by long, hot summers and short, mild winters, with warm spring and fall transitional periods. Austin averages around 34 inches of rainfall per year, with May, September, and October being the wettest months. Yearly total rainfall varies widely, from 11.42 inches in 1954 to 65.31 inches in 1919 (NWS, 2018). Austin also experiences periodic drought conditions, with a record of 88 days without precipitation in 1894-1895 (NWS, 2018). According to the Climate Change Projections for the City of Austin report, projected changes in Austin's climate include increases in annual average temperatures, more frequent high temperature extremes, and more frequent drought conditions in the summer. The report also projects little change in annual average rainfall, but more frequent extreme rainfall (Hayhoe, 2014).

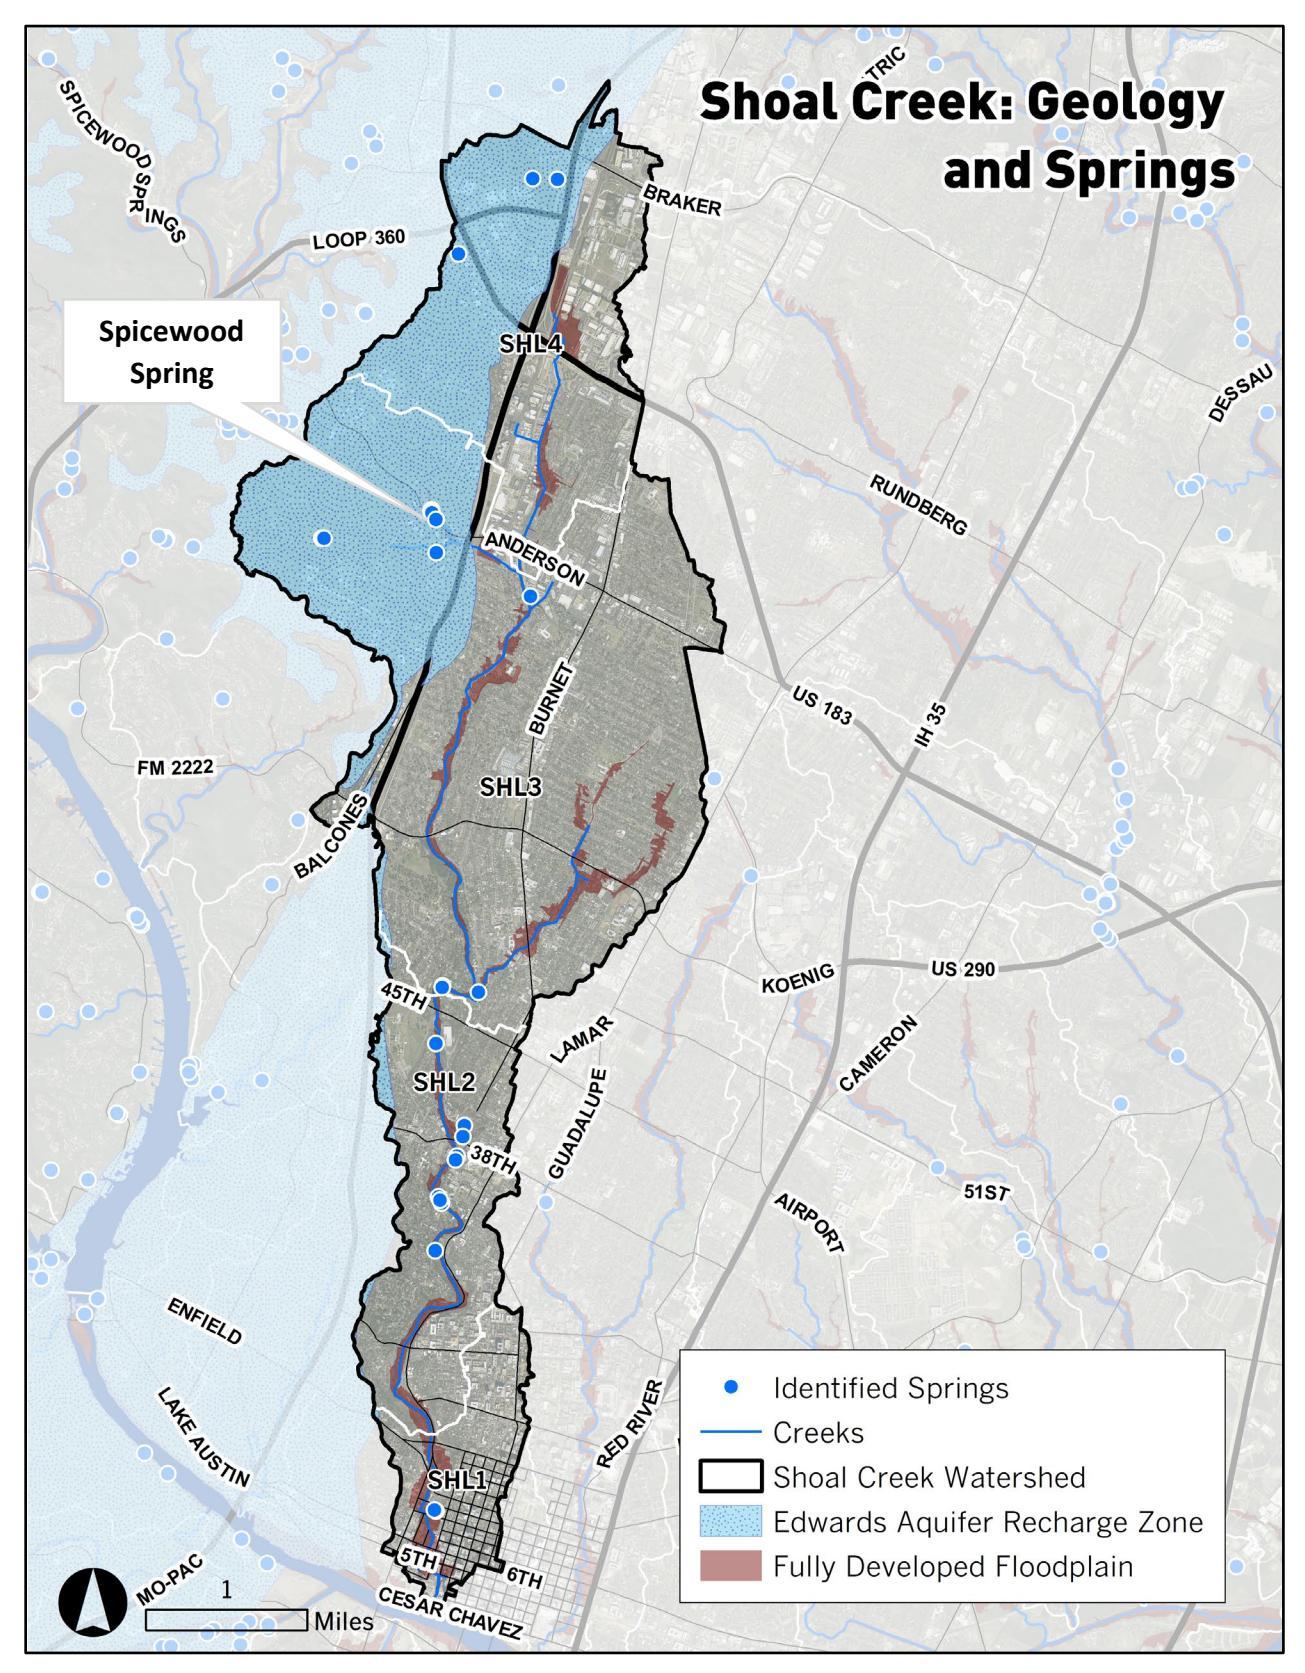
Figure 5 Shoal Creek Geology and Springs (COA-WPD, 2018)

With 30 identified natural seeps or springs, the Shoal Creek watershed contains approximately 5% of the identified seeps/springs within the City of Austin full purpose jurisdiction (COA-WPD, 2018). Two notable springs within the Shoal Creek watershed include Seiders Spring and Spicewood Spring. Seider Spring was the site of popular resort and bathhouse that operated from 1871 to 1896 (Brune, 2002). Spicewood Spring is a verified habitat for the Jollyville Plateau salamander (Eurycea tonkawae), which was listed as federally threatened under the Endangered Species Act in 2012. The Jollyville Plateau salamander has a very limited range—it is found only in springs, spring-fed streams, and subterranean streams of nine watersheds within the Northern Edwards Aquifer. Because this species remains aquatic throughout its life, it depends on the quality and quantity of groundwater for its survival (O'Donnell et al. 2008).

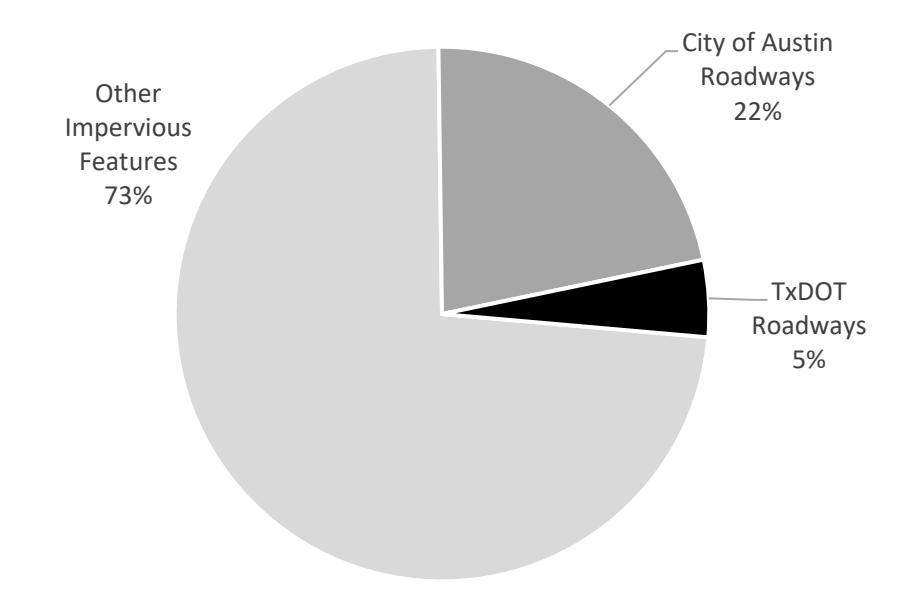
Figure 15 Composition of Shoal Creek Watershed's Impervious Cover (COA-WPD, 2019)

The Shoal Creek watershed is the fourth most impervious watershed in the city, with 54% existing impervious cover. Roadways comprise approximately 27% of the watershed's impervious cover (see Figure 15). Most roadway impervious cover is not currently treated for water quality, with approximately 16% of roadway impervious cover treated via water quality controls (COA-WPD, 2019).

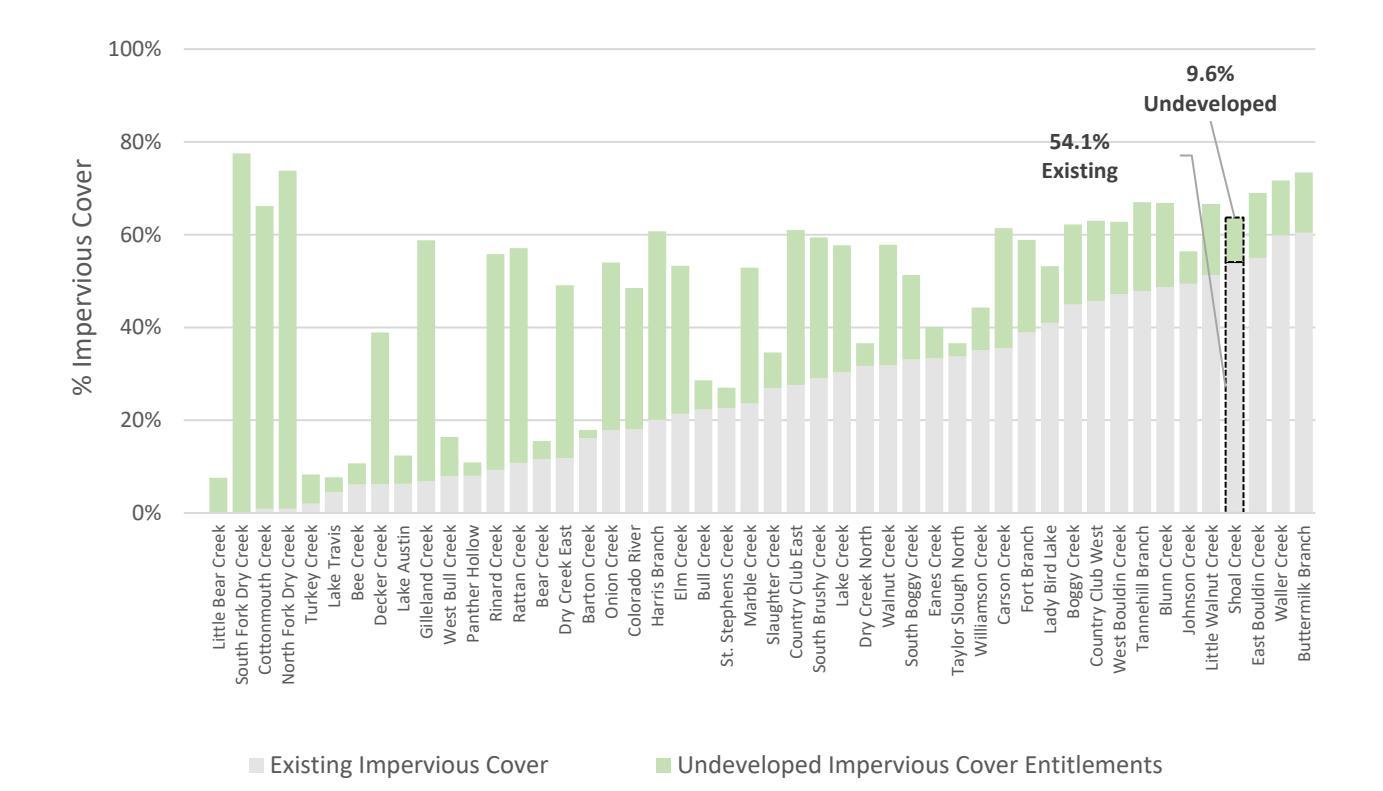
Figure 16 Existing and Maximum Allowed Impervious Cover; Full Purpose Jurisdiction (COA-WPD, 2018)

Based on a City of Austin Watershed Protection Department (COA-WPD) analysis of impervious cover maximum buildout, Shoal Creek watershed could reach approximately 64% impervious cover if each site within the watershed developed to its impervious cover maximum (COA-WPD, 2018). This analysis represents a conservative estimate of maximum buildout, as it does not account for site-specific environmental features such as steep slopes, sensitive features, and trees. The regulatory protections associated with these features could potentially lower the total amount of impervious cover achieved for any given site. Thus, the maximum percentage of impervious cover shown below for each watershed is higher than the ultimate anticipated buildout.

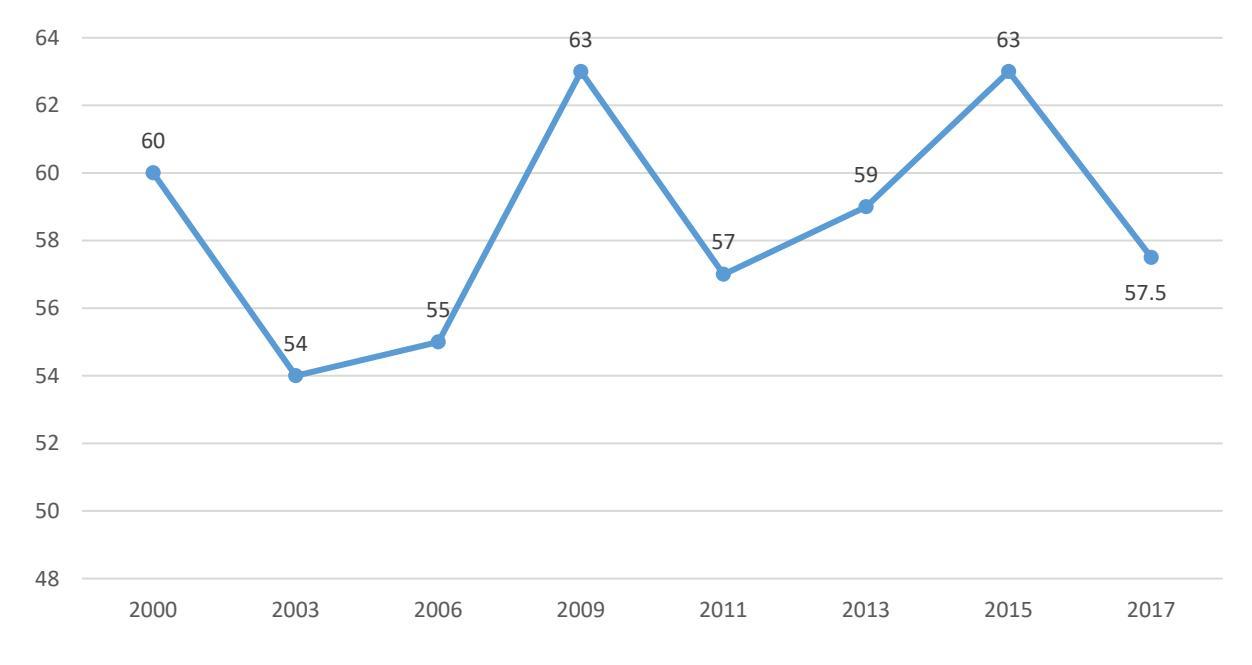
Figure 17 Overall Environmental Integrity Index Score (2003 - 2017) (COA-WPD, 2017)

The overall EII score is calculated as the average of the subindices, which results in equal weighting of each subindex. The scores range between 0 and 100, with higher EII scores indicating more fully functional creek reaches that are less degraded by human disturbance. A reach with an overall EII score ranging from 62.5 to 75 is classified as in "Good" health. The 2017 EII indicates that Shoal Creek is within the "Fair" range with a score of 57.5 (See Figure 17). The full EII summary for Shoal Creek can be found in <u>Appendix A</u>.

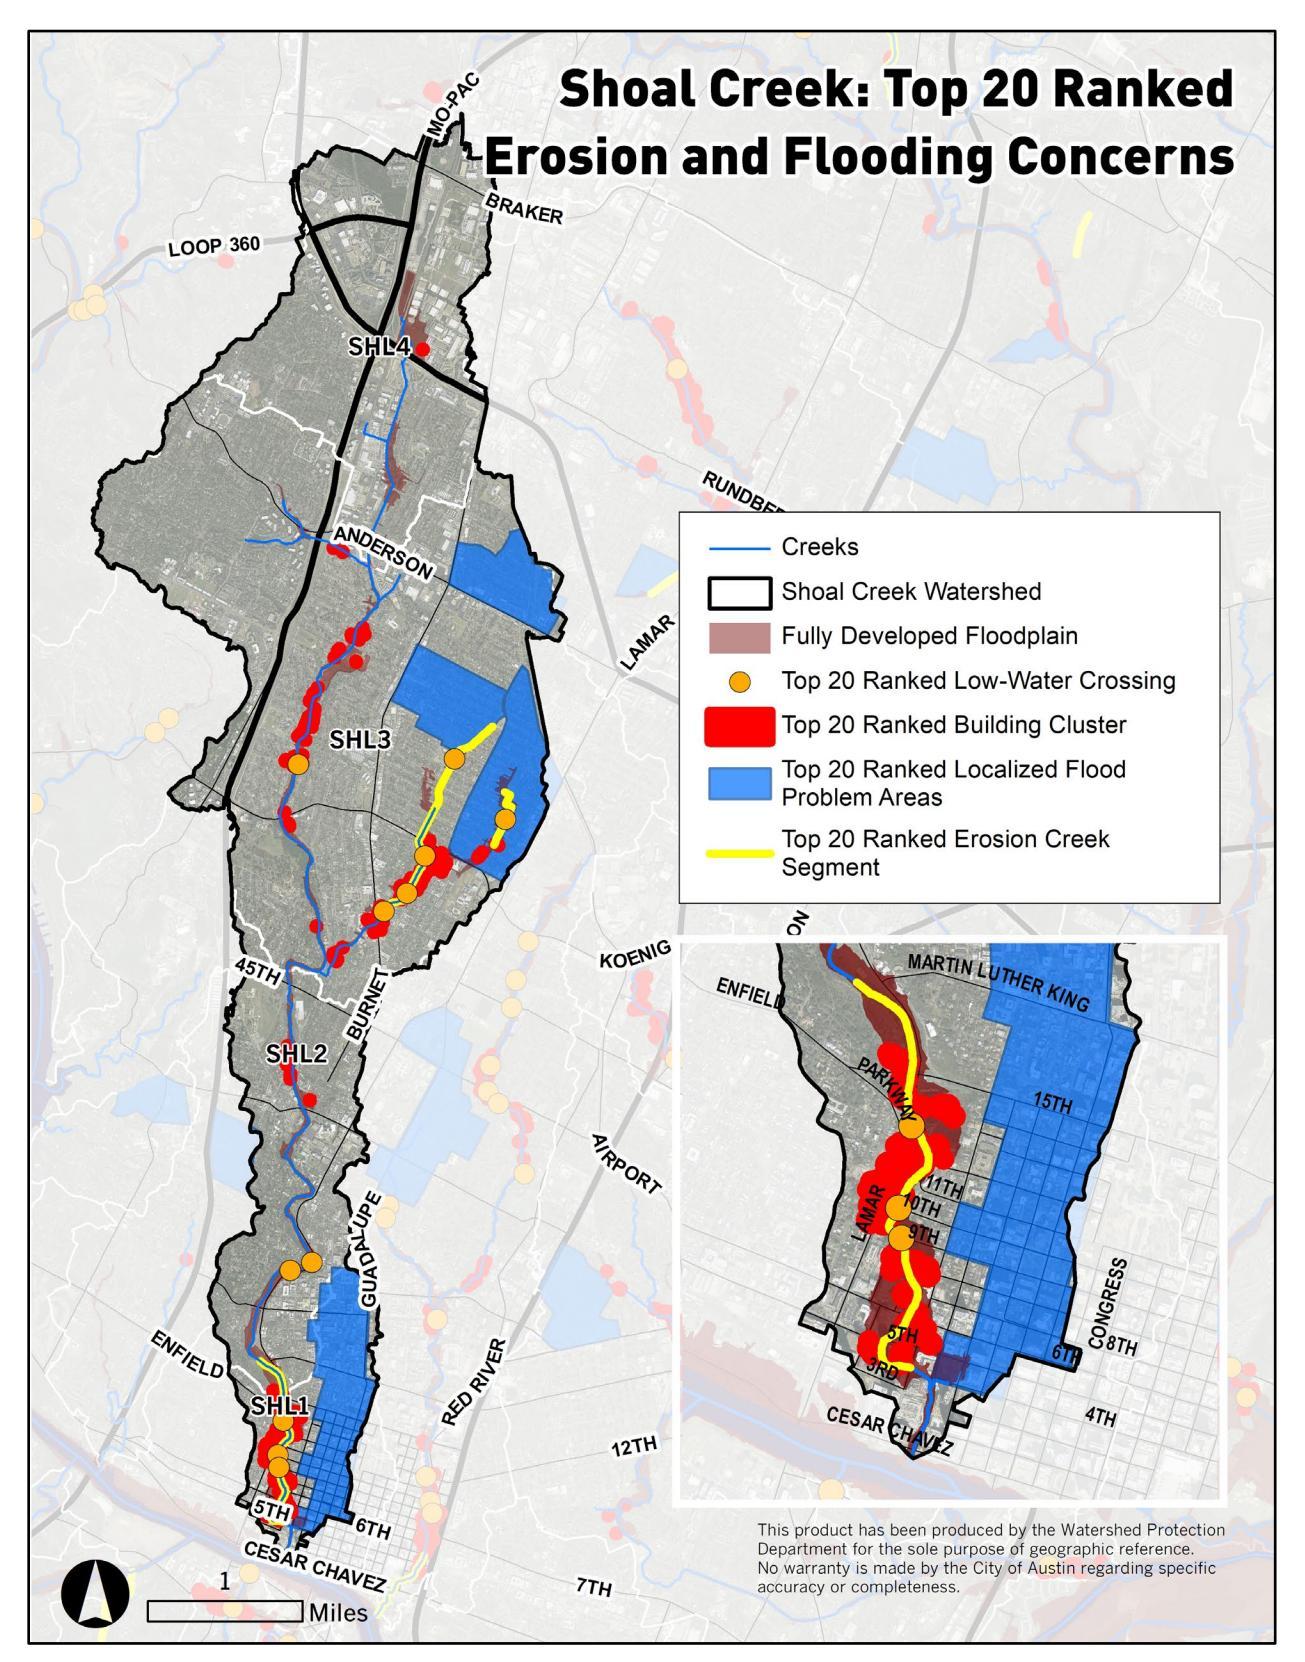
Figure 19 COA-WPD Fiscal Year 2019 Top 20 Ranked Erosion and Flooding Concerns (COA-WPD, 2018)

Location	Reach	Narrative Score	Citywide Rank
Grover Tributary - From confluence with Shoal Creek to upstream end near Grover Dr	Hancock-Grover-2	Very High	3
Arroyo Seco - From 550 ft. upstream of North Loop Rd. to W St. Johns	Hancock-3	Very High	9
Shoal Creek Mainstem - From W. 6th St to W. 15 <sup>th</sup> Street	Shoal-3	Very High	20

"Localized flooding" is a term used when flooding occurs away from creeks and due to problems with the secondary drainage system. The secondary, or engineered drainage system is composed of pipes, curb inlets, manholes, minor channels, roadside ditches, and culverts. This system is intended to convey stormwater runoff to the primary drainage system, the creek. Because the Shoal Creek watershed was largely built-out prior to the implementation of drainage criteria in 1977, much of Shoal Creek's infrastructure is undersized or experiences failure of components due to deteriorating materials. Both factors contribute to localized flooding. COA-WPD currently prioritizes localized flooding problems areas using reports of flooding from residents. Reports of flooding of buildings is considered the most severe for purposes of prioritizing projects for implementation. The table below summarizes the localized flooding problem areas within the Shoal Creek watershed that are among the fiscal year 2019 Top 20 most severe problem areas in the city. See Figure 19 for a map of these problem areas.

Erosion problems can stem from changing land use conditions (i.e., urbanization) that modify watershed hydrology by increasing stormwater runoff. Other problems occur due to improper placement of man-made resources near stream banks. Changes in streamflow have resulted in accelerated changes in local creek characteristics across Austin. The Shoal Creek watershed was largely developed before this relationship between urbanization and erosion was well-understood—development was often placed too close to creek banks, which put those resources at risk when Shoal Creek experienced deepening and widening due to increased runoff. As a result, development along Shoal Creek has been significantly impacted by erosion. The table below summarizes the reaches within the Shoal Creek watershed that are among the fiscal year 2019 Top 20 most severe problem reaches in the city. See Figure 19 for a map of these problem areas.

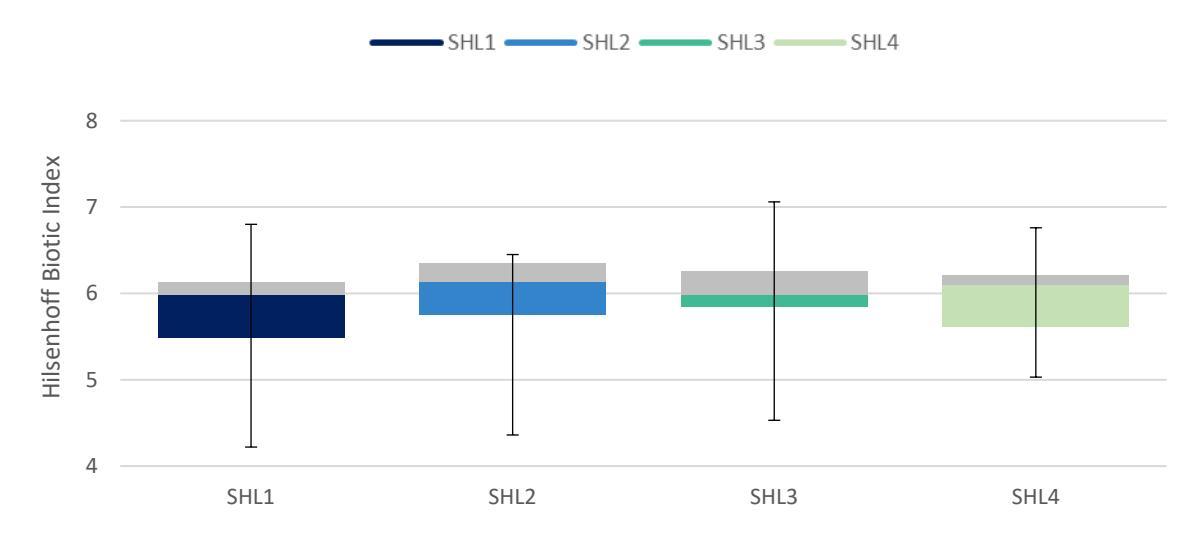
Figure 24 Hilsenhoff Biotic Index (COA-WPD, 2017)

The Hilsenhoff Biotic Index (HBI) metric estimates the overall tolerance of the community. Organisms are assigned a tolerance number from 0 to 10 pertaining to that group's known sensitivity to organic pollutants; 0 being most sensitive, 10 being most tolerant. All of the sites on Shoal Creek have a community that is relatively tolerant to nutrient stressors, with a relative lack of sensitive species.

Figures 24 - 27 describe the diversity and tolerance of the macroinvertebrate and diatom communities found at each EII sampling site during the most recent sampling. The whiskers indicate the minimum and maximum values and the boxes indicate the interquartile range. Throughout the report, individual EII reaches are indicated with the following colors:

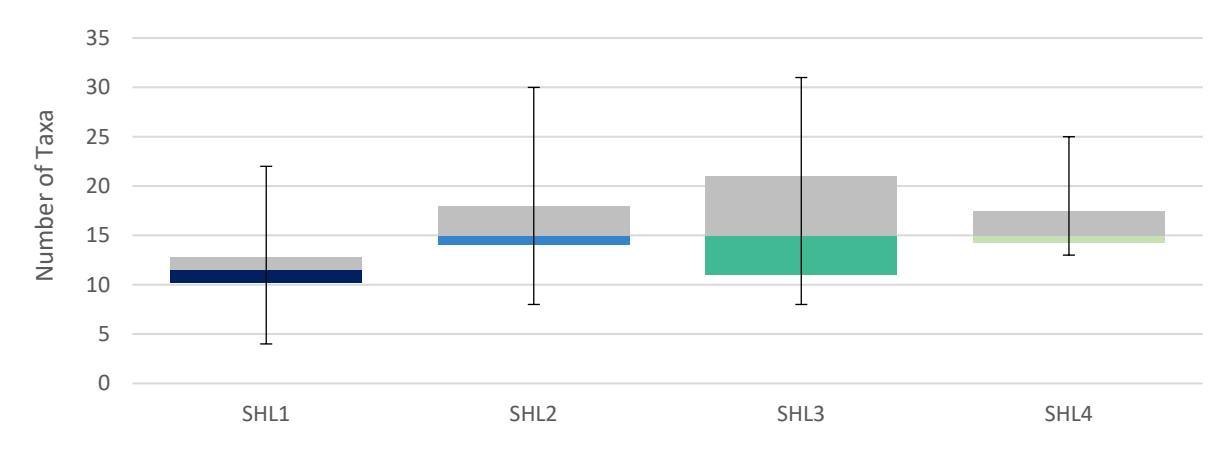
Figure 25 Number of Benthic Macroinvertebrate Taxa (COA-WPD, 2017)

Total number of bug taxa is a measure of diversity and an excellent indicator of overall stream health. The number of taxa generally increases from downstream to upstream reaches, but the difference is relatively small among reaches. This suggests that the upstream reaches have a healthier bug community.

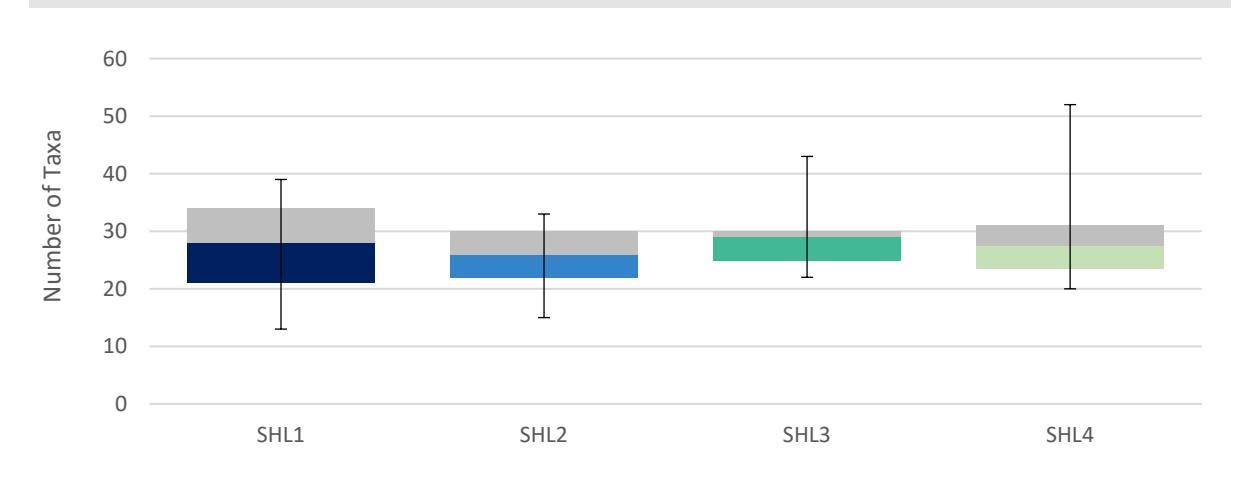
Figure 26 Number of Diatom Taxa (COA-WPD, 2017)

The number of diatom taxa is not very different among the four Shoal Creek sites, suggesting that for this measure the sites are relatively similar, with total taxa counts around 25.

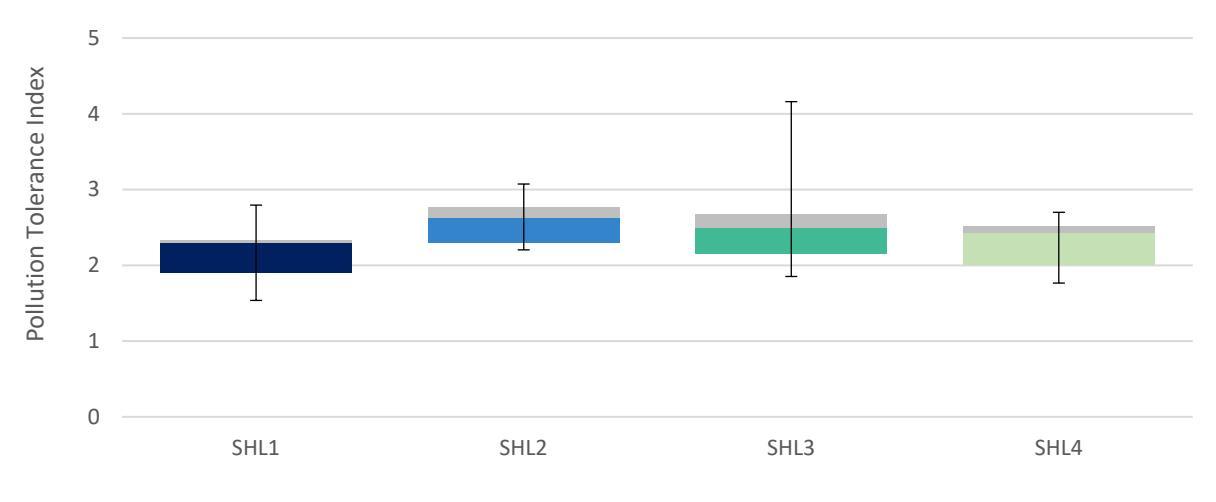
Figure 27 Diatom Pollution Tolerance Index (COA-WPD, 2017)

The Pollution Tolerance Index rates diatom taxa by their sensitivities to increased environmental degradation. There is some improvement of scores at the middle sites, but generally all sites are similar, with scores between 2 and 3.

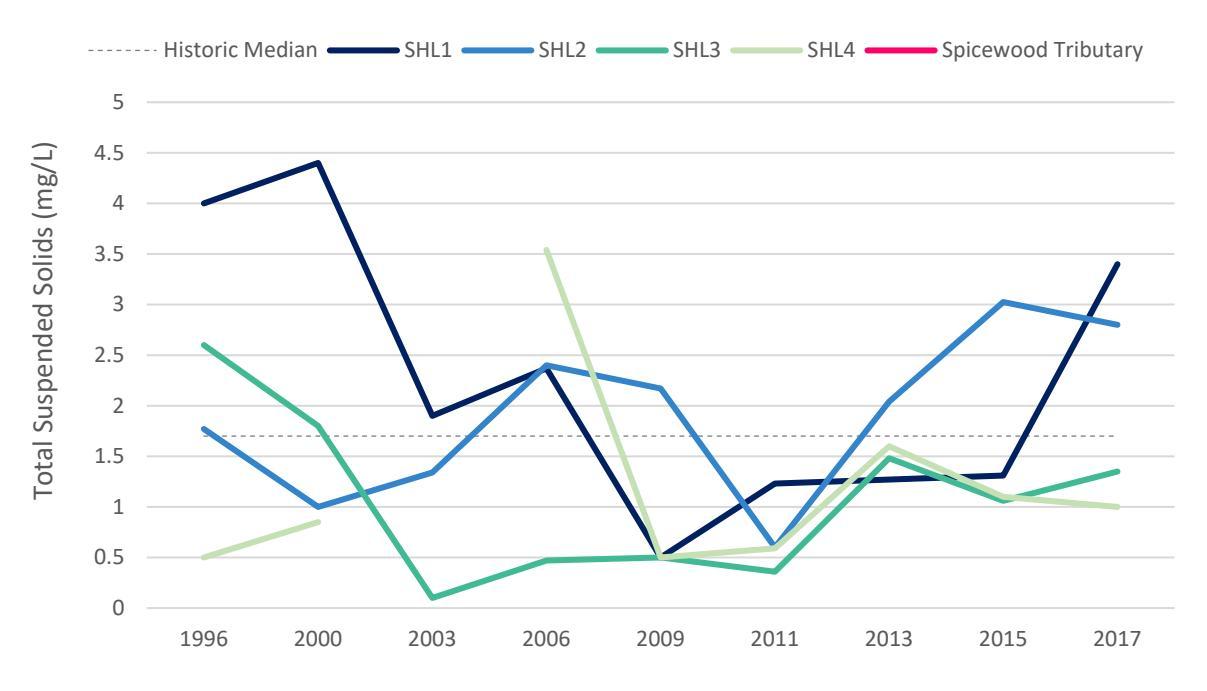
Figure 28 Total Suspended Solids (mg/L) (1996 – 2017) (COA-WPD, 2018)

Although it is naturally occurring, sediment levels can be elevated from accelerated and unnatural erosion from active and historic development practices. Nutrients and other pollutants can be released from eroded soil and the fine silty particles degrade the habitat for aquatic life. Shoal Creek is generally below average for Total Suspended Solids compared to other watersheds. Total Suspended Solids is typically higher and more variable for Shoal Creek's downstream reaches (SHL1-2) and decreases as you travel upstream (SHL3-4).

On the following pages are figures depicting the water chemistry subindices for the Shoal Creek watershed (Figures 28 - 36). Spicewood Tributary information is provided where available. A full summary of the EII reaches, including tables and box and whisker plots, is found in <u>Appendix A</u>. The raw data can be found at <u>data.austintexas.gov/Environment/Water-Quality-Sampling-Data/</u>.

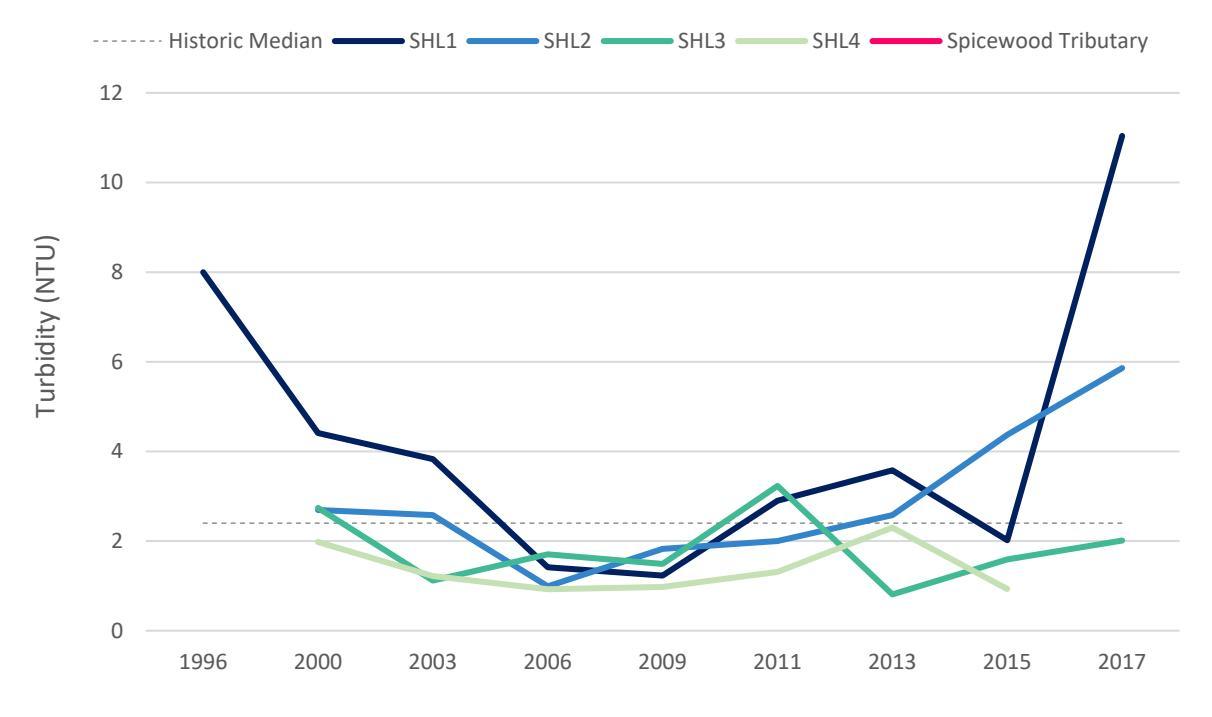
Figure 29 Turbidity (2000 - 2017) (COA-WPD, 2018)

Turbidity is the measure of the clarity of a liquid. Murky, turbid water blocks sunlight for aquatic vegetation and can harm sensitive tissues such as fish and invertebrate gills and eggs. Shoal Creek generally has low turbidity.

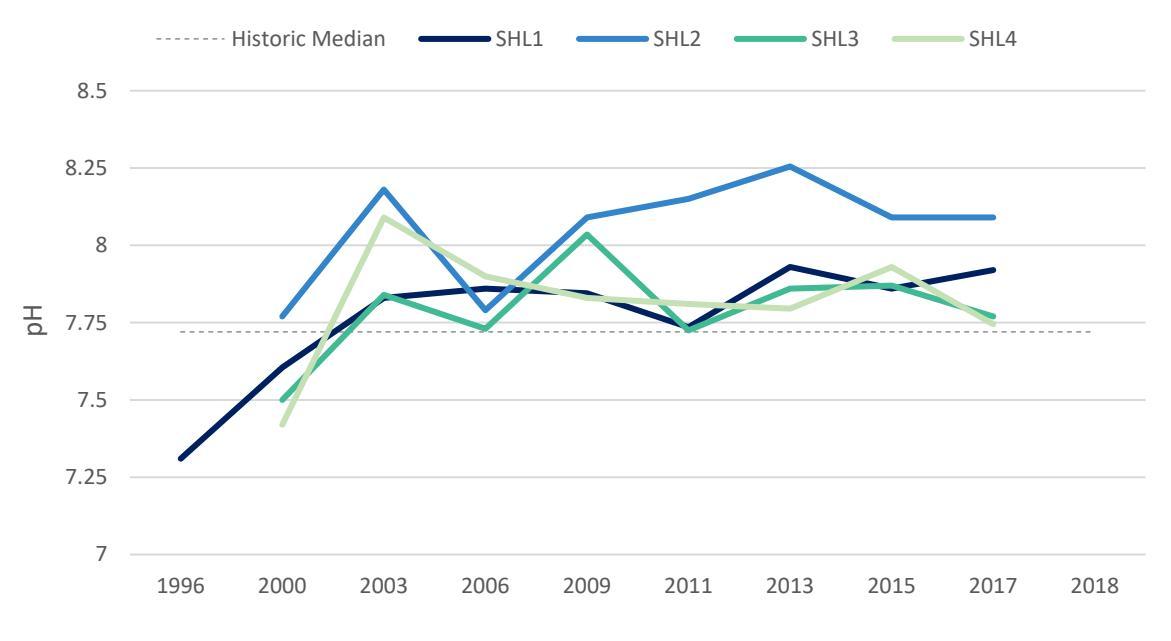
Figure 30 pH (2000 – 2017) (COA-WPD, 2018)

Shoal Creek's pH generally falls within the expected range.

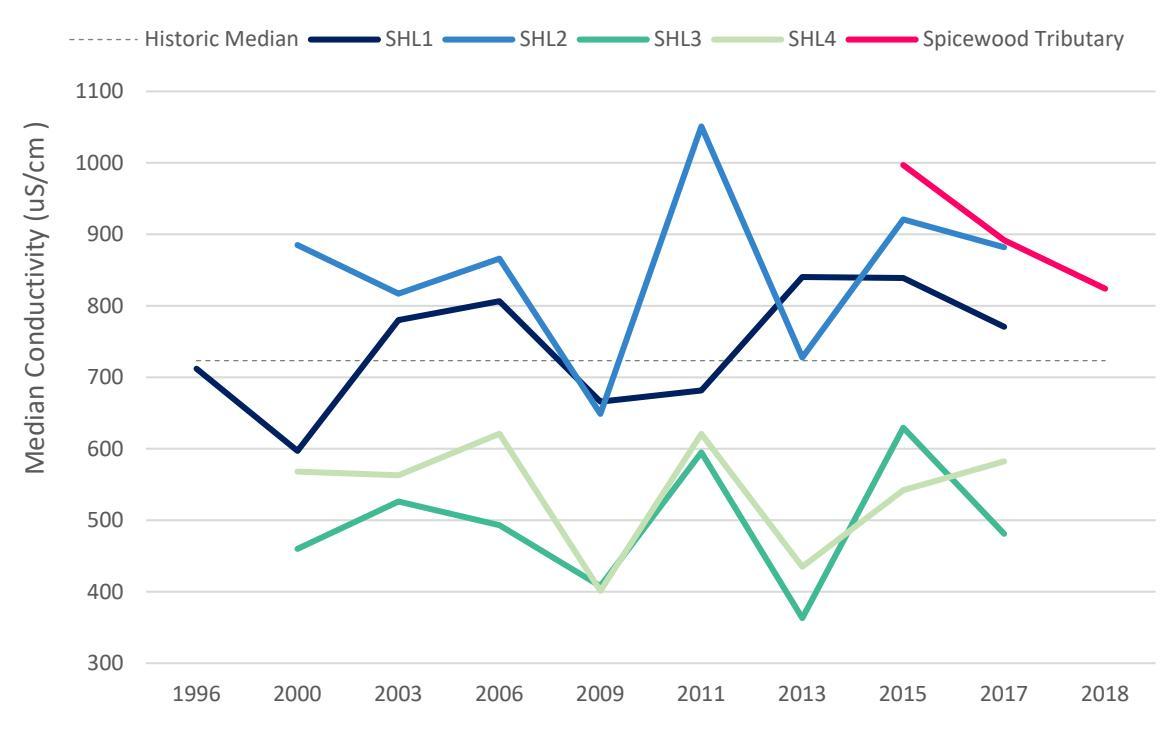
Figure 31 Conductivity (µS/cm) (2000 – 2018) (COA-WPD, 2018)

Conductivity is a measure of the amount of salts in water and a good indicator of a range of urban pollutants. Shoal Creek frequently exceeds 700  $\mu$ S/cm, which is indicative of a more urbanized watershed. Note that conductivity is typically higher and more variable for Shoal Creek's downstream reaches (SHL1) and decreases steadily as you travel upstream (SHL2-4).

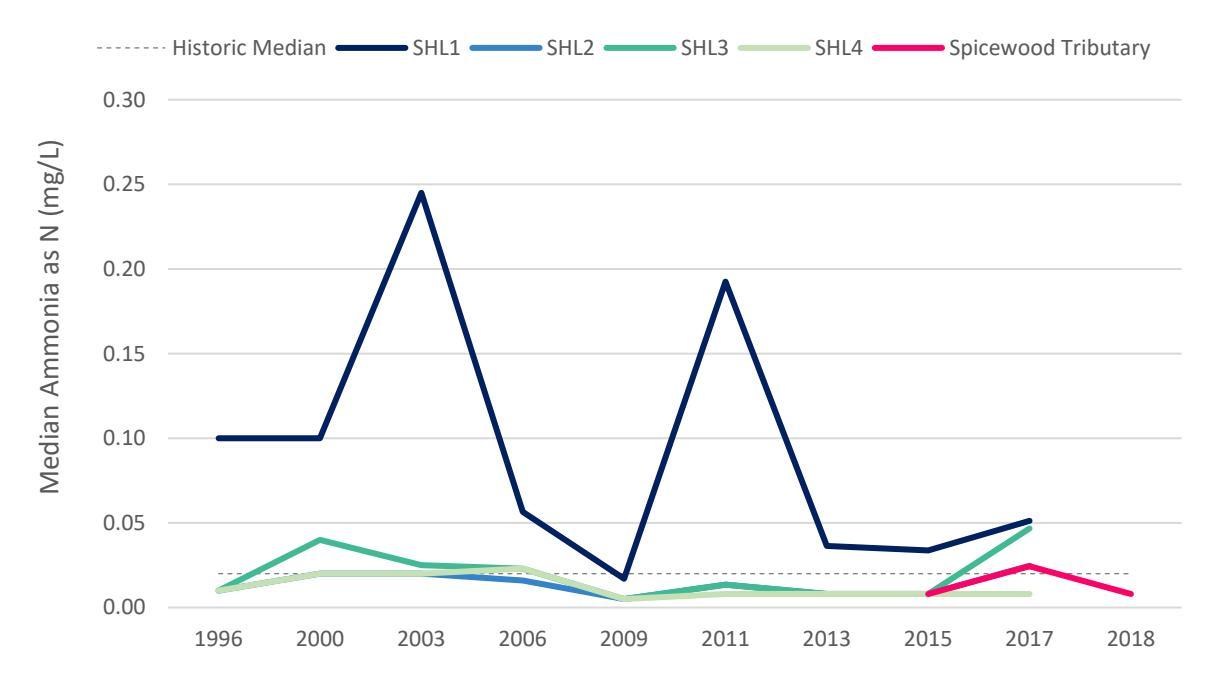
Figure 33 Ammonia (mg/L) (1996 – 2018) (COA-WPD, 2018)

Ammonia is one of several forms of nitrogen that exist in aquatic environments. Ammonia is typically higher and more variable for Shoal Creek's most downstream reach (SHL1).

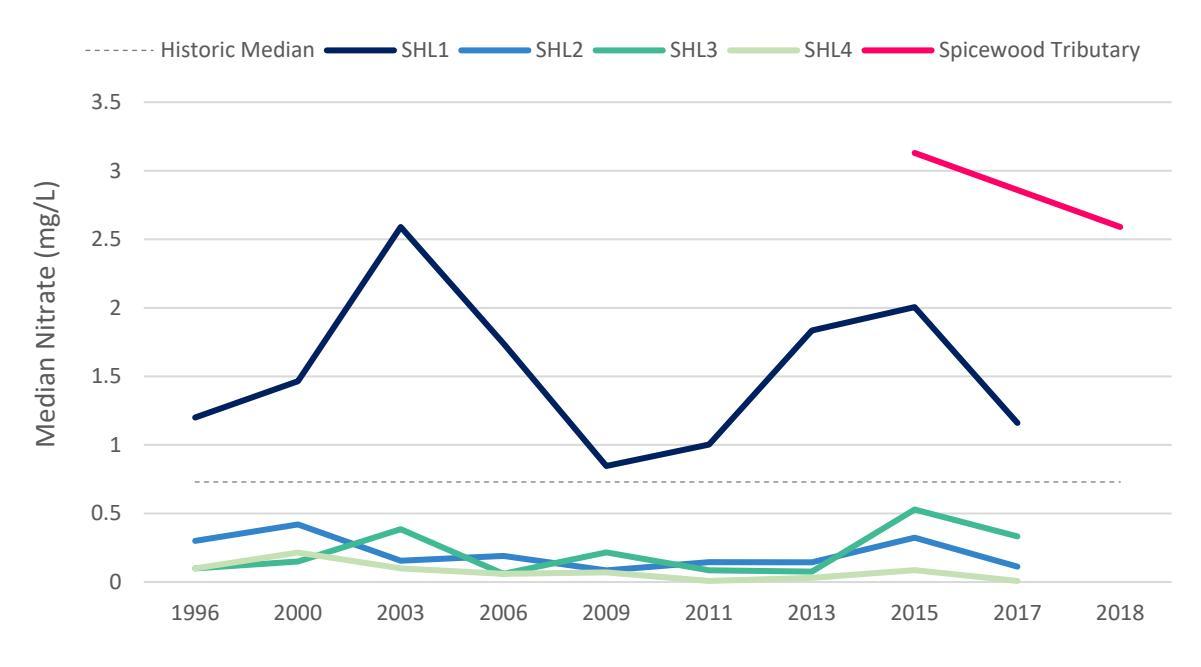
Figure 34 Nitrate (mg/L) (1996 – 2018) (COA-WPD, 2018)

Nitrates are a form of nitrogen, which is found in several different forms in terrestrial and aquatic ecosystems. Levels of nitrate are very high for the Spicewood Spring Tributary.

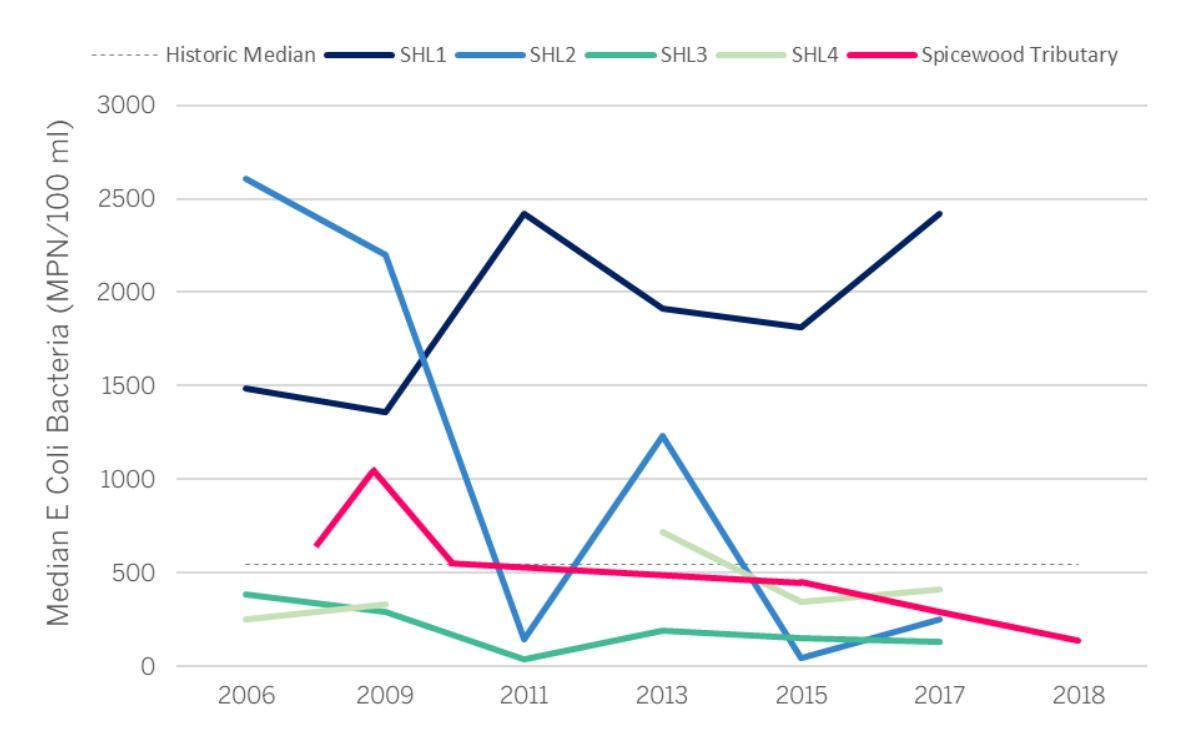
Figure 36 E. Coli Bacteria for EII Reaches and Spicewood Springs Tributary (2006 – 2018) (MPN/100 ml)

Most samples exceed the contact recreation standard for E. coli. Bacteria concentrations are typically higher and more variable for Shoal Creek's downstream reaches.

Pathogenic bacteria in streams is a significant water quality problem because it restricts contact recreation, but it also serves as an indicator or surrogate for other pollutants such as nutrients and low dissolved oxygen. The potential sources of elevated bacteria in streams are diverse, diffuse, and often difficult to isolate. E. coli concentrations have historically been elevated throughout Shoal Creek, likely due to aging wastewater infrastructure in which spills and overflows are common. As these lines get replaced and there are other incremental improvements to the wastewater infrastructure, the total bacteria load should decrease (Clamann et al., 2015). Urban areas also tend to have a higher concentration of human and animal fecal inputs. The most probable sources of E. coli contamination in urban streams include sewage spills, chronic sewage leaks from wastewater lines, leakage from on-site sewage facilities, uncollected pet waste, untreated latrine sites that develop where indigent communities congregate, and areas where fecal material from urban wildlife accumulates (Jackson and Herrington, 2012). See Figure 36 for a summary of E. coli bacteria for EII reaches.
