# Shoal Creek Watershed Characterization Report

## August 2019

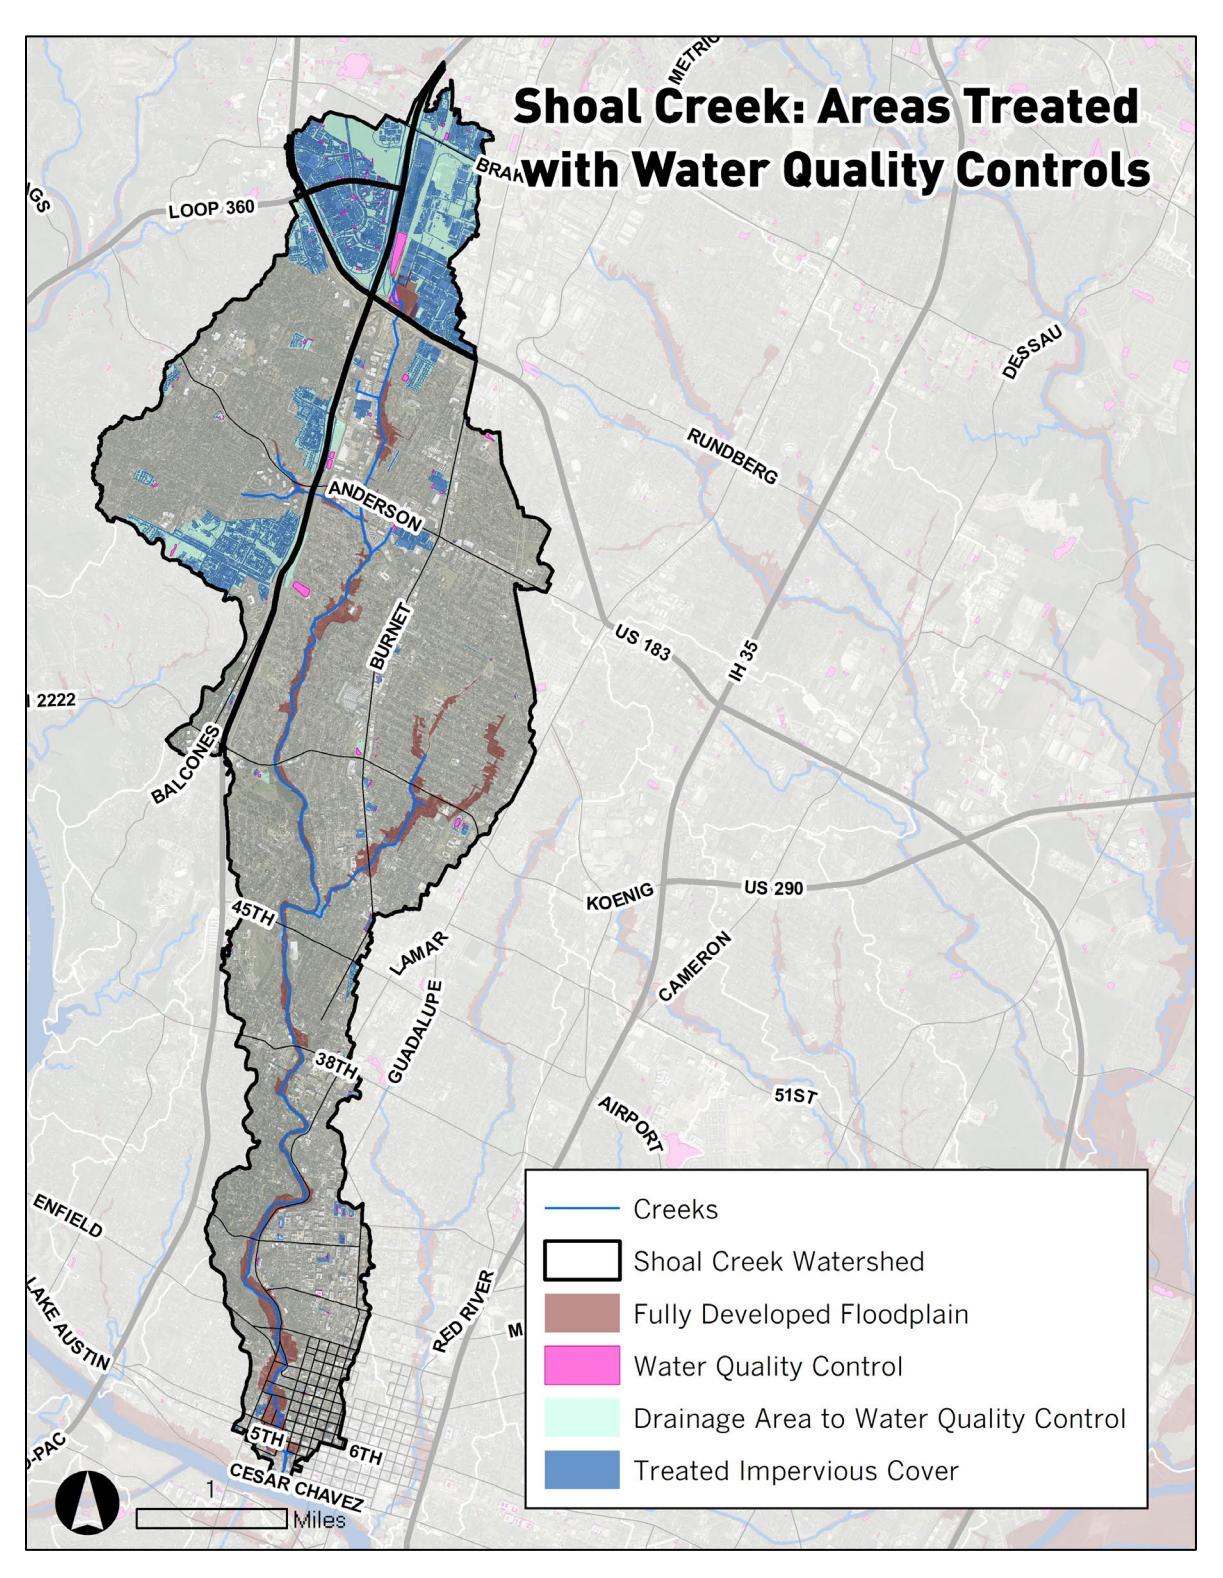
Figure 40 Areas Treated with Water Quality Controls - The dark blue areas represent impervious cover that is treated for water quality. While the portion of the Shoal Creek watershed north of US 183 is almost completely treated, approximately 80% of the watershed's impervious cover has no treatment. (COA-WPD, 2018)

Because Shoal Creek was among the first areas to be developed in Austin, large portions of the watershed were developed prior to modern watershed regulations. Thus, most watershed protection efforts in the Shoal Creek watershed must necessarily target the repair of problems caused by longstanding, unregulated development. Shoal Creek watershed has the largest number of parcels developed prior to the 1974 Waterway Ordinance. Over 56% of development in Shoal Creek was built prior to this ordinance, while 71% of development was built prior to the introduction of water quality control requirements in 1991. Because most development occurred prior to 1991, only 19% of the watershed's impervious cover is treated by water quality controls (see Figures 39 and 40). Please refer to Page 63 for a comprehensive description of watershed regulations.

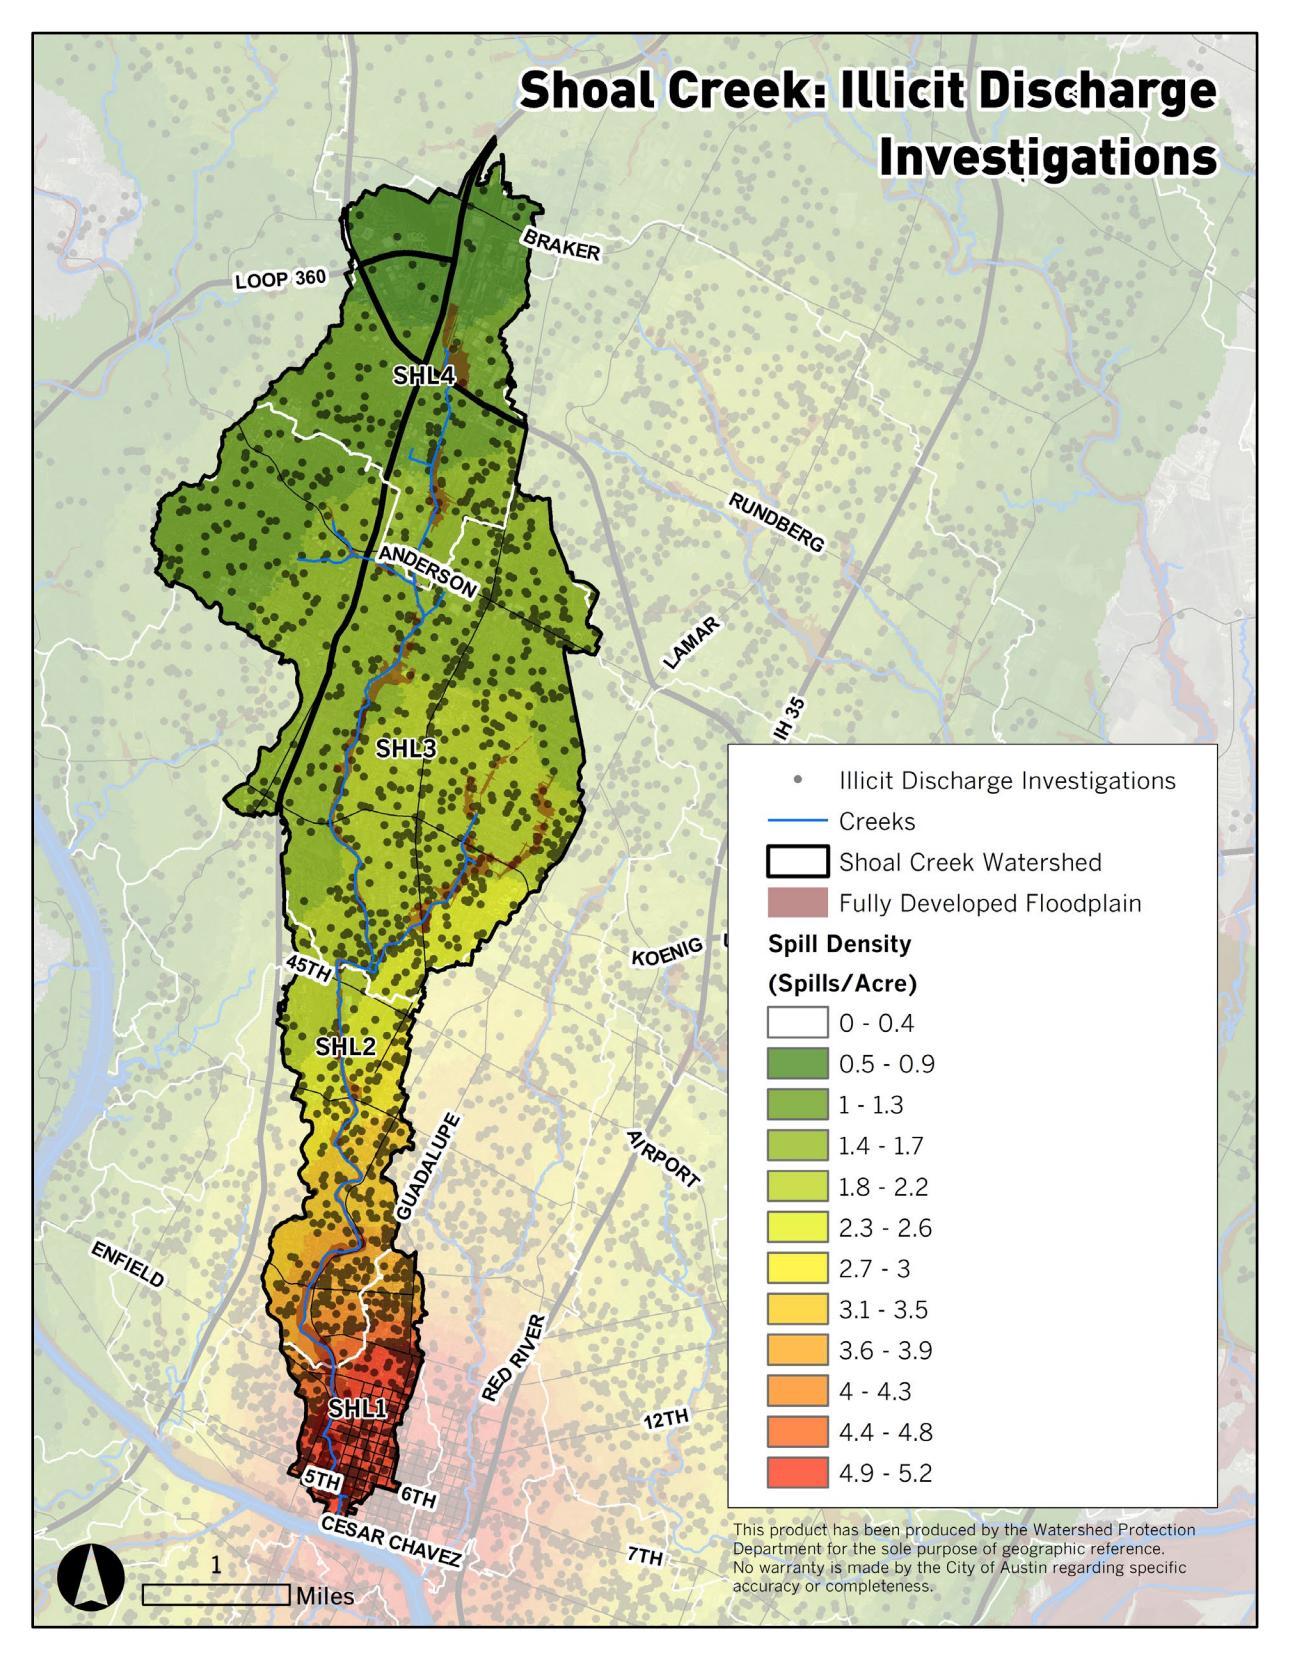
Figure 43 Illicit Discharge Investigations – Illicit discharge investigation density increases as proximity to downtown increases. (COA-WPD, 2018)

COA-WPD's Spills Response program investigates illicit discharges to the storm sewer system and spills of hazardous and non-hazardous materials that threaten waterways. Spills Response investigations include identifying the source of the discharge and monitoring cleanup. Discharges may occur through illicit plumbing connections to the City's storm sewer system, wastewater overflows, deliberate dumping, or accidental spills. Because the wastewater infrastructure tends to be older and more prone to failure, Shoal Creek has a relatively high rate of illicit discharges compared to other watersheds. Investigations of illicit discharges reports are concentrated in the SHL1 and SHL2 reaches, most likely due to a higher density of population and urban activity.

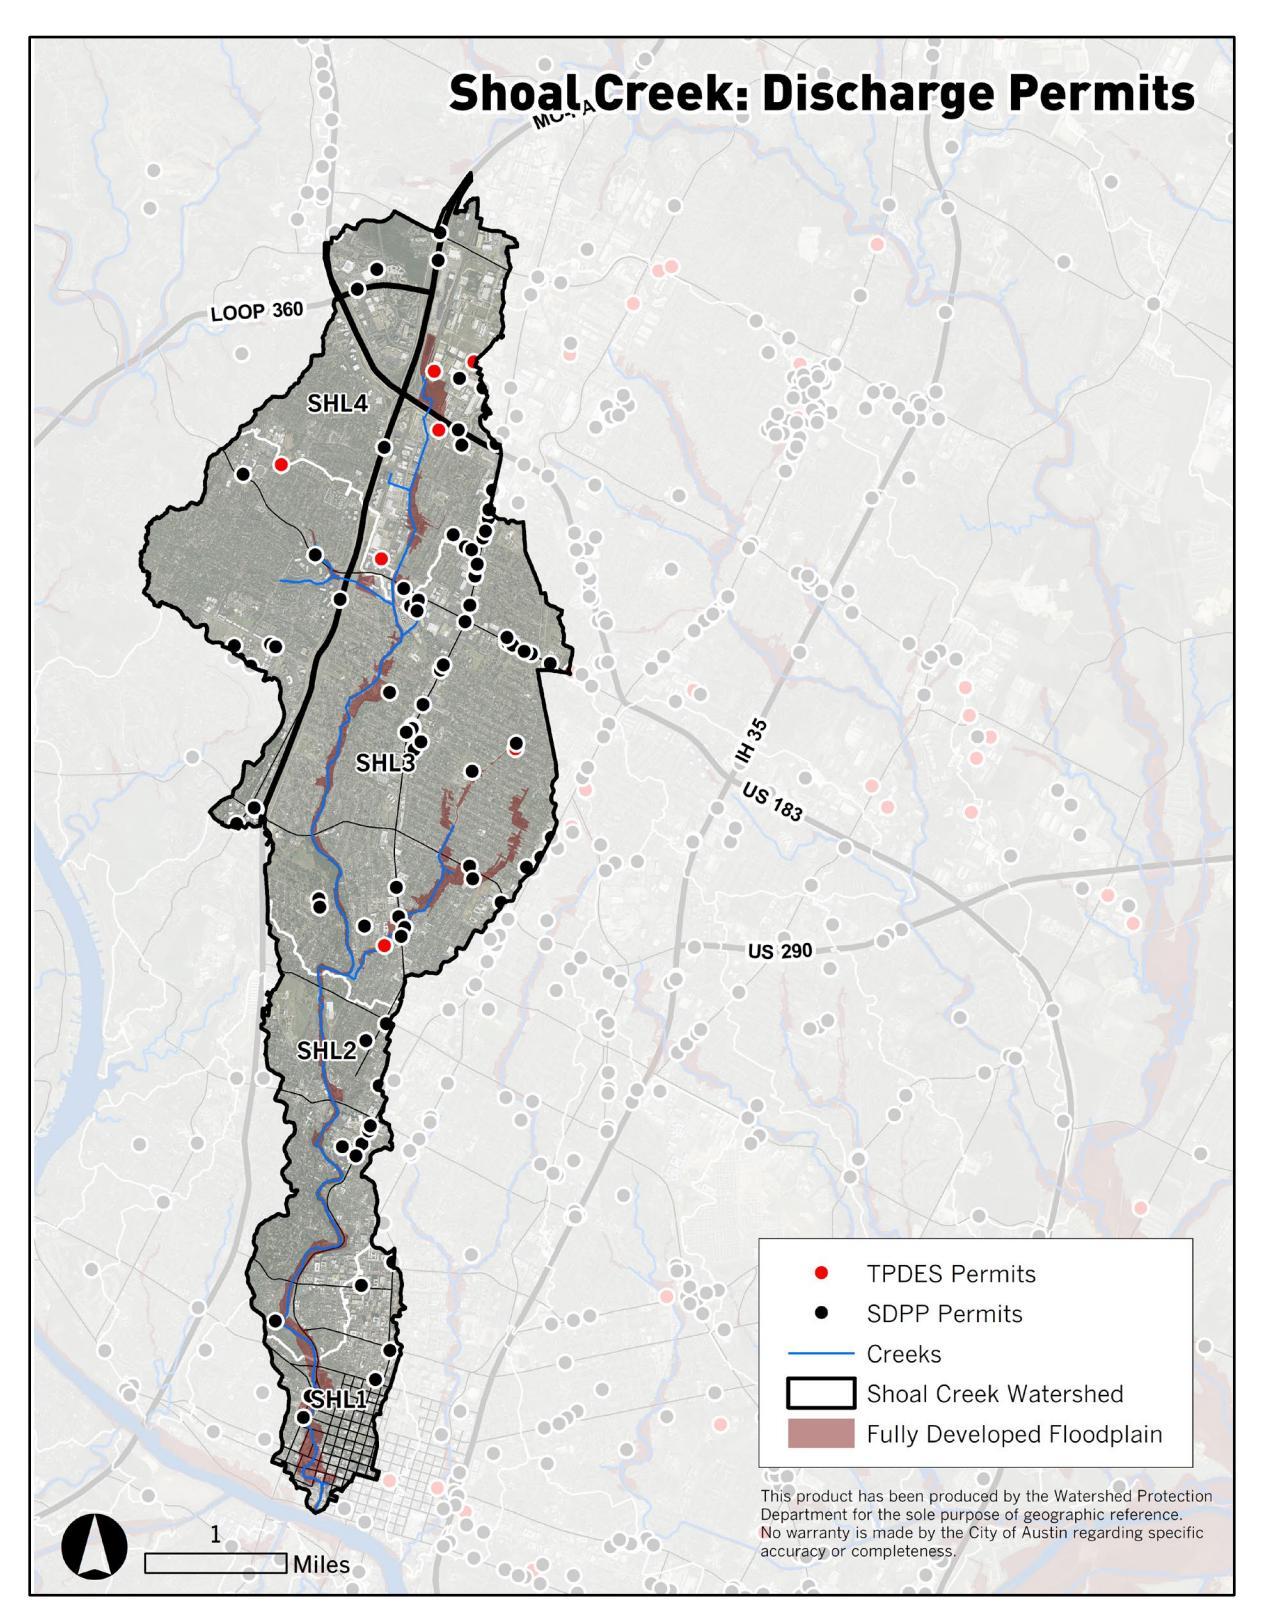
Figure 44 State and City Discharge Permits – There is a high density of SDPP discharge permits along North Lamar Boulevard. (COA-WPD, 2018)

COA-WPD's Stormwater Discharge Permit Program (SDPP) is responsible for identifying and tracking business facilities that may contribute a substantial pollutant load to the City's municipal separate storm sewer system (MS4). This program permits and routinely inspects specific commercial and industrial businesses within the Austin City limits to ensure best management practices are followed to prevent polluting discharges. Site inspections evaluate waste handling, storage and disposal practices, maintenance activities, and operational condition of water quality controls. This program also maintains a database of industrial and high-risk facilities subject to <u>Texas Pollution Discharge Elimination System</u> (TPDES) permits. There are 83 SDPP city permits (7.6% of total permits) and 7 TPDES state permits (8.5% of total permits) within the Shoal Creek watershed.
